Mechanical Properties Degradation of Teflon[®] FEP Returned From the Hubble Space Telescope

Prepared for the
36th Aerospace Sciences Meeting & Exhibit
sponsored by the American Institute of Aeronautics and Astronautics
Reno, Nevada, January 12-15, 1998

After 6.8 years on orbit, degradation has been observed in the mechanical properties of second-surface metalized Teflon[®] FEP (fluorinated ethylene propylene) used on the Hubble Space Telescope (HST) on the outer surface of the multi-layer insulation (MLI) blankets and on radiator surfaces. Cracking of FEP surfaces on HST was first observed upon close examination of samples with high solar exposure retrieved during the first servicing mission (SM1) conducted 3.6 years after HST was put into orbit.¹ Astronaut observations and photographs from the second servicing mission (SM2), conducted after 6.8 years on orbit, revealed severe cracks in the FEP surfaces of the MLI on many locations around the telescope. This paper describes results of mechanical properties testing of FEP surfaces exposed for 3.6 years and 6.8 years to the space environment on HST. These tests include bend testing, tensile testing, and surface micro-hardness testi

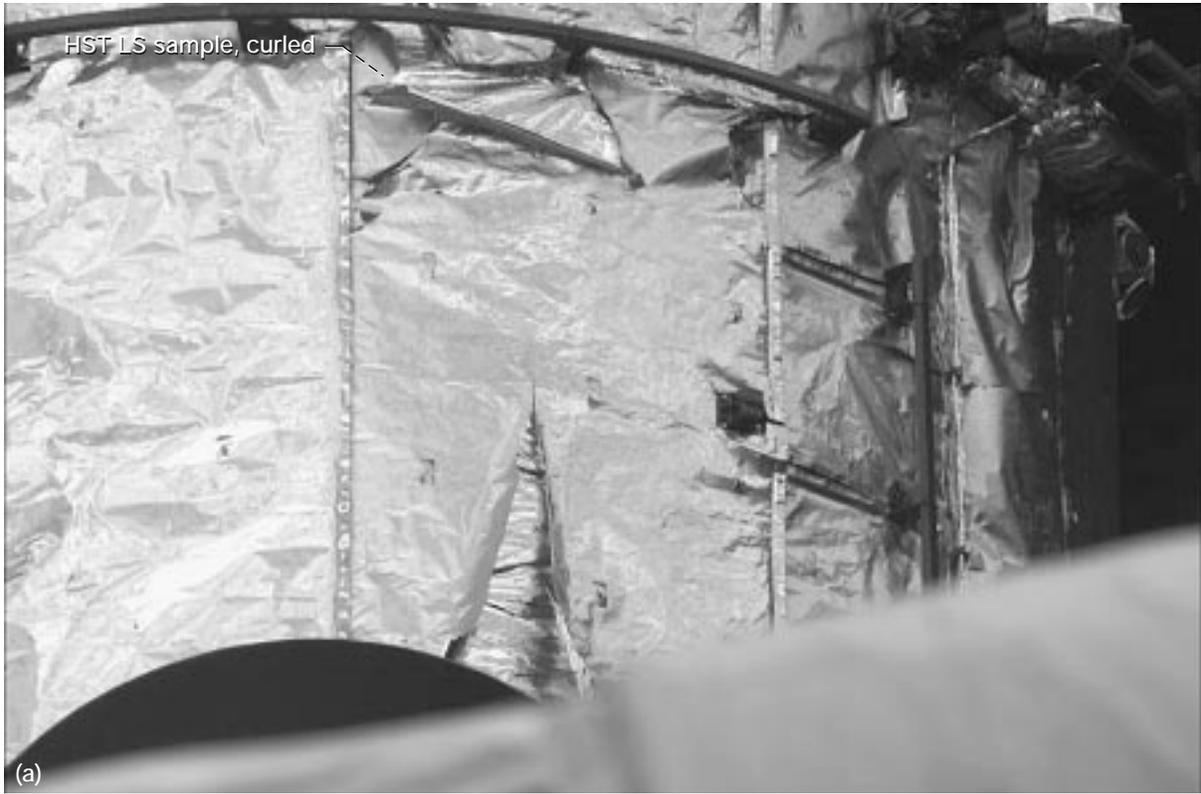
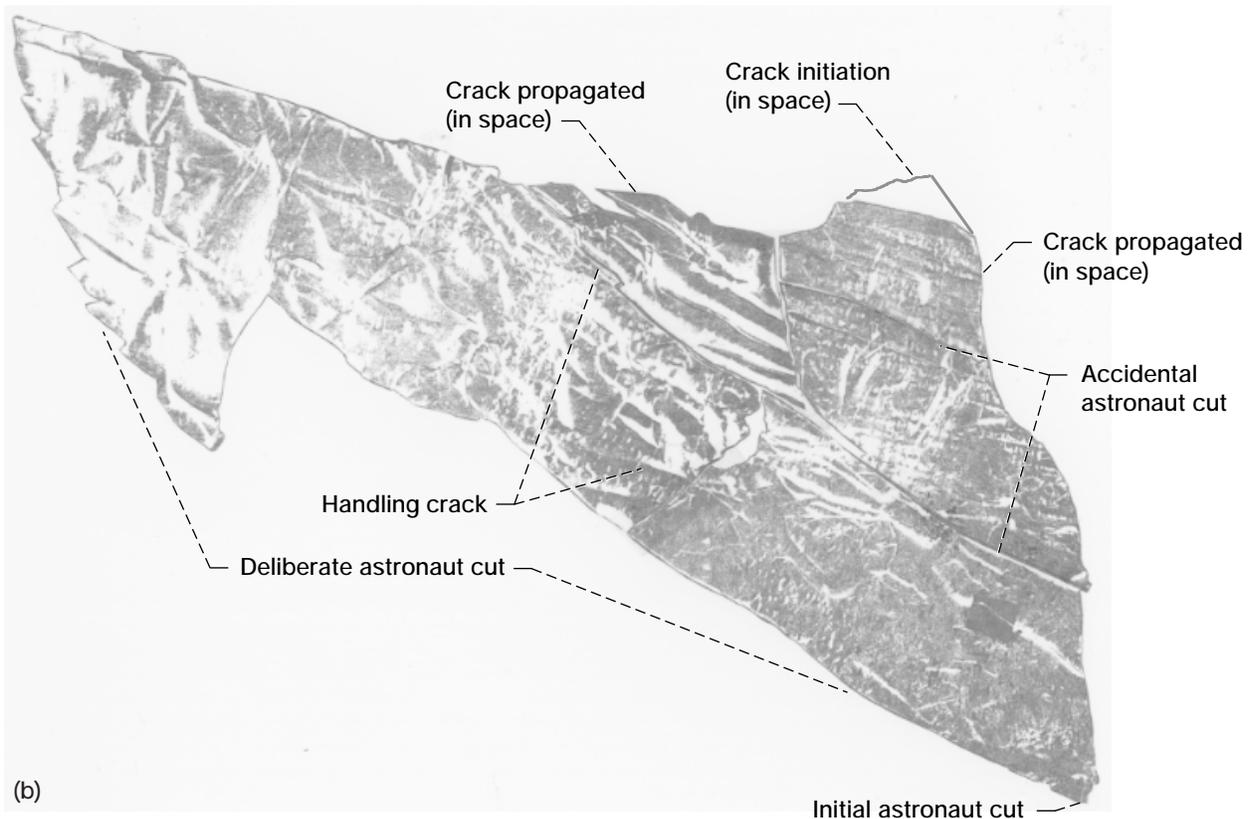
The two largest cracks in the HST LS MLI had 127 μm (0.005 in.) FEP/VDA MLI blanket patches installed over them during the SM2 mission. A small sample of the cracked MLI was trimmed off of the LS by astronauts during patch installation and was brought back to Earth for analysis. The cracked material (Fig. 2(a)) had curled, with the space-exposed FEP surface facing the inside of the roll, to a diameter of 1.5 cm (as measured after retrieval), indicating a volume shrinkage gradient. As evidence of its embrittlement, this specimen broke into several pieces as a result of handling during its return to Earth. Figure 2(a) shows the specimen on the HST LS prior to removal. Figure 2(b) shows the specimen reassembled following its return to Earth. Figure 2(b) identifies pre-launch and astronaut scissor cuts, crack initiation sites (where the blanket was cut to fit around a handrail stanchion), cracks that propagated in space, and subsequent handling cracks.

Figure 2.—HST SM2 Light Shield sample. (a) In place on the HST Light Shield prior to removal. (b) Photographs of pieces reassembled to show original configuration.

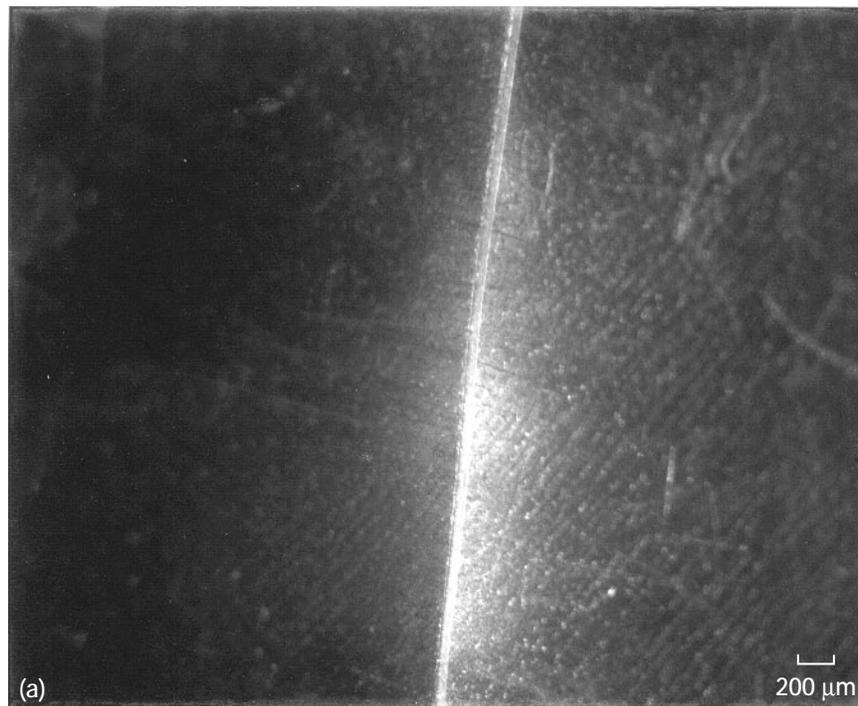
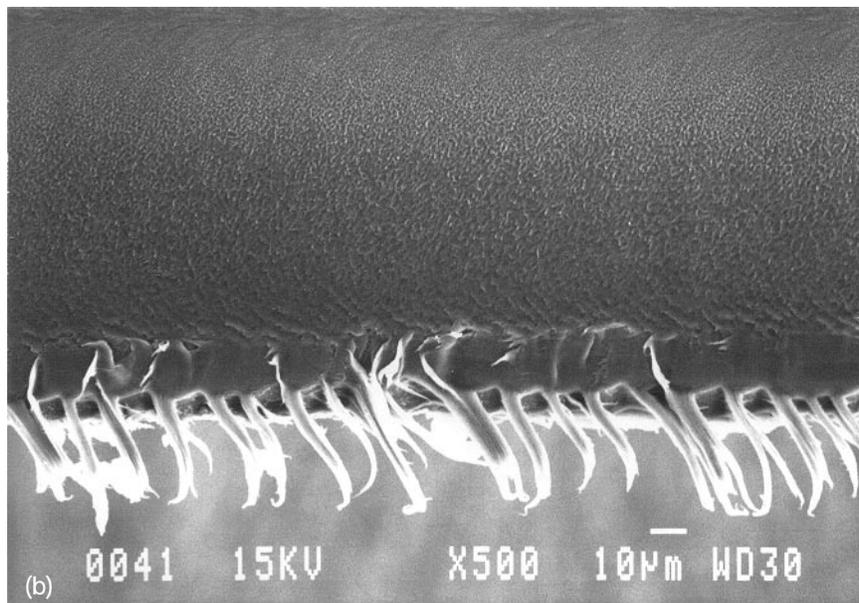
Each SM2 LS sample showed sudden formation of a single straight full-width crack due to bending around just one or two mandrels where there had been no previous sign of cracking. In each case, the crack formed was quite deep, leaving only a small amount of material holding the two halves of the bend-tested sample together. The SM2 LS fracture behavior is similar to that of brittle glass or ceramic materials where crack initiation is the critical stage of the fracture process. Once the crack is initiated, catastrophic fracture is inevitable, because energy absorbing processes such as plastic deformation, which would prevent crack propagation in ductile materials, do not occur. A single crack initiation site is typically observed. As shown in Table 2, cracking occurred at approximately 2 to 2.5 percent strain for SM2 LS samples. Figure 3(a) shows a photomicrograph of one of the cracks formed by bend testing the SM2 LS material. One SM2 LS bend-tested sample broke into two pieces due to handling. A scanning electron photomicrograph of the fracture surface of this sample, Figure 3(b), shows there are two distinct regions. The crack surface formed during bend-testing is the fibrous region, which accounts for approximately 80 percent of the fracture surface. The lower 20 percent of the fracture surface has long fibers of material extending from the fracture surface. These long fibers are probably the last remaining material which once held the bend-tested cracked sample together. Although it is likely that the degree of embrittlement in the SM2 LS material is a function of depth, these two distinct regions cannot be simply classified as embrittled and non-embrittled regions. The bending fracture mechanism is complicated by the fact that stress/strain will decrease after the crack is generated at the surface and continues to decrease as the crack propagates through the thickness of the specimen. Therefore, it is unlikely that the depth of the crack formed during bend testing is directly related to the depth of

Figure 3.—Crack in HST SM2 LS sample induced by bend-testing. (a) Photomicrograph of cracked surface. (b) Scanning electron photomicrograph of cross section of crack surface.

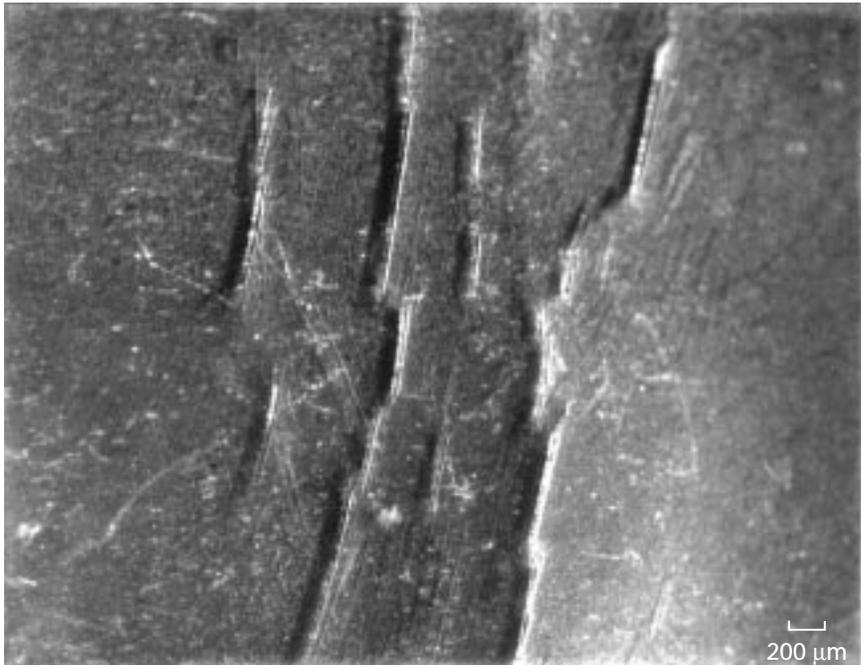
Results of bend testing of the SM1 MSS-A and MSS-D materials are also shown in Table 2. For these samples, hairline cracks due to handling already existed in the as-retrieved material. The data in Table 2 show the mandrel size and strain at which worsening of these existing cracks first occurred. Slight increases in length and width of existing cracks occurred as the material was bent around successively smaller mandrels. Although it was not measured, it is possible that depth of cracks also increased to some extent. However, bend-testing of these samples to the smallest mandrel did not result in deep catastrophic cracking as occurred with the SM2 LS material. Cracks formed in the SM1 MSS materials were much shallower than those formed in the SM2 LS material as evidenced by the structural integrity of the SM1 MSS bend-tested samples. Figure 4 shows an example of the jagged crack pattern as occurred in sample MSS-D.

Figure 4.—Photomicrograph of crack in HST SM1 MSS sample induced by bend-testing.
