**NASA  
Technical  
Paper  
3635**

Photovoltaic Plasma Interaction Test II

Bradford A. Kaufman,  
Daniel Chrulski,  
and Roger M. Myers

Bradford A. Kaufman and Daniel Chrulski  
*Lewis Research Center  
Cleveland, Ohio*

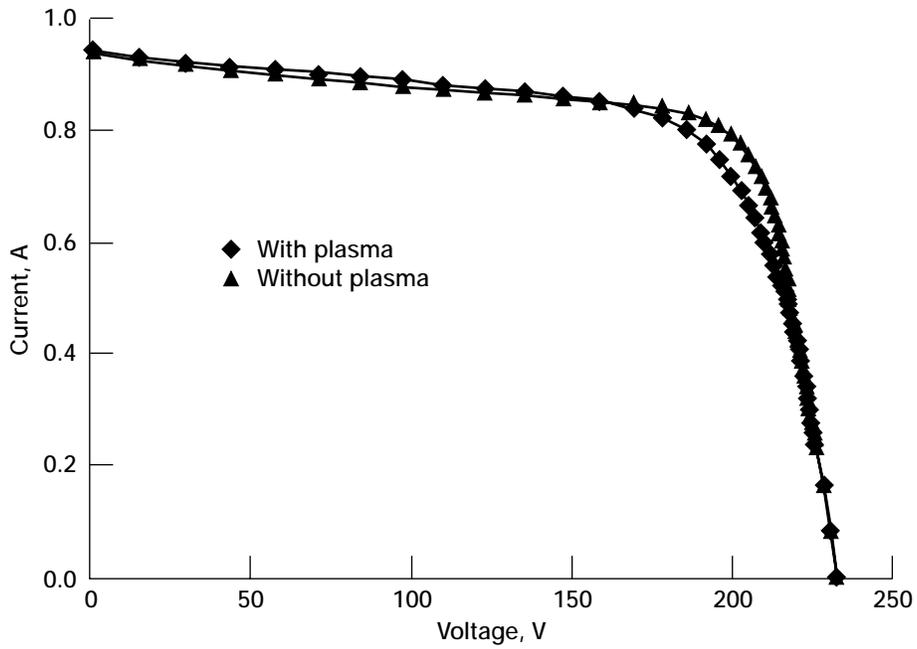
Figure 14.—Initial conditions. Bias voltage, 90.

*Results.*—A representative set of I–V curves with and without a plasma are presented in figure 14 and show that the curve shifted when the plasma was introduced into tank 5. What the curve does not show is that the shift was permanent and

remained throughout the testing. One possible explanation for this degradation is that some diffusion pump backstreaming coated the cells. Although the shift may have been significant in an absolute sense, it was insignificant for the PVPIT II, the results of which were only relative because there was no initial flashtest. An example of the floating potential is shown in figure 15.

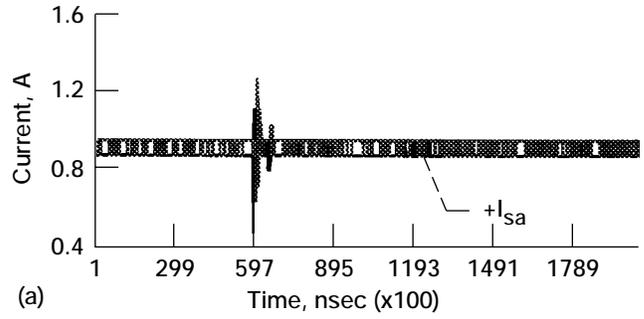
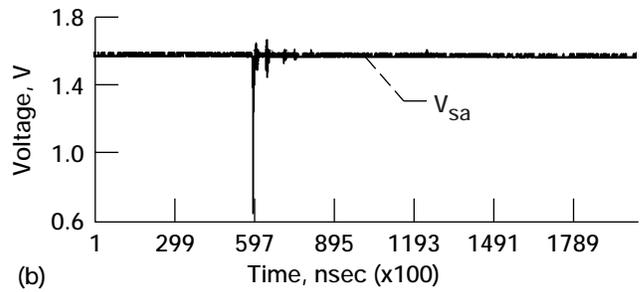
Figure 18.—Arc at 200-V bias and 160-V load. (a) Structure current;  $+I_{sa}$ , positive side of array. (b) Array voltage,  $V_{sa}$ .

Therefore, a plasma contactor that can raise the negative floating potential to not greater than  $-85$  V but to less than  $0$  V should prevent the array from arcing. The test with the unilluminated array confirmed these results. Figures 17(a), 18(a), and 19(a) show the current, and figures 17(b), 18(b), and 19(b) show the voltage for arcs that occurred with a 200-V bias and a 160-V load.

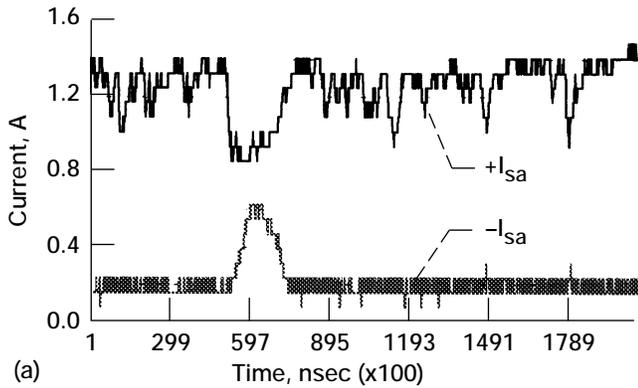
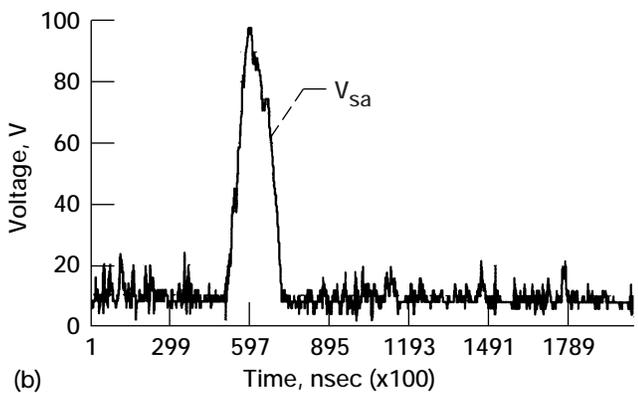
Figure 17.—Arc at 200-V bias and 160-V load. (a) Structure current;  $+I_{sa}$ , positive side of array;  $-I_{sa}$ , negative side of array. (b) Array voltage,  $V_{sa}$ .

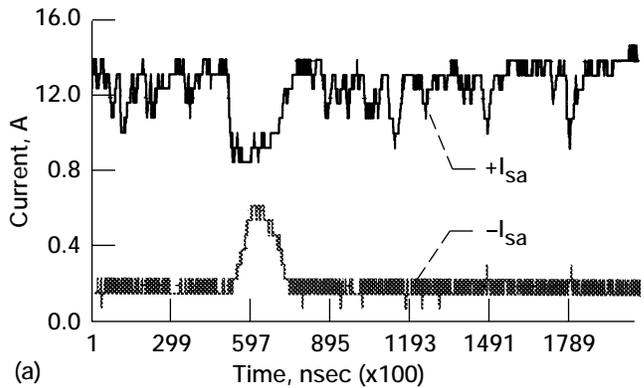
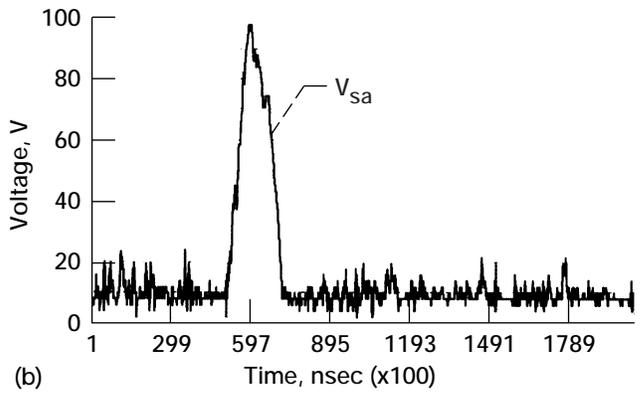
Figure 19.—Arc at 200-V bias and 160-V load. (a) Array current;  $+I_{sa}$ , positive side of array;  $-I_{sa}$ , negative side of array. (b) Array voltage,  $V_{sa}$ .

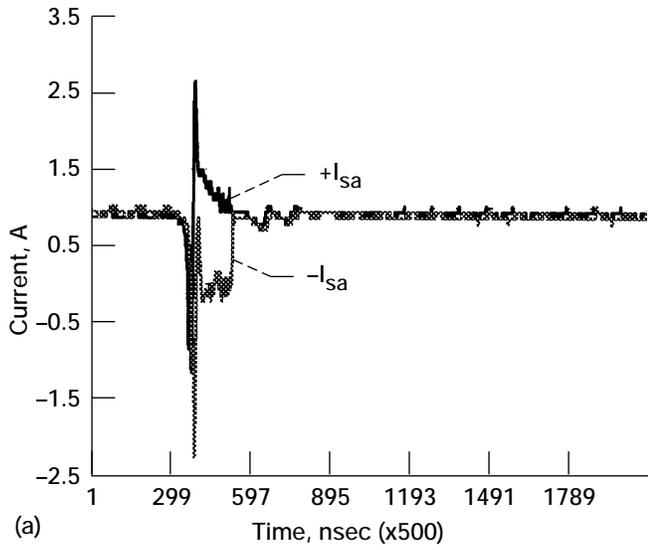
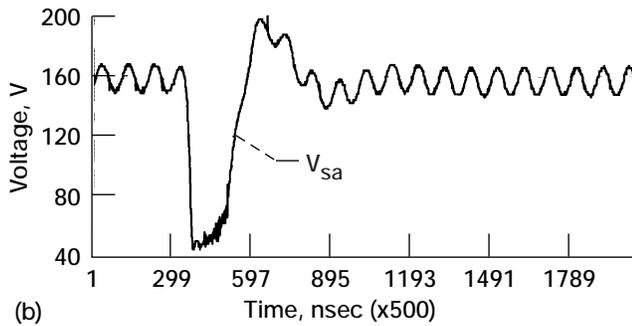
Figure 20.—Arc at 200-V bias and no load voltage. (a) Array current;  $+I_{sa}$ , positive side of array;  $-I_{sa}$ , negative side of array. (b) Array voltage,  $V_{sa}$ .

Figures 20(a) and (b) show the current and voltage, respectively, for an arc with a 200-V bias and no load voltage. Likewise, the photographs in figures 21 and 22 show some of the arc-caused damage to the cell edges. No observable performance degradation in output voltage or current resulted from the arc marks on the cells.

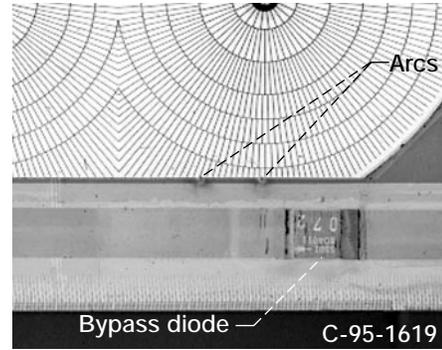
Figure 21.—Cell edge damage (negative image for clarity).

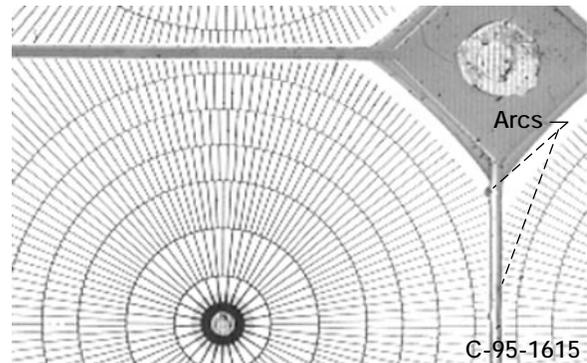
Figure 22.—Cell edge damage (negative image for clarity).

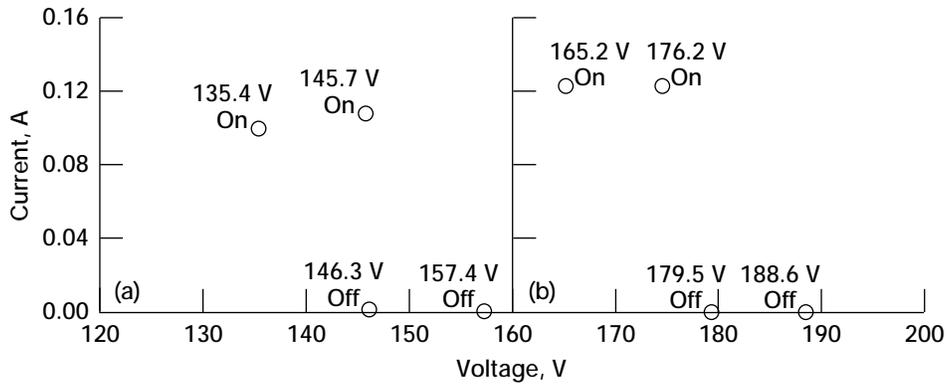
Figure 23.—Contactor current requirements with SSU. (a) 160-V unregulated voltage. (b) 200-V unregulated voltage.

*Results.*—With the SSU switching at 20 kHz, the plasma contactor reduced the negative floating potential of the array for both load voltage conditions, as it was designed to do. The current that the plasma contactor drew from the array appeared to be a linear function of the array load voltage (as the load voltage increased, so did the contactor current). Figure 23 shows the plasma current versus the array load voltage for both load voltage conditions.

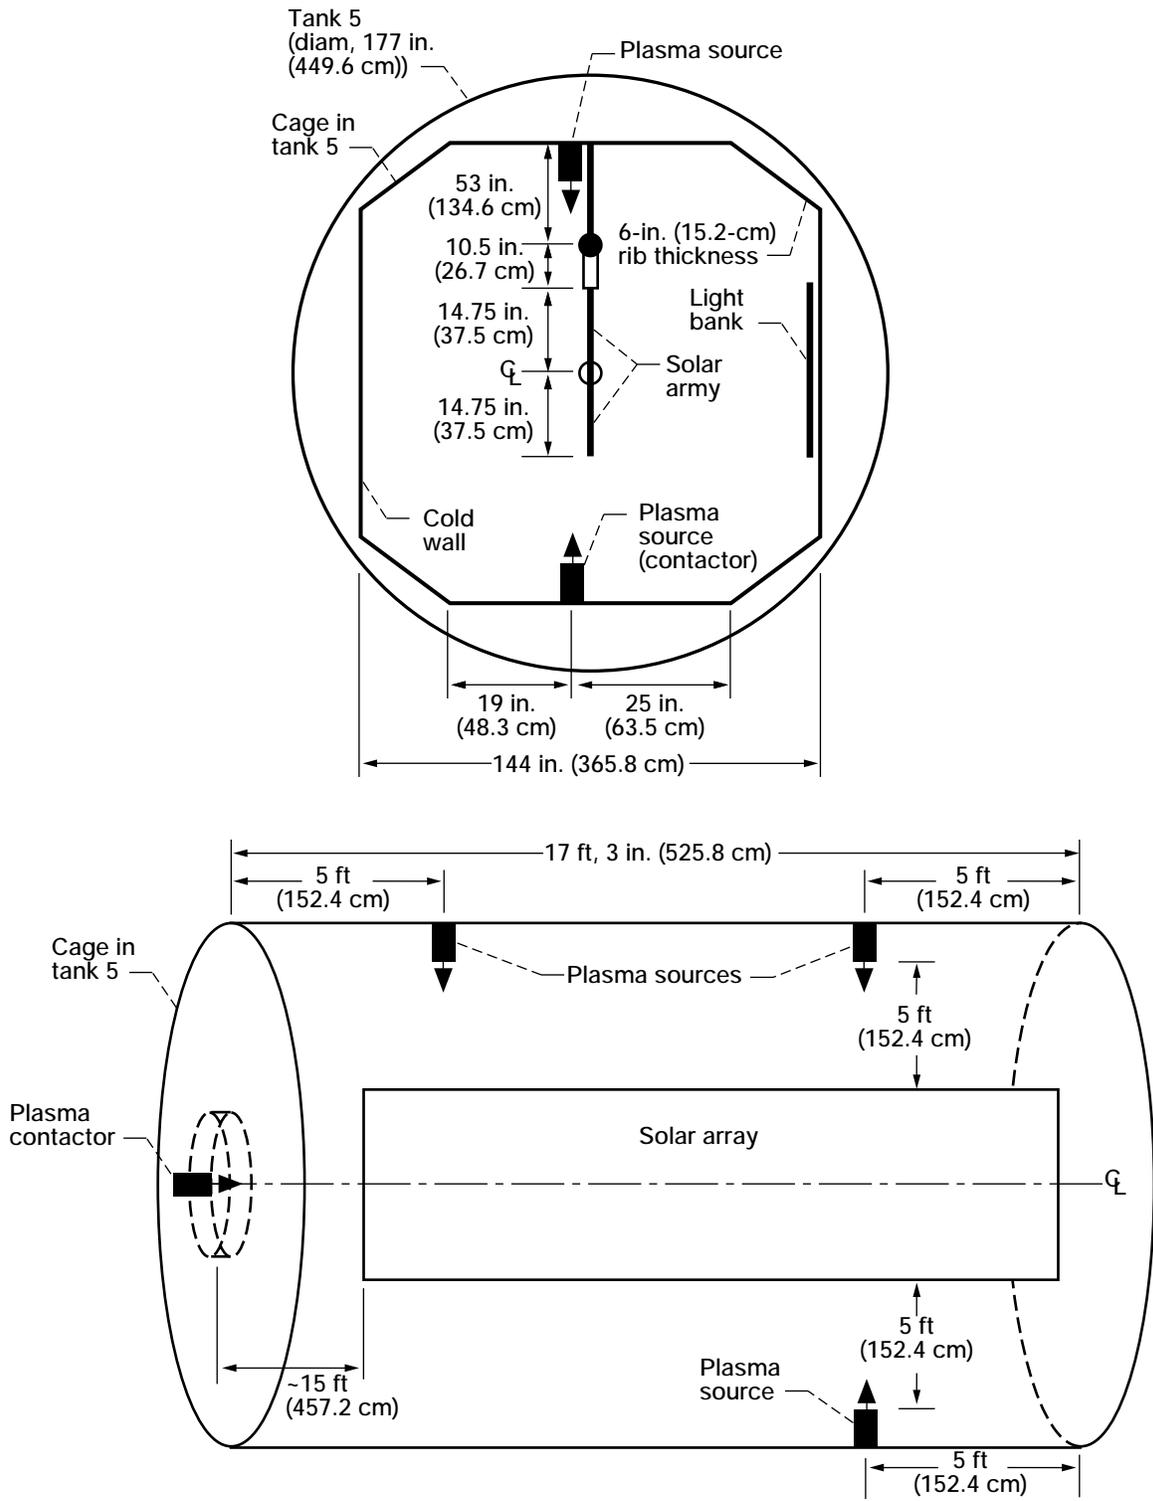
Figure 24.—Contactor and source locations. Note: drawing not to scale; plasma source was only used as a plasma contactor for first part of test and was never used to provide plasma environment.

*Method.*—A hollow-cathode plasma source was added to the illuminated, loaded solar array circuit (it was operating and a jumper was used to switch it in or out of the circuit as shown in fig. 13). When connected to the circuit, this plasma source functioned as a plasma contactor by shifting the floating potential of the array. Because both the plasma source and contactor are hollow-cathode devices, the plasma source is essentially a plasma contactor. About halfway through testing, an actual breadboard plasma contactor became available. The plasma source was shut down, the plasma contactor was activated and connected to the circuit, and testing was continued. The locations of the plasma source and the contactor differed (fig. 24).

The plasma source was near the bottom corner of the array, closest to the cryopanel, and it fired up toward the array; the plasma contactor was at the opposite end of the array and fired along its center axis towards the cryopanel.

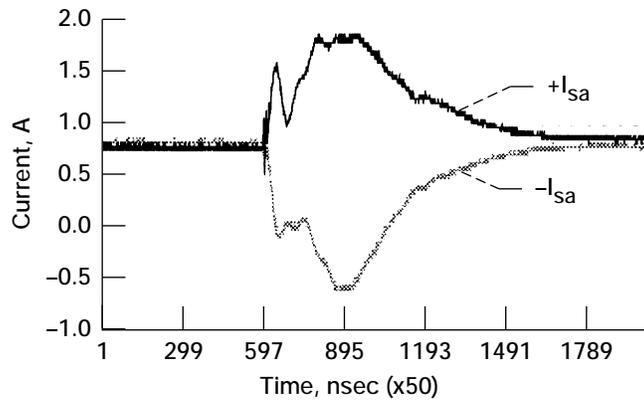
Figure 25.—Array voltage during arc. Array current;  $+I_{sa}$ , positive side of array;  $-I_{sa}$ , negative side of array.

*Results.*—During the test, the plasma contactor acted quickly to raise the floating potential of the array. The current transients for the positive and negative ends of the array are shown in figure 25.

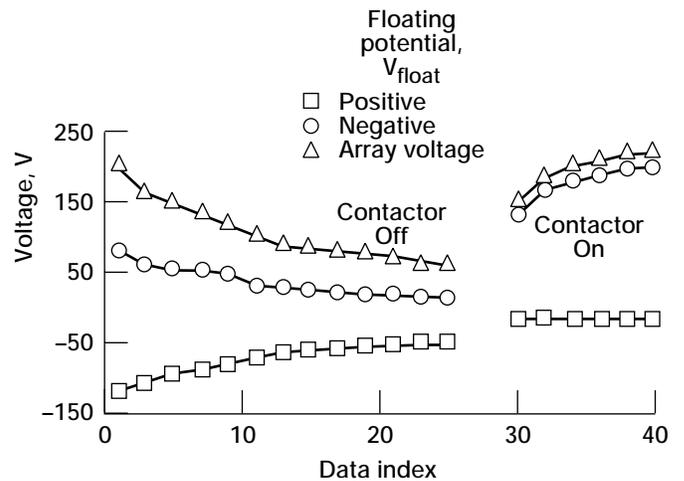
Figure 32.—Constant negative floating potential with contactor.

*Results.*—Without the contactor, the FASTMast arced rapidly. Arc data were collected as rapidly as the transient data collection system could capture the arcs. The magnitude of these arcs varied from approximately 1.4 to 6.0 A and their duration was about 50  $\mu\text{sec}$ . Figures 28 (1.5 A) and 29 (6 A) are representative of the arcs observed. The array voltage during the 6.0-A arc event is shown in figure 30 ( $V_{\text{sa}}$ ), and the negative and positive array currents during this same arc event are shown in figure 31 ( $I_{\text{sa}}$ ). Arcing ceased when the load voltage was lowered to approximately 65 V. More significantly, arcing also ceased when the plasma contactor was activated (fig. 32).

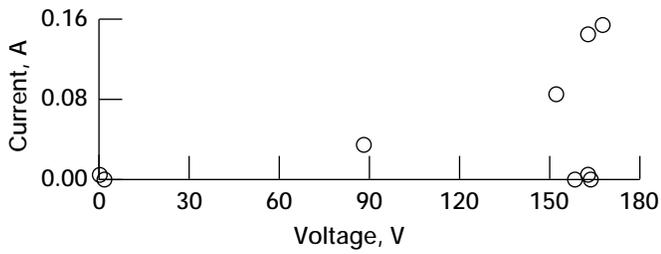
Figure 33.—Contactor current versus array voltage in and out of eclipse.

*Results.*—As a result of limitations on the lamp bank power supplies and controls, it could not be switched on instantaneously, only gradually over a matter of seconds. Shutting off power to the lamp bank was instantaneous, but because they took some time to darken, the lights were very hot. Therefore, the only data that could even be considered true transient data were those during the eclipse simulation. Because of these considerations, no transient data were recorded. Figure 33 shows the contactor currents during the simulations, and they are consistent with those previously measured.

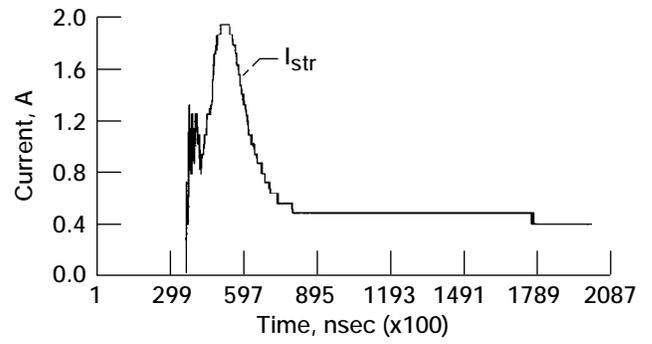
Figure 36.—Arc without sequential shunt unit (SSU).

*Results.*—This test was similar to the preceding one in that it had the same problems simulating eclipse and illumination transients. Unlike that test, data were collected for arcing transients when the contactor was not activated. Some of these arcing events are shown in figures 34 and 35. Figure 36 is an arc without the SSU switching, and figure 37 is an arc with a 20-kHz SSU switching.

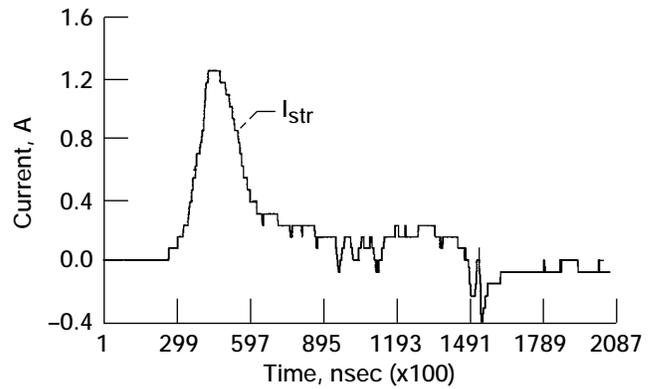
Figure 37.—Arc with sequential shunt unit (SSU).
