NASA/TM—1998-208832

Effects of Fiber Coating Composition on Mechanical Behavior of Silicon Carbide Fiber-Reinforced Celsian Composites

Narottam P. Bansal and Jeffrey I. Elderidge
Lewis Research Center, Cleveland, Ohio

December 1998

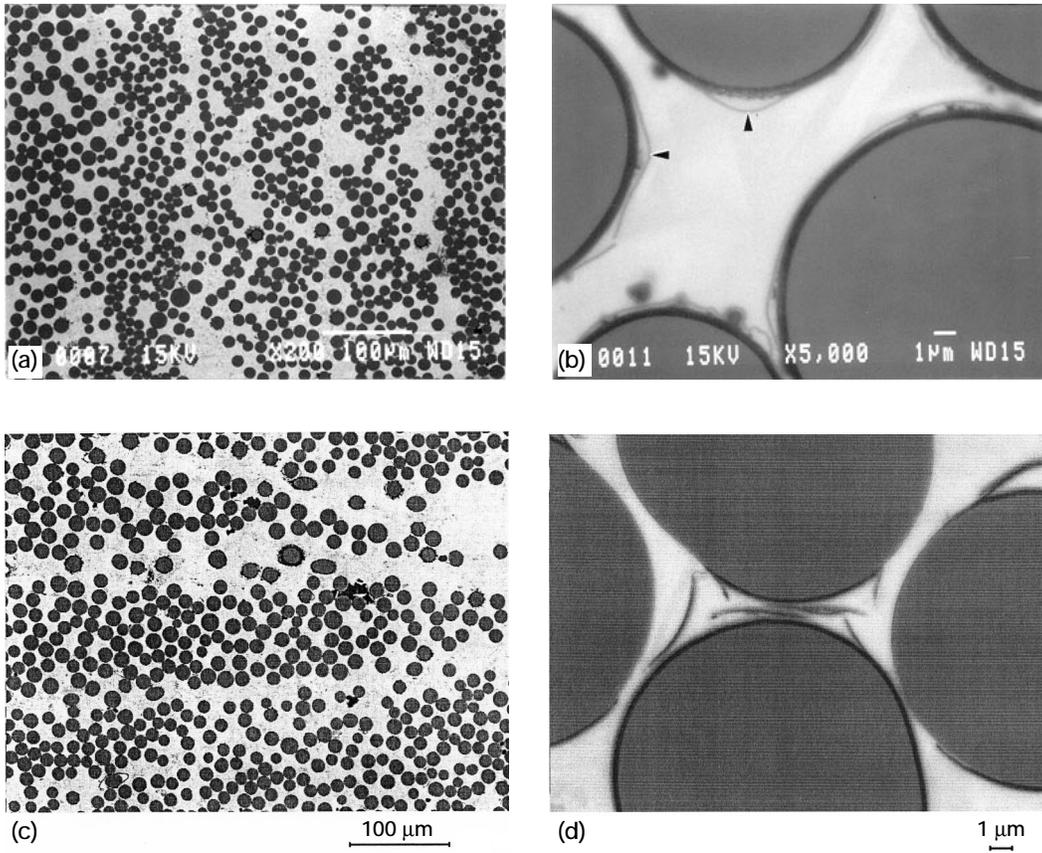
Figure 1.—SEM micrographs of polished cross-sections of unidirectional HiNicalon/BN/ SiC/ Celsian composites: (a, b) batch 1 composite and(c, d) batch 2 composite.

SEM micrographs taken from the polished cross-sections of the two composites (fig. 1) indicate uniform fiber distribution and good matrix infiltration within the fiber tows resulting in high composite density. Occasional pores within the fiber tows are present. The outer SiC coating has debonded from some of the fibers in both composites. However, the BN/SiC duplex coating was completely detached from some of the fibers in the CMC reinforced with batch 2 coated fibers as seen in figure 1(d) which represents the worst case (atypical). XRD patterns taken from the polished surface of the CMC panels indicated the presence of only monoclinic celsian. This implies that the desired monoclinic celsian phase is formed *in situ*, from the oxide precursor during hot pressing. No hexacelsian was detected from XRD.

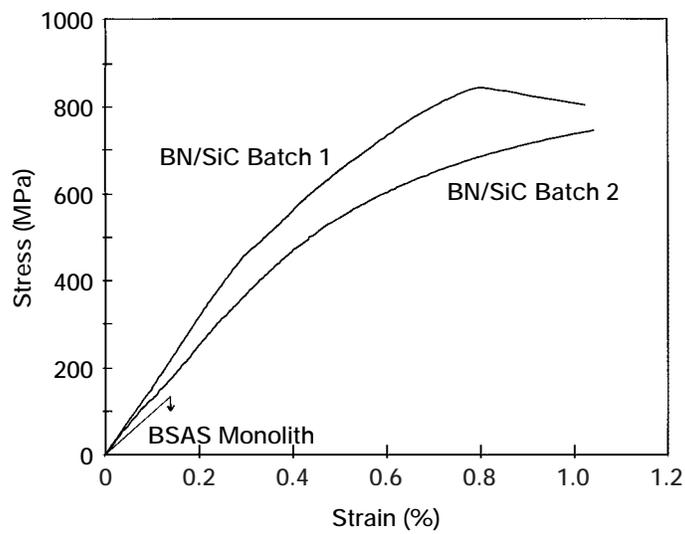
Figure 2.—Apparent stress-strain curves recorded in three-point flexure for celsian matrix composites reinforced with Hi-Nicalon fibers coated with BN/SiC in two separate batches. Also shown for comparison are the results for a hot pressed BSAS monolith.

Typical stress-strain curves recorded in three-point flexure for the two composites are presented in figure 2. The stress-strain curve for a hot pressed celsian monolith is also shown for comparison. The monolith shows a modulus of 96 GPa, flexural strength of 131 MPa and fails in a brittle mode as expected. Both CMCs show initial linear elastic behavior followed by deviation from linearity. This indicates load transfer to the fibers beyond the proportional limit indicating a true composite behavior. SEM micrographs of fracture surfaces after the flexure tests are shown in figure 3. Extensive long lengths of fiber pullout are observed for both composites indicating toughening behavior. Values of density, fiber volume fraction, elastic modulus and various mechanical properties are given in table I. Both the composites show high ultimate strength in accordance with the value of the fiber volume fraction. However, a large difference is observed in the values of σ_{mc} for the two composites. This is quite surprising because both composites were processed under exactly similar conditions. The only difference was that the duplex BN/SiC coating on the fibers used for fabrication of the two composites were deposited in two different batches, but by the same vendor. The difference in fiber volume fractions in the two composites

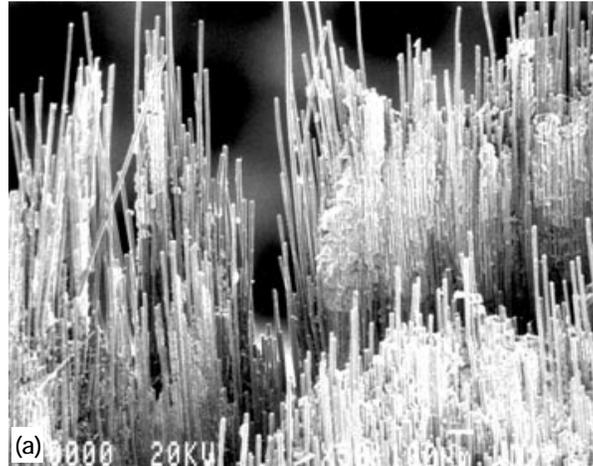
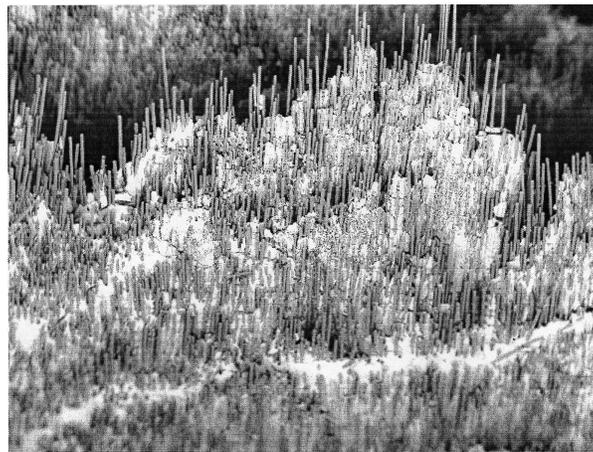
Figure 3.—SEM micrographs showing fracture surfaces of celsian matrix composites reinforced with Hi-Nicalon fibers coated with BN/SiC in two separate batches: (a) batch 1 coating, (b) batch 2 coating.

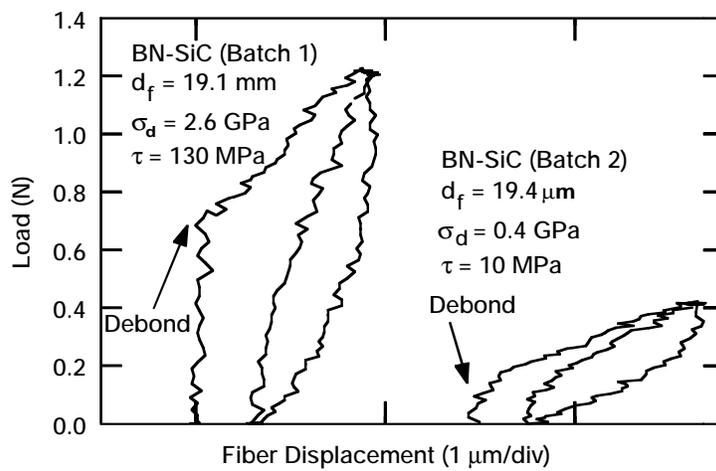
Figure 4.—Load versus fiber displacement curves recorded during fiber push-in testing of celsian matrix composites reinforced with Hi-Nicalon fibers coated with BN/SiC in two separate batches.

In order to determine whether differences in interfacial behavior were the source of the disparity in σ_{mc} for the two composites with “similar” BN/SiC interphase coatings, fiber push-in tests were carried out. A number of fibers were pushed in for each composite. Typical cyclic push-in curves at room temperature for the two composites with BN/SiC interface coatings are shown in figure 4. The data were analyzed by first subtracting the appropriate load-train compliance correction from the measured displacements. An estimate of frictional sliding stress, $\tau_{friction}$, was determined using the constant $\tau_{friction}$ model of Marshall and Oliver (ref. 10) which includes effects of residual stresses, but does not consider fiber roughness or Poisson expansion. Values of $\tau_{friction}$ were determined by fitting the compliance corrected data from the first reloading curve to the relationship:

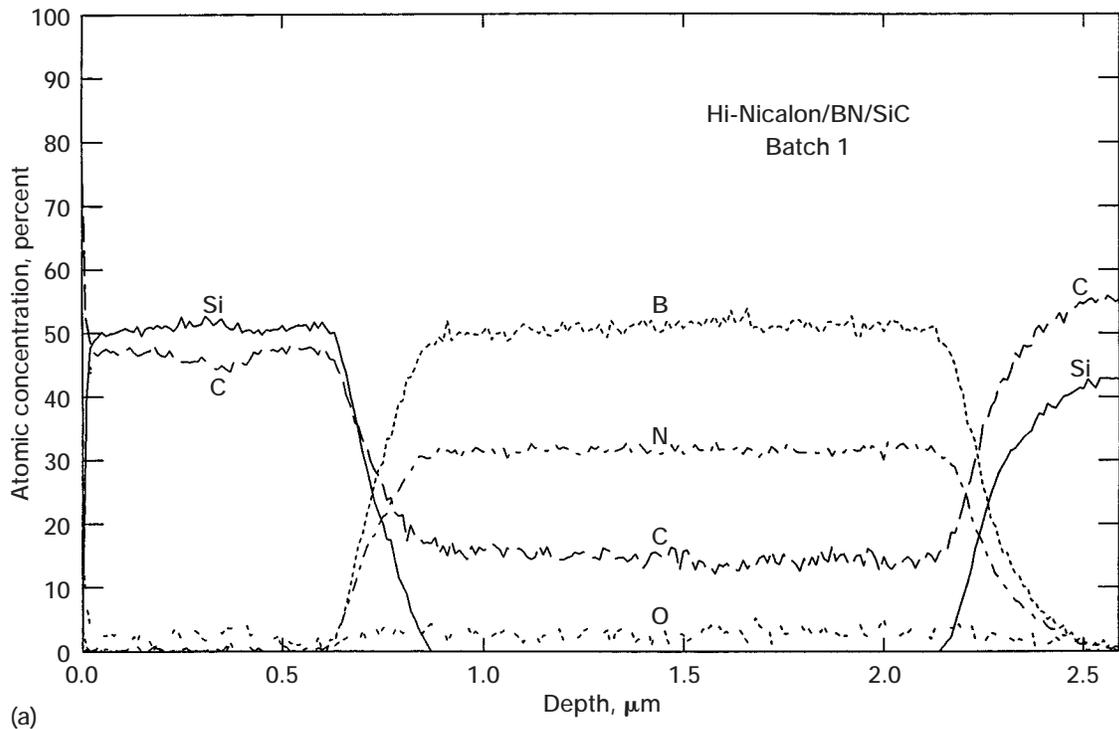
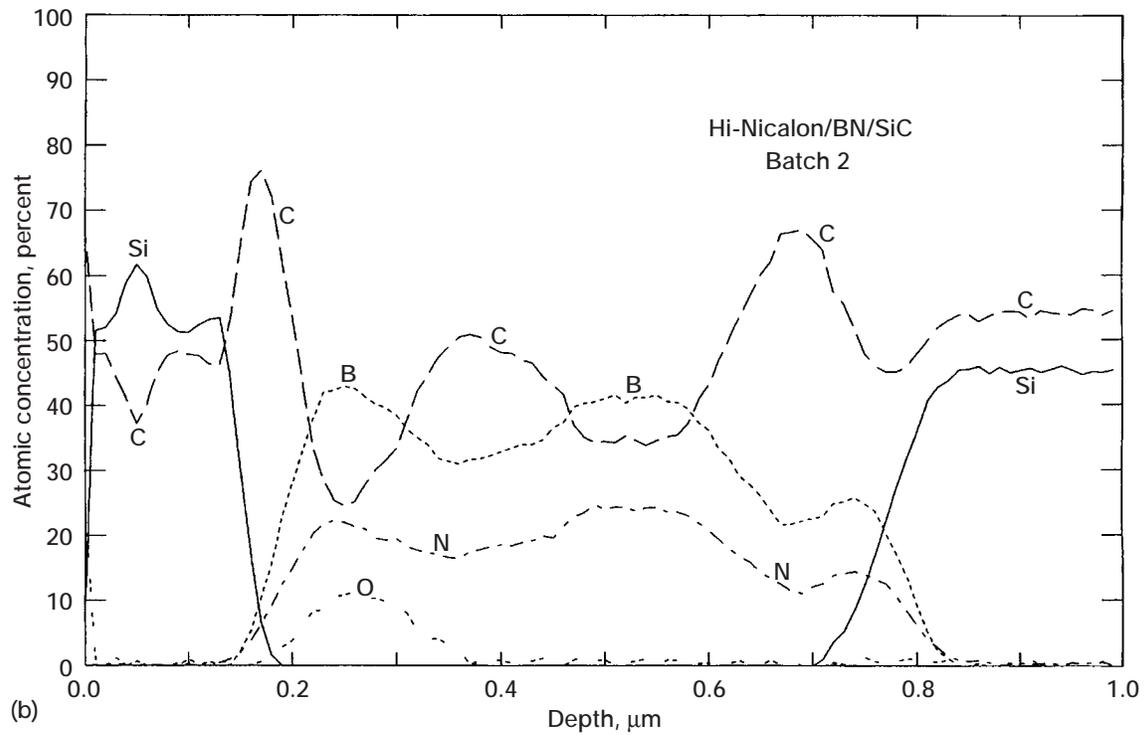
Figure 5.—Scanning Auger microprobe depth profiles of various elements for Hi-Nicalon fibers having a duplex BN/SiC surface coating deposited by CVD: (a) coating batch #1, and (b) coating batch #2.

Elemental composition depth profiles obtained from scanning Auger microprobe analysis for the two batches of BN/SiC coatings on Hi-Nicalon fibers are shown in figure 5. The batch 1 coating consists of $\sim 0.7 \mu\text{m}$ thick outer layer of slightly silicon-rich SiC followed by a boron-rich BN layer $\sim 1.5 \mu\text{m}$ thick. The BN layer also contains ~ 15 at % of carbon and ~ 2 percent oxygen. The thickness of the dual coating on this filament is much higher than the nominal coating thickness of $0.4 \mu\text{m}$ BN and $0.3 \mu\text{m}$ SiC. The batch 2 coating consists of $\sim 0.15 \mu\text{m}$ thick Si-rich SiC followed by $\sim 0.6 \mu\text{m}$ of carbon rich “BN.” A carbon layer is also present between the SiC and “BN” coatings. Another predominantly carbon layer is observed between the “BN” and the

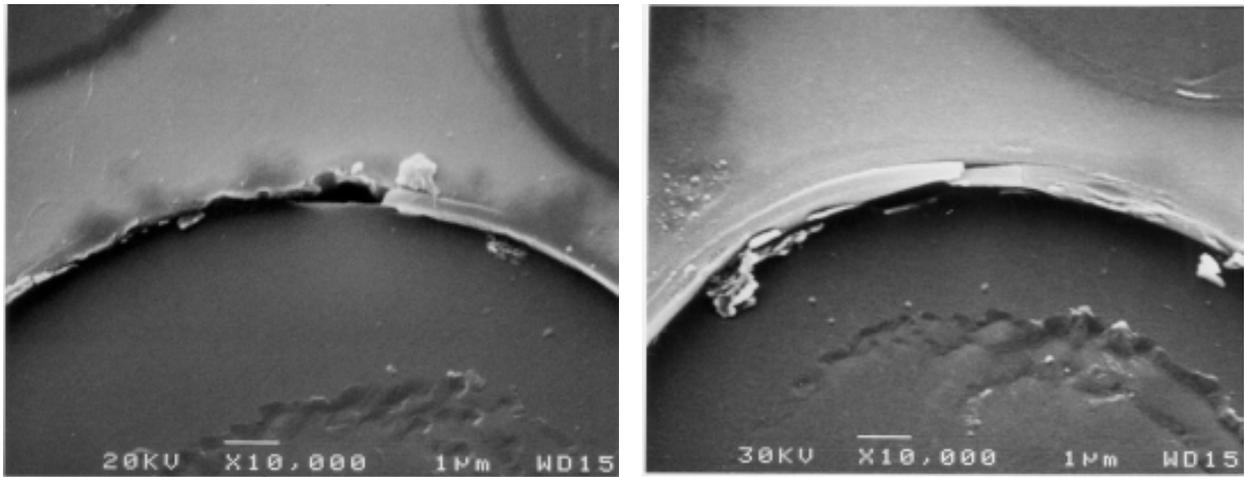
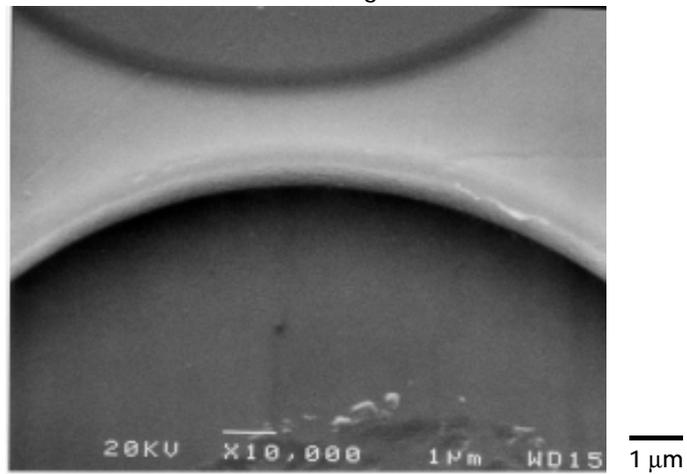
Wear debris regions

Clean failure region

Figure 6.—SEM micrographs showing interface failure during fiber push-in for celsian matrix composites reinforced with Hi-Nicalon fibers coated with BN/SiC in batch 1.

Microscopic examination (figs. 6 and 7) of the fiber pushed-in samples indicated the presence of wear debris at the interface. The wear debris consists of thick sections of coating in composite #1 (fig. 6) but only of thin sublayers of coating in composite #2 (fig. 7). The debonding occurs primarily between the innermost coating and the fiber for both composites. Therefore, according to the Auger results, interfacial sliding occurs at the fiber(SiC)/BN interface for composite #1 and at the fiber(SiC)/carbon interface for composite #2. Comparison of σ_d and τ_{friction} values for the two composites indicate that the interface is more strongly bonded and the frictional sliding forces are higher between fiber/BN in composite #1 than the fiber/carbon interface in composite #2. Brennan et al. (ref. 11) obtained a value of 9.9 ± 3.5 MPa for τ_{friction} for the Nicalon/LAS composites, from a similar fiber push-in method using the analysis of Marshall and Oliver (ref. 10). This is consistent with the observation of *in situ* formation of a thin carbon layer at the fiber/matrix interface during processing of this composite. τ_{friction} values of 139 ± 95 and 124 ± 71 MPa have been reported (refs. 11 and 12) for Nicalon/BN/SiC/BMAS and Nicalon/BN/SiC/LAS glass-ceramic matrix composites from the fiber push-in technique as used in the current study. The BN/SiC fiber coatings in these composites were also applied by 3M and the scanning Auger microprobe analysis indicated these coatings to be similar to batch 1 coatings of the present work. Several factors such as residual thermal clamping stresses, fiber roughness, and modulus and thickness of the fiber coating which can control the former factors contribute to the value of τ_{friction} . However, values of τ_{friction} differing by a factor of about 12 in the two composites of the present study may be attributed primarily to the much lower sliding friction between C/SiC versus BN/SiC interfaces and also to the difference in the size of the wear debris at the interface.

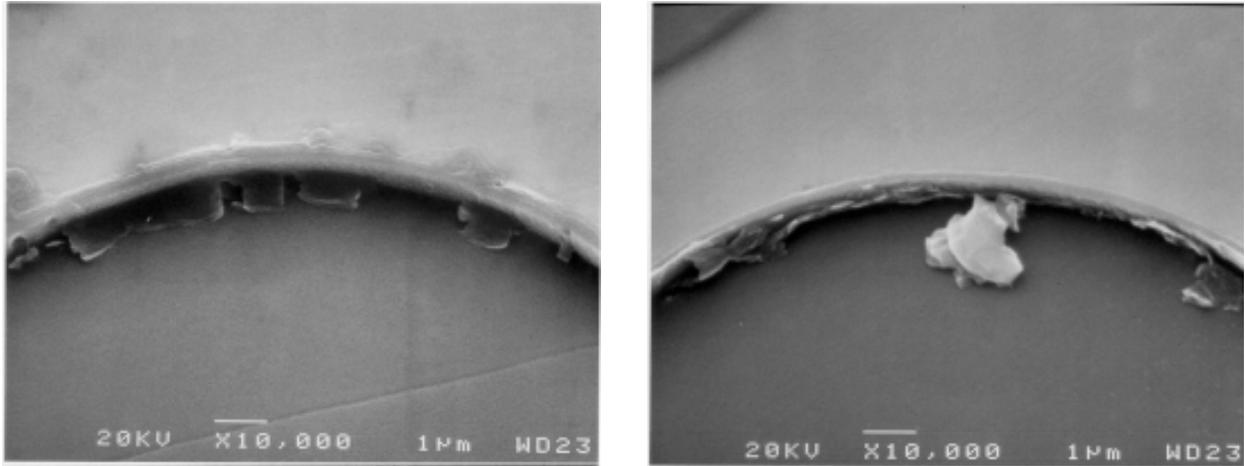
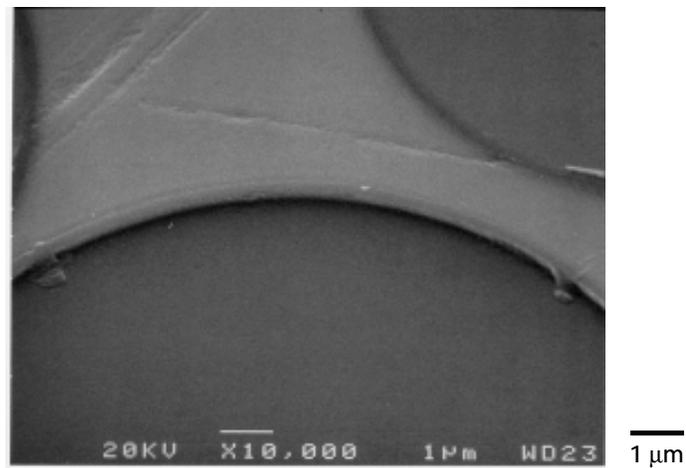
Wear debris regions

Clean failure region

Figure 7.—SEM micrographs showing interface failure during fiber push-in for celsian matrix composites reinforced with Hi-Nicalon fibers coated with BN/SiC in batch 2.
