Evaluation of Space Power Materials Flown on the Passive Optical Sample Assembly

NASA/TM—1999-209061

April 1999

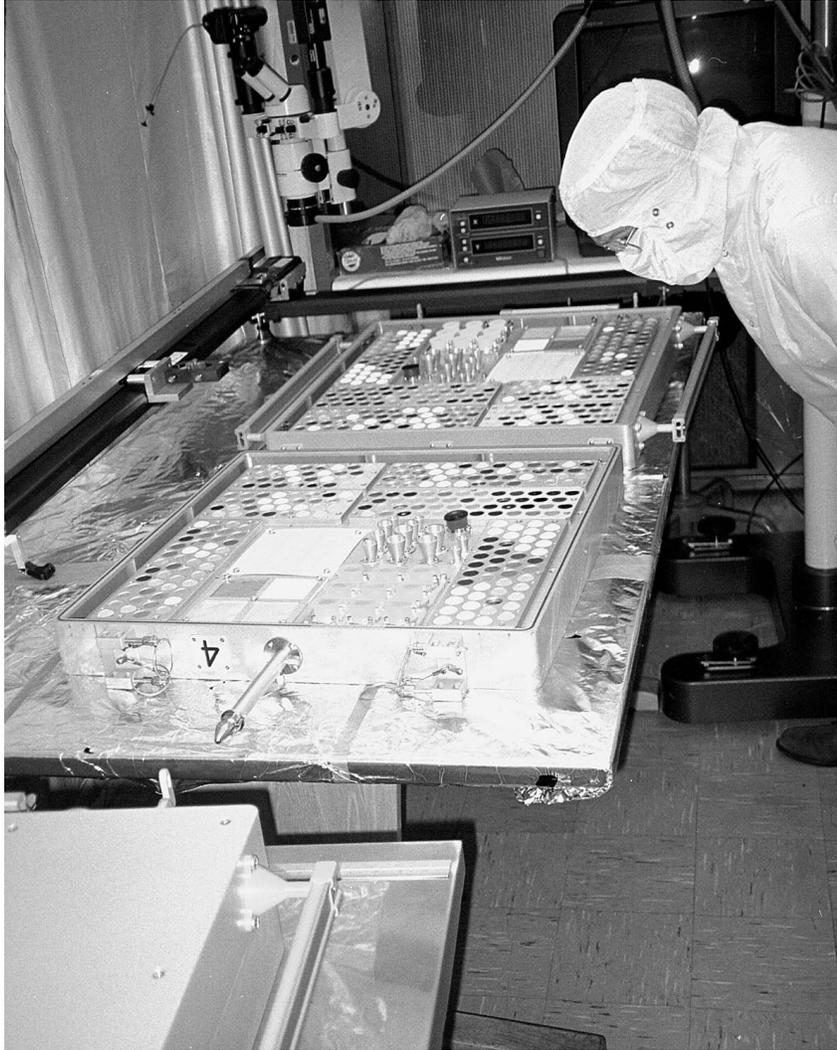
Figure 1a. POSA II package being opened after flight.

Figure 1a shows the POSA II package being opened after flight. In general, the appearance of the returned samples was as expected. There was evidence of atomic oxygen erosion on the unprotected Kapton samples, and there was some discoloration on samples and mounting hardware. It was interesting to note that some regions were not discolored, apparently protected from the source of the discoloring agent due to shadowing. The degree of atomic oxygen erosion was obviously less than expected, because pieces of sacrificial Kapton remained in place. The most obvious and unexpected feature was found on the space facing side of the package, where as shown in Figure 1b there was a spattering across the surface best characterized as the dried remains of droplets. These dried remains are thought to have come from one or more waste water dumps from the space shuttle, while docked to Mir, hereafter referred to as the organic contaminant.

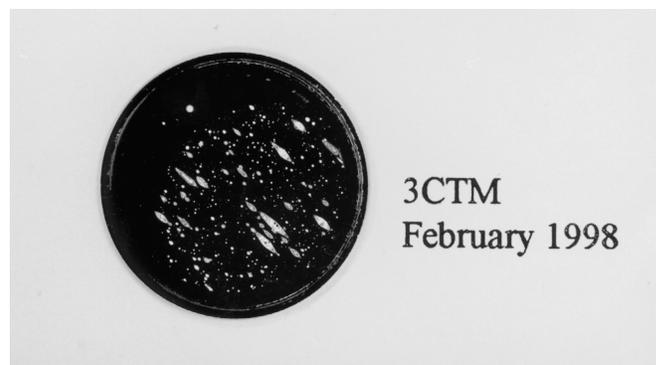
Figure 1b. Close up of one sample from the space facing side, showing the spattering of droplets.

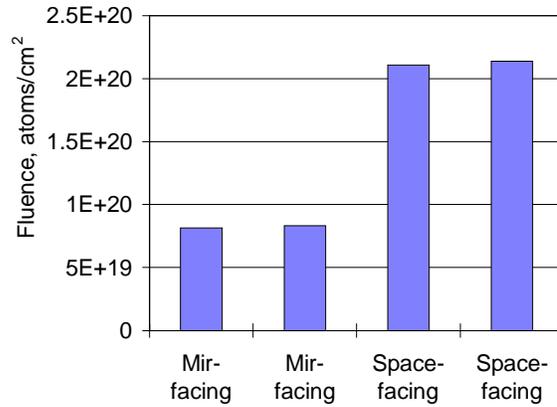
Figure 2. Atomic oxygen fluence measured by Kapton.

Figure 2 summarizes the atomic oxygen fluence measured by the two Mir facing and the two space facing Kapton samples. The two Kapton samples on the Mir facing side of the POSA-2 package both had a mass loss near 0.0012 grams, yielding an estimated atomic oxygen fluence of 8.2×10^{19} atoms/cm². The two Kapton samples on the space facing side of the POSA II package both had a mass loss near 0.0031 grams, yielding an estimated atomic oxygen fluence of 2.1×10^{20} atoms/cm². It is interesting to note that the SiO_x coated Kapton H showed no change in dehydrated mass. With the protective coating of SiO_x, the atomic oxygen fluence was found to be too small for undercutting studies. The absence of change in mass further suggests that the mass of contaminants found on these (and all the other samples including the Kapton samples) was negligibly small.

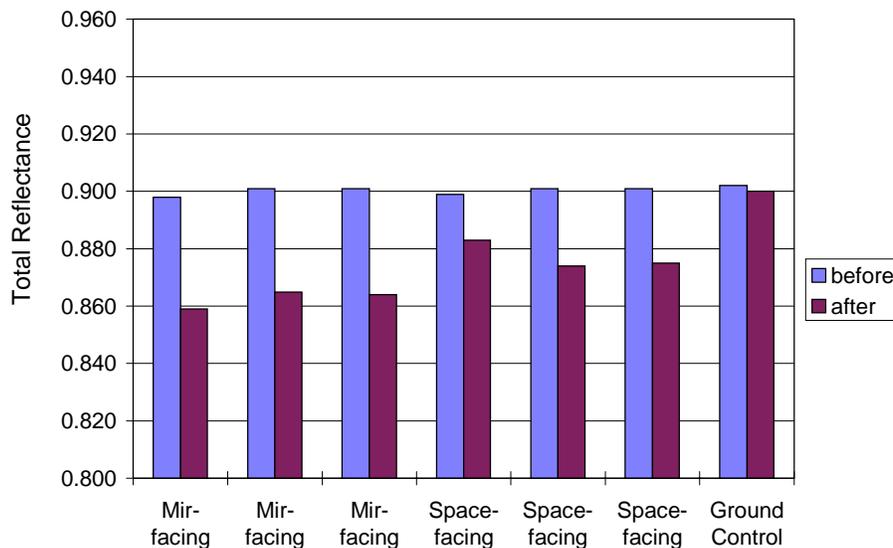
Figure 3. Total reflectance of front surface aluminized sapphire.

Figure 3 shows that the total reflectance of the front surface aluminized sapphire samples decreased as a result of exposure on Mir. On the Mir facing side, the total reflectance decreased, on average, from 0.900 to 0.863. On the space facing side, the total reflectance decreased, on average, from 0.900 to 0.877. Both of these changes suggests a contaminant on the surface, with the thickness of the contaminant being greater on the Mir facing side compared to the space facing side. This non organic contaminant was identified and quantified by variable angle spectroscopic ellipsometry (VASE) at the University of Nebraska – Lincoln.

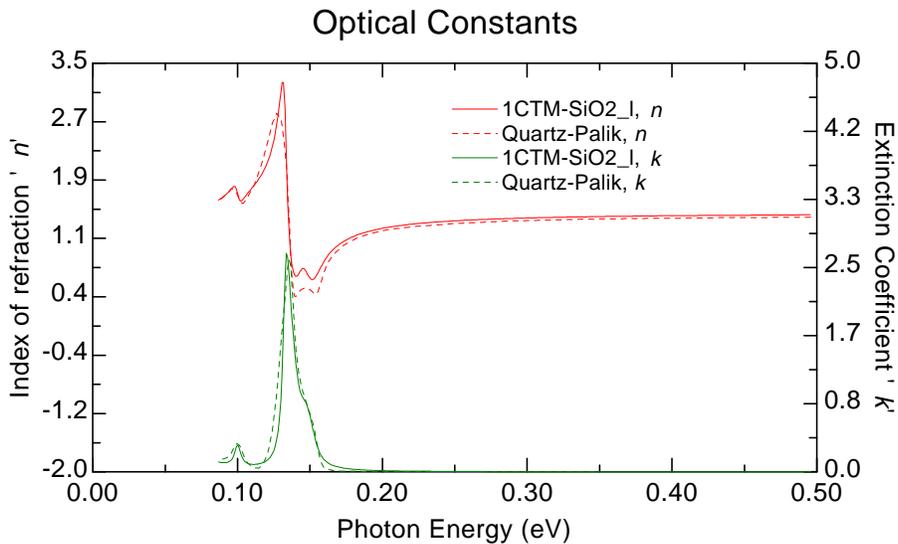
Figure 4. Comparison of measured contamination optical constants with quartz optical constants from the literature, suggesting SiO_2 contamination.

VASE is an optical characterization technique used for thin film measurements⁸⁻¹⁰. It is typically used to determine thin film thickness and refractive index (n and k). A unique feature of VASE in the infrared is the ability to obtain chemical bond information from very thin films. Chemical bonds absorb at select frequencies in the infrared; thus by mapping absorption bands to their corresponding chemical bonds one can determine the chemical structure of a material. Using VASE in the infrared, the imaginary part of the refractive index (k) of the contamination layer was measured, which is essentially the normalized absorption in a material. The molecular bond absorption bands present in the measured refractive index suggest that the contamination is SiO_2 , hereafter referred to as the inorganic contaminant.

In Figure 4 the measured contaminant optical constants are compared to quartz optical constants from the literature¹¹, showing that the molecular bond absorptions match very well. Table 1 gives the measured contamination layer thickness for the Mir facing and space facing samples. The thickness given for the space facing sample is an average of the four locations measured. The larger thickness of the Mir facing sample suggests that this sample was more in the line of sight of the contamination source.

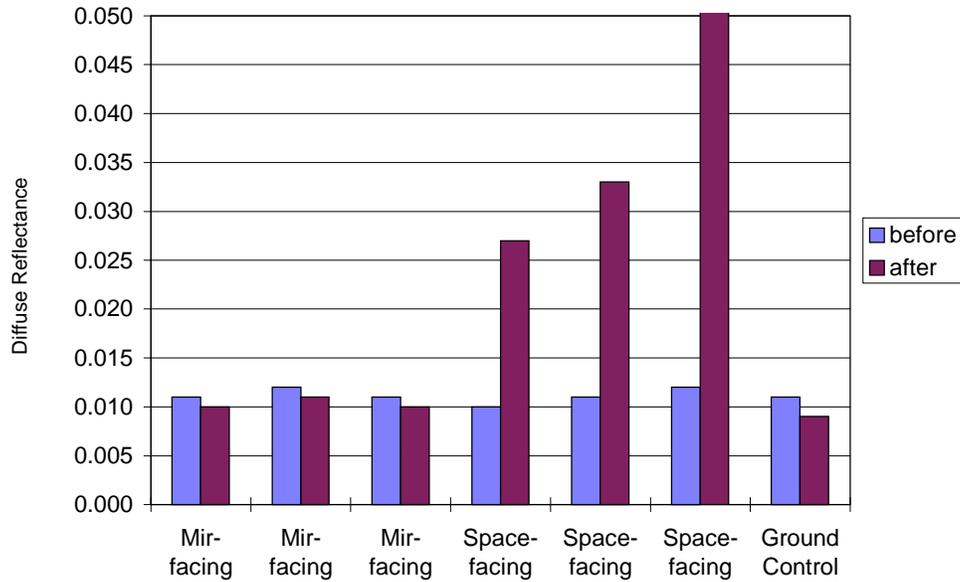
Figure 5. Diffuse reflectance of front surface aluminized sapphire.

Figure 5 shows that the diffuse reflectance of the Mir facing samples remained essentially unchanged, at 0.011, while the space facing diffuse reflectance increased from 0.011 to a maximum of 0.053, undoubtedly due to the organic contaminant mentioned earlier.

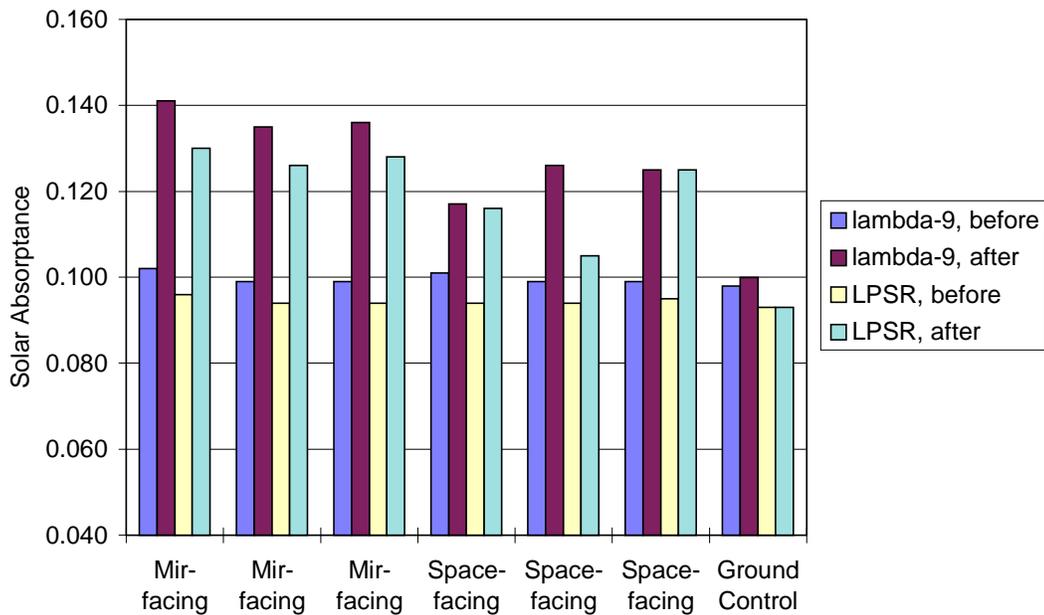
Figure 6. Solar absorptance of front surface aluminized sapphire.

As shown in Figure 6, the inorganic contaminant had the impact of increasing the solar absorptance of these samples, from 0.100 to 0.137 on the Mir facing side, and from 0.100 to 0.123 on the space facing side. The organic contaminant is thought to be responsible for the increase in emittance observed on the space facing samples, as seen in Figure 7.

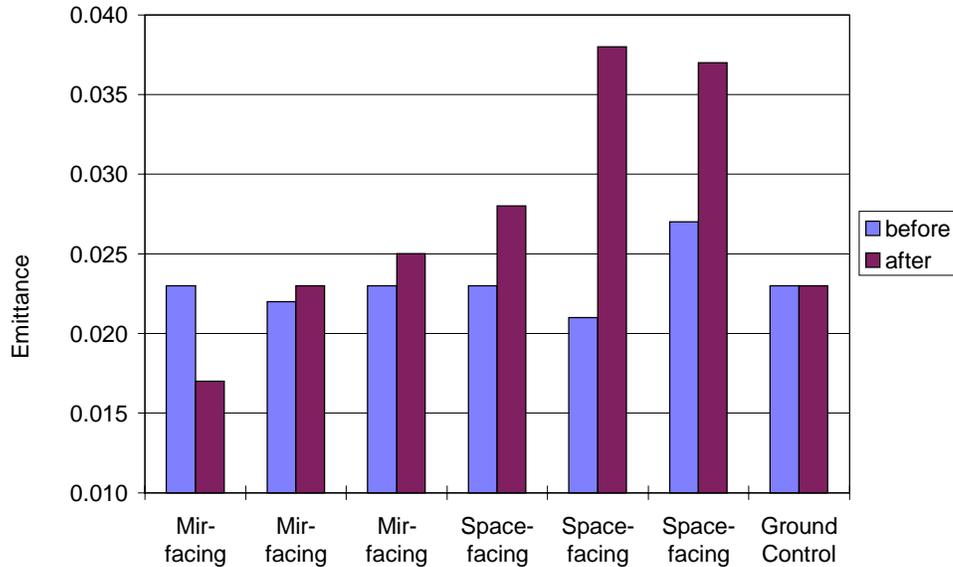
Figure 7. Emittance of front surface aluminized sapphire.

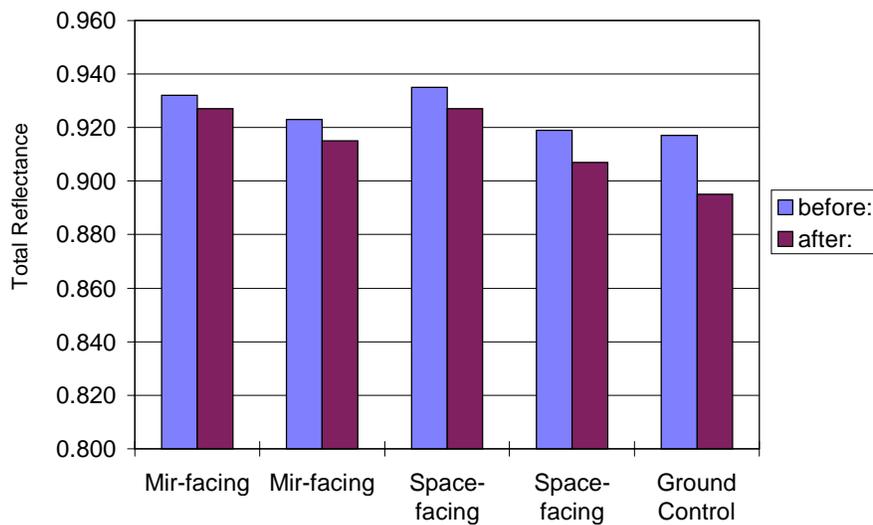
Figure 8. Total reflectance of silver on spin-coated polyimide.

Some minor changes in the optical properties of the silver on spin-coated polyimide were observed. Figure 8 shows that all of the samples decreased slightly in total reflectance, with the ground control having the greatest decrease in the series. This is probably due to the oxidation of the silver. Given the increased amount of time spent in our atmosphere, it is no surprise that the ground control had the greatest amount of oxidation. Figure 9 shows that all of the samples also exhibited an increase in diffuse reflectance, with the space facing diffuse reflectance increasing substantially due to the organic contaminant mentioned earlier. It was difficult to determine the influence of atomic oxygen on these samples owing to the small atomic oxygen fluence and the large amount of contamination. Figure 10 shows little change in the solar absorptance of either the Mir facing or the space facing samples. However, it does show a noticeable increase in the solar absorptance of the ground control, again due to oxidation that occurred here on Earth. Figure 11 shows that the emittance increased slightly for the space facing samples, again due to the organic contaminant.

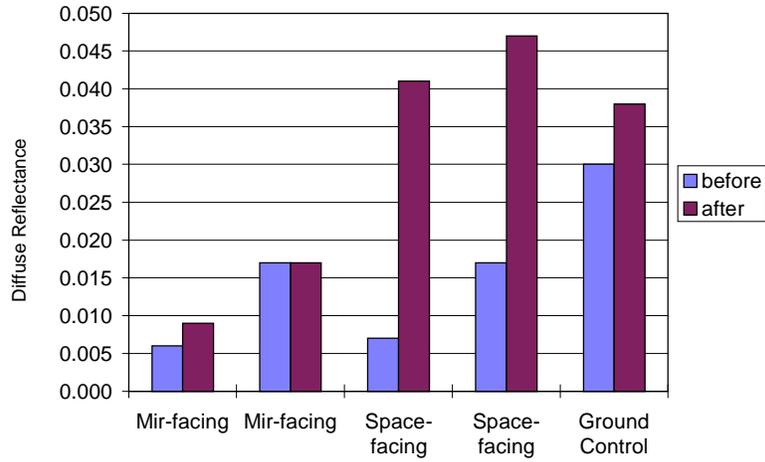
Figure 9. Diffuse reflectance of silver on spin-coated polyimide.

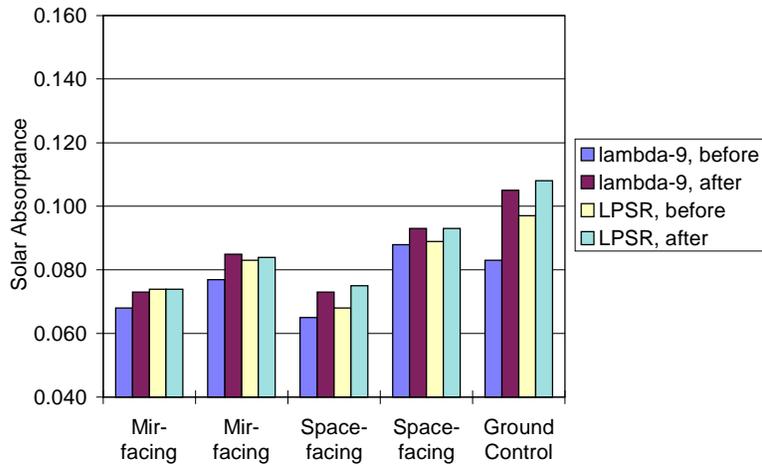
Figure 10. Solar absorbance of silver on spin-coated polyimide.

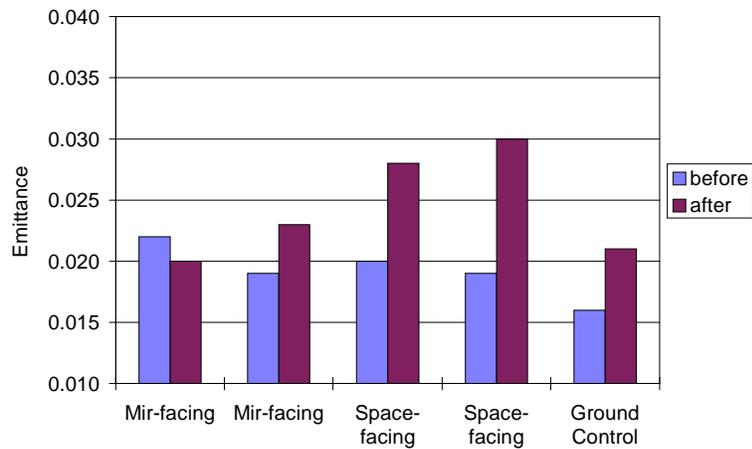
Figure 11. Emittance of silver on spin-coated polyimide.

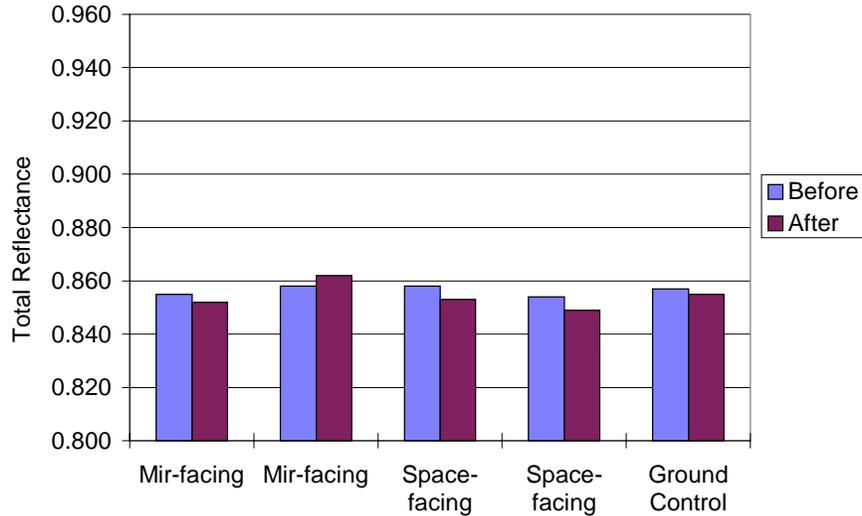
Figure 12. Total reflectance of aluminum on spin-coated polyimide.

Only minor changes in the total reflectance of the aluminum on spin-coated polyimide were observed, as shown in Figure 12. Unlike the silver, there was no appreciable oxidation of the aluminum in the ground control, at least as indicated by total reflectance. Figure 13 shows that some changes were observed in diffuse reflectance, with the space facing diffuse reflectance exhibiting a substantial increase due to the organic contaminant. There was no appreciable change in solar absorptance for any of the samples, as shown in Figure 14. Emittance increased slightly for the space facing samples, as shown in Figure 15.

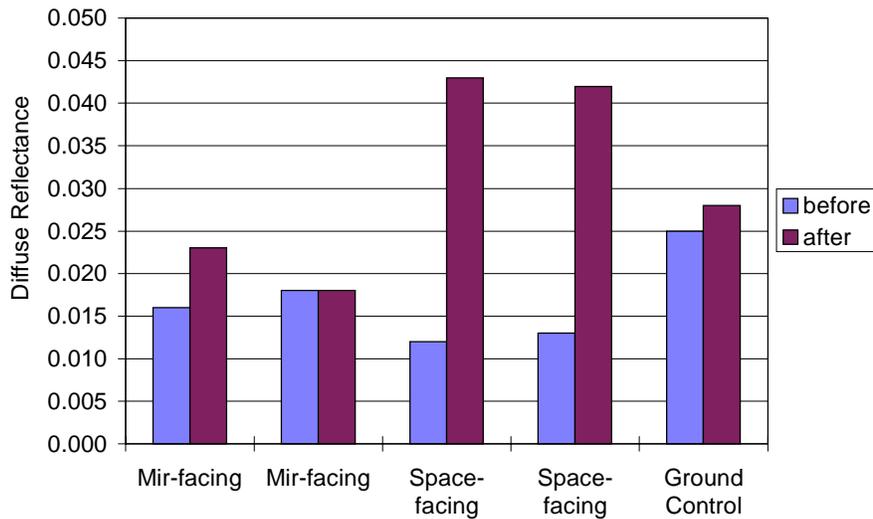
Figure 13. Diffuse Reflectance of aluminum on spin-coated polyimide.

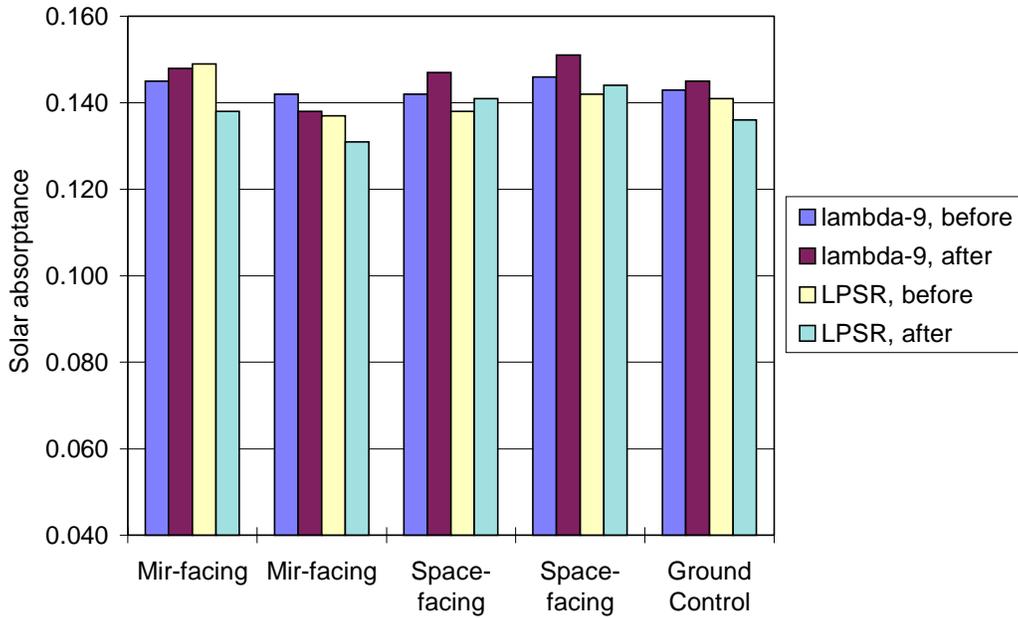
Figure 14. Solar absorptance of aluminum on spin-coated polyimide.

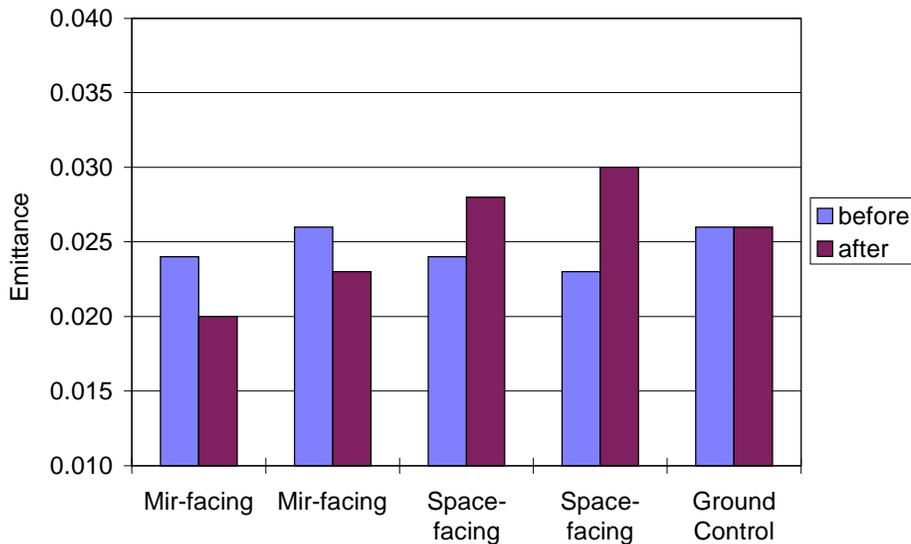
Figure 15. Emittance of aluminum on spin-coated polyimide.

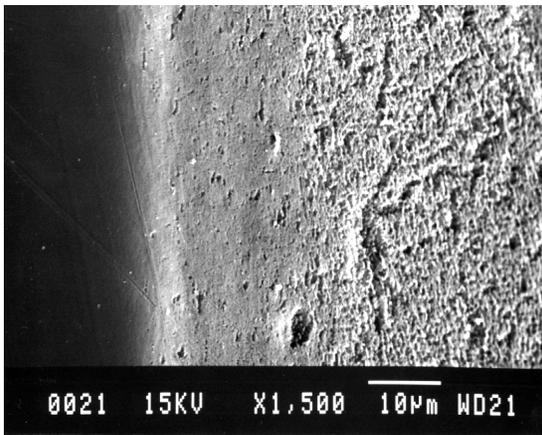
Figure 16a. Protected, shadowed, and unprotected Kapton, Mir facing.

The partially eroded Kapton was successfully used for scanning electron microscopy (SEM). Features from the Mir facing samples are summarized in Figure 16. The Kapton was both textured and covered with contaminant. One SEM photograph showed a particle on the surface and indicates the oblique angle of atomic oxygen arrival, where some material was protected from atomic oxygen on the shadowed side of the particle. One crater-like impact site was found. The textured/contaminated surface of the Kapton was interrupted by an occasional splatter pattern. Further texturing seems to have occurred in the center of the splatter patterns. Features from the space facing sample are summarized in Figure 17. In this case, the Kapton was noticeably textured. One region showed some streaking, similar to the splatter pattern seen on the Mir facing side. However, the streaking on the space facing side is better characterized as texture that was somehow knocked down. Another particle found on the surface, shows a protected “mesa” with atomic oxygen texturing in the background. An SEM photograph of the dried organic contaminant is shown. Also shown is a region where the organic contaminant was purposely washed off. It is interesting to note the step at the interface between the area of erosion and the area of Kapton previously covered by contaminant, suggesting that the contaminant was present for some time.

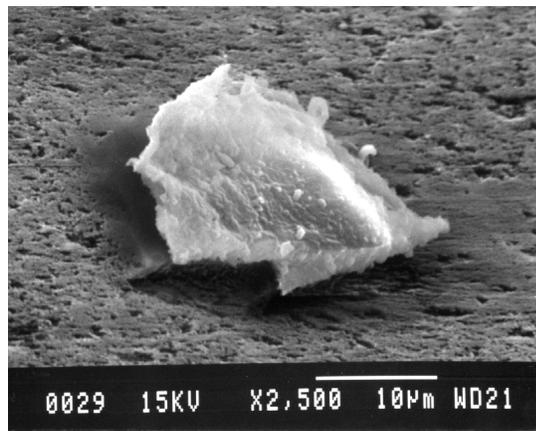
Figure 16b. Particle showing oblique angle of atomic oxygen arrival.

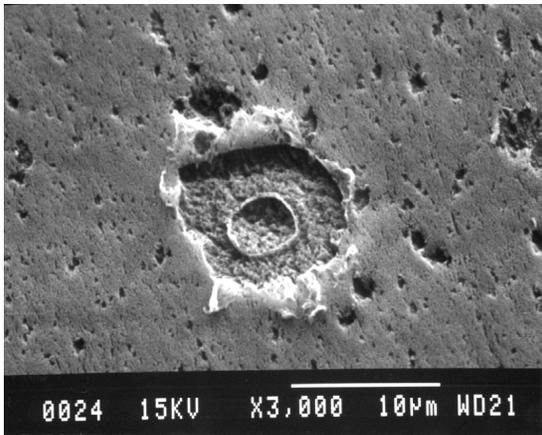
Figure 16c. Evidence of particle impact site.

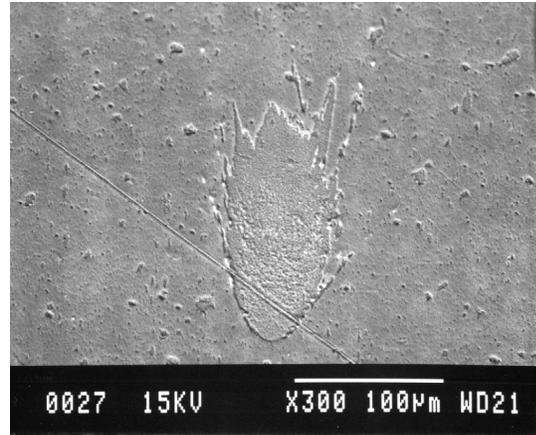
Figure 16d. Splatter pattern with atomic oxygen texturing located in the center.

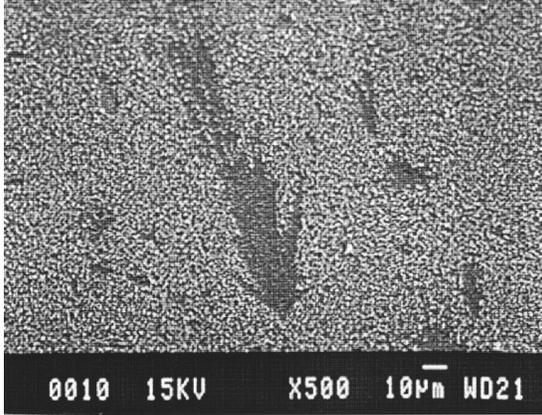
Figure 17a. Streaking of the atomic oxygen texturing.

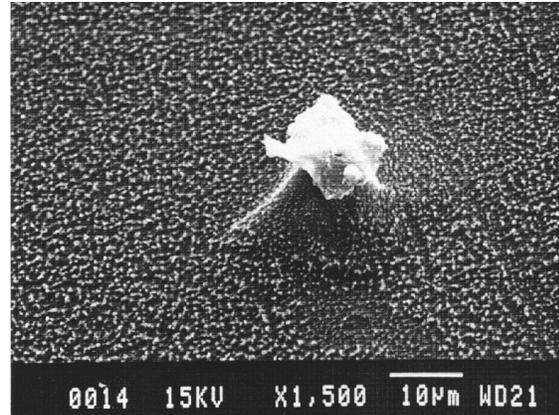
Figure 17b. Protected "mesa" with atomic oxygen texturing in the background.

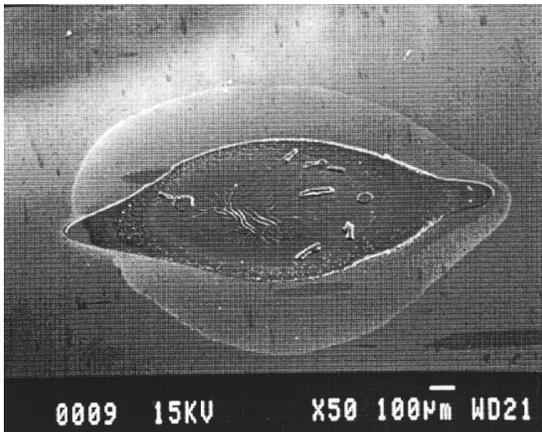
Figure 17c. Organic contaminant, uncleaned.

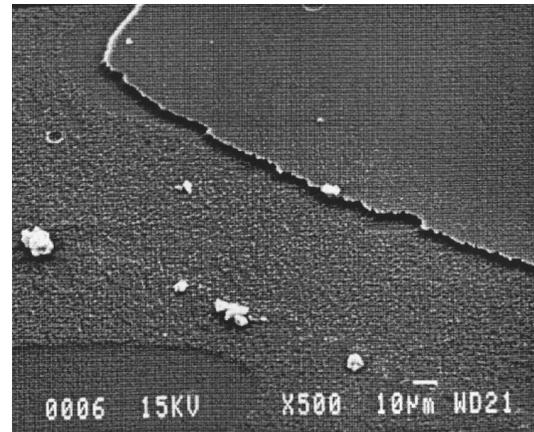
Figure 17d. Texturing near organic contaminant, after cleaning.

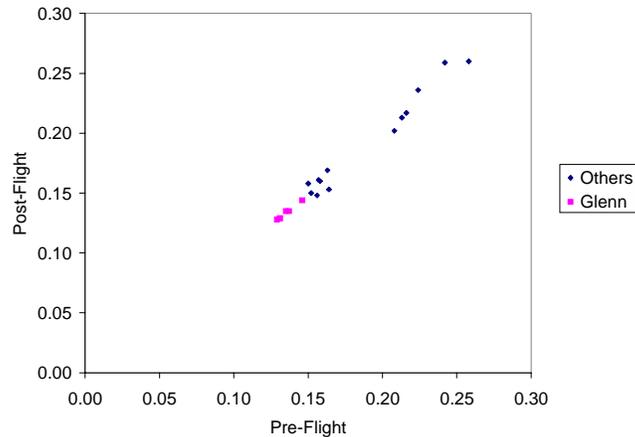
Figure 18. Pre-flight versus post-flight solar absorptance for Glenn samples, and others on POSA II.

There was little to no change in the solar absorptance of the Z-93-P samples characterized by Glenn, and only a small change in their infrared emittance. Figure 18 summarizes the pre-flight vs. post-flight solar absorptance for several Z-93-P samples on POSA II, including the Glenn samples. Figure 19 summarizes the pre-flight vs. post-flight infrared emittance for the same samples. The decrease in infrared emittance was less pronounced in Glenn samples compared to the other samples on POSA II.
