Investigation of the Erosion Characteristics of a Laboratory Hall Thruster

Peter Y. Peterson
QSS Group, Inc., Cleveland, Ohio

David H. Manzella
University of Toledo, Toledo, Ohio

Prepared for the
39th Joint Propulsion Conference and Exhibit
cosponsored by the AIAA, ASME, SAE, and ASEE
Huntsville, Alabama, July 20–23, 2003

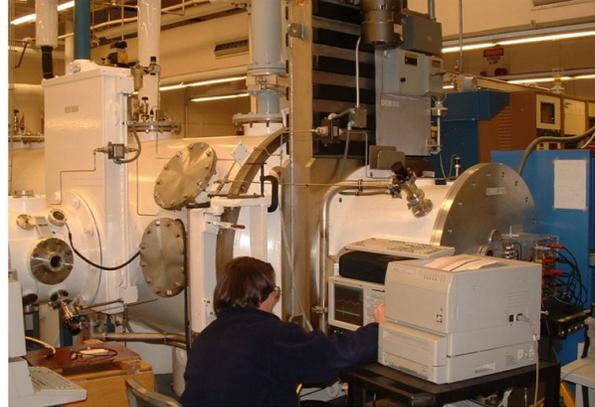
Figure 1. Vacuum Facility 8.

NASA GRC's Vacuum Facility 8 (VF-8; shown in Figure 1) is a 1.5-m diameter by 4.7-m long tank with a pumping speed in excess of 160,000 liters per second (air) produced by four 0.9-m diameter oil diffusion pumps. For this investigation VF-8 was used for the erosion characterization of various Hall thruster discharge chamber insulator materials.

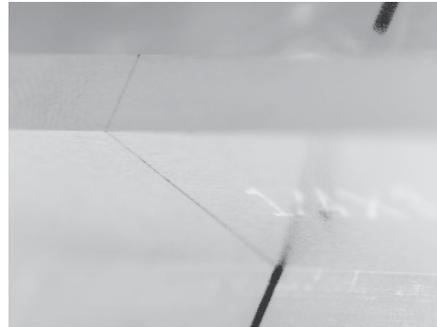
Figure 3. Sample image of a 0.25 in. x 0.75 in. gauge block that illustrates the laser profile of the surface.

on the surface of the sample forms a line that can be imaged by a CCD camera located at a different angle. A sample of an imaged profile of a 0.25 in. x 0.75 in. gauge block is shown in Figure 3. The laser, CCD camera and thruster are mounted on a rigid, optical aluminum frame. The thruster is affixed to a rotational stage and the laser adjusted such that the plane of light crosses the center of the thruster. The erosion profiles for the inner and outer walls of the discharge channel are typically mapped every one degree. The average error was less than 0.05 mm for both radial and axial directions. The error was determined by examining the distortion width of the imaged beam profiles of the reported erosion profiles in this paper. An illustration of the laser profilometry system is presented in Figure 4.

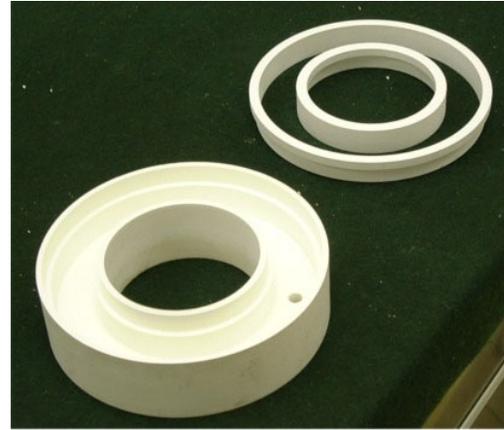
Figure 12. The NASA-120M replaceable segmented discharge channel.

For this portion of the investigation the discharge chamber of the NASA-120M was modified to accommodate replaceable segments for the inner and outer channel walls, as seen in Figure 12. This

modification expedited fabrication of new test specimens and reduced test sample cost. The axial length of the segments were chosen such that the interface of the base BN channel and each segment would not interfere with the operation and erosion characteristics of the thruster. This length was determined from the results of the initial study. The HP grade of BN was chosen for this stage of the investigation due to its favorable cost and its similarity to M26 with respect to erosion and operating characteristics. This was desirable because, as noted, M26 has been used successfully by Russian Hall thrusters on orbit for decades.
