NASA/TM—2002-211364

Vacuum Ultraviolet Radiation and Atomic Oxygen Durability Evaluation of HST Bi-Stem Thermal Shield Materials

Joyce Dever and Kim K. de Groh
Glenn Research Center, Cleveland, Ohio

February 2002

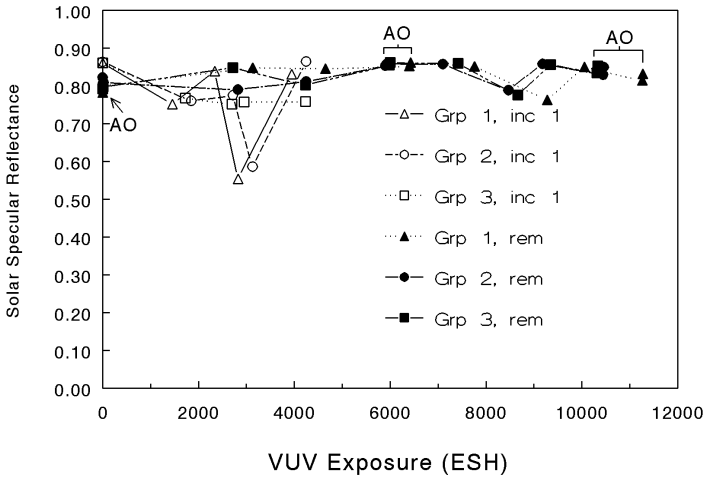
Figure 8 shows a plot of solar specular reflectance of the Ctm1 contamination witness mirrors as a function of VUV exposure. After the first increment of VUV exposure but before the first increment of AO exposure, the Ctm1 witness mirrors for each chamber were removed for possible further analyses and were replaced with new ones, also designated as Ctm1. The plots labeled "inc. 1" are for the first VUV exposure increment. The plots labeled "rem" are for the mirrors which were used for the remainder of the testing after the first VUV exposure increment. Minor fluctuations in the specular reflectance were observed throughout the exposures except in the case of the Group 1 and Group 2 witness mirrors which showed a significant decrease in specular reflectance at approximately 3000 ESH VUV and a restoration of reflectance at approximately 4000 ESH. It is unknown why such degradation occurred at this point and then recovered by the next increment. If contamination was the cause for this reflectance decrease, then any deposited contamination would have been removed from both the witnesses and the samples during the next exposure increment based on the measured restoration of reflectance following the next exposure increment. Atomic oxygen exposure caused slight increases in specular reflectance at each increment probably indicating removal of any VUV facility-produced contaminants.

The contamination witness mirrors that were measured only before and after the entire test, labeled Ctm2, showed a negligible change in specular reflectance. These mirrors were not replaced during the course of VUV and AO-VUV testing. Initial solar specular reflectance was measured to be 0.850, and the maximum change in this value upon exposure to VUV and AO-VUV was ± 0.004 which is within instrument repeatability.

Figure 8: Solar specular reflectance of contamination witness mirrors as a function of VUV exposure.

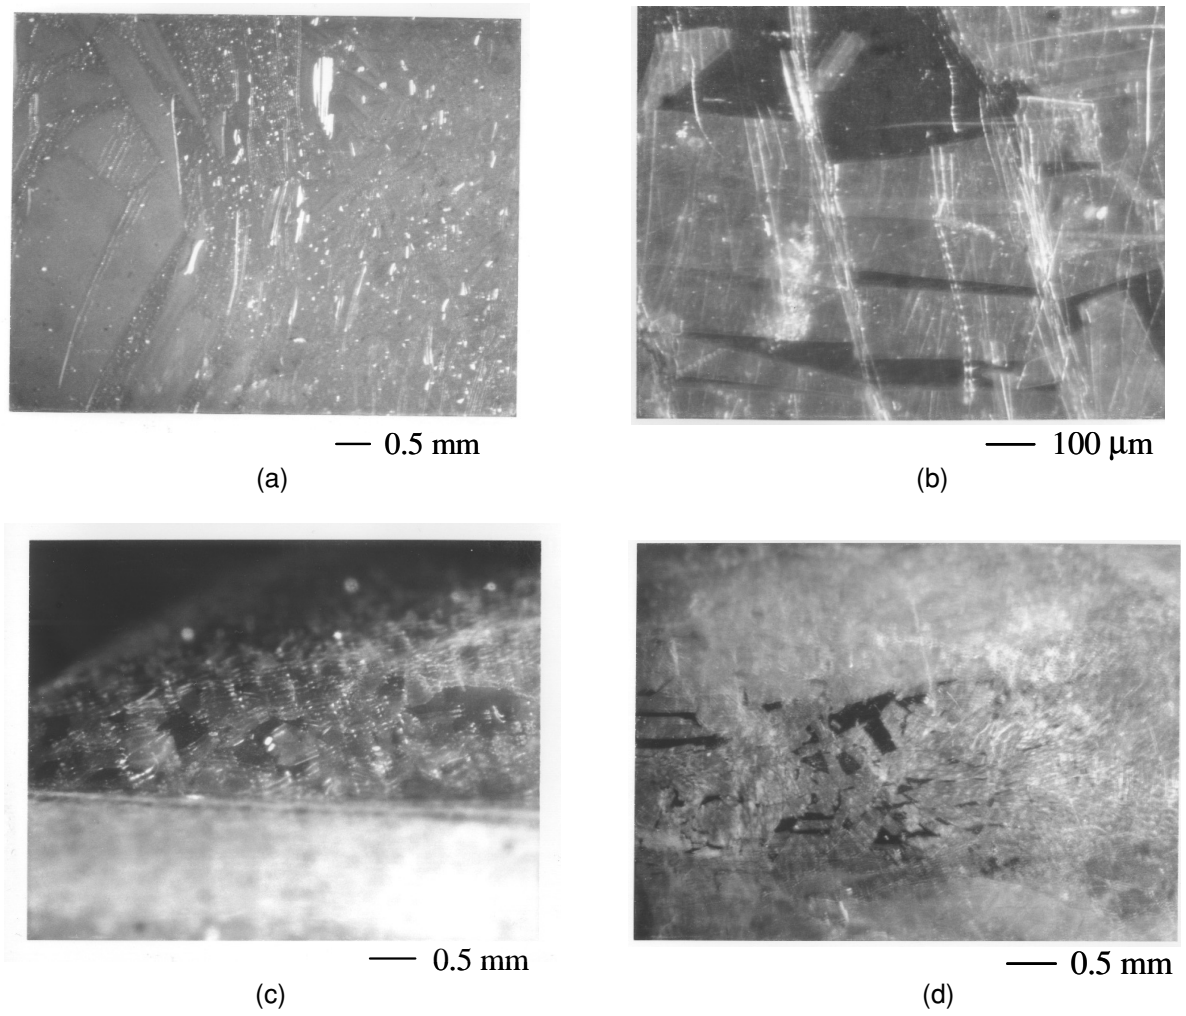
Optical microscopy examination of SiO_X- and OCLI-coated samples from the first or "original" sample set prior to VUV exposure revealed coating delamination and spalling failures for many samples. A few examples of these coating adhesion problems are shown in Figures 10(a) to (d). A summary of the coating integrity for all of the original coated samples, as indicated by whether or not spalling occurred, is provided in Table 3 (the term "spalled" in this table refers to coating areas that have possibly delaminated, curled-up and/or flaked-off). Detailed optical microscopy examination of the original group of coated samples revealed the following results. For all double-coated samples (SiO_X and OCLI coatings), welded and planar, which had been exposed to RTC there was a serious coating delamination and spalling problem, with the OCLI-coated samples being more severely affected than the SiO_X samples. For the single-coated samples (SiO_X and OCLI coatings), welded and planar, which were exposed to RTC, initial stages of spalling were apparent on approximately one-third to two-thirds of the planar samples, and on both welded samples. All coated samples (SiO_X and OCLI coatings), single and double-coated, welded and planar, which had not been exposed to RTC, often contained cracks in the coatings, but did not have any observable delamination or spalling. Therefore, it was concluded that coating failures occurred upon RTC exposure.

Figure 10: Examples of coating adhesion failures of the original samples prior to VUV exposure for (a) sample ssa-05 where many patches of coating are missing and many coating areas curled up; and (b) sample rra-01, (c) sample rrb-02, and (d) sample rra-08 where dark areas in the micrographs indicate coating areas that are missing.

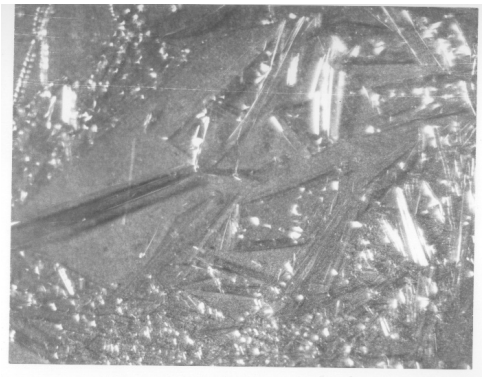
Observations after the first increment of exposure to VUV and AO provided evidence of the very serious nature of spalling as evidenced by the increase in severity of coating spalling and the production of coating particles. Figure 11, a micrograph of sample ssa-05 after initial VUV and AO exposure, typical of the entire sample, shows that the coating is peeling away and flaking off the sample. Rainbow specks were noticed on the fixtures of the Sample Group 3 (OCLI-coated) samples that were concluded to be flakes of OCLI coating on the fixture (see Figure 12(a)). Also, after removal of the sample group from the microscope, there was a piece of OCLI coating (as indicated by a typical blue hue) left on the microscope slide (see Figure 12(b)). There are many possible causes for production of these flakes from the already damaged coatings during the VUV exposure process including: handling (even with very careful handling the samples can vibrate), thermal exposure, collapsing of the welds (which was noticed after the first increment of VUV exposure), and the VUV and AO exposures themselves.

Figure 11: Micrograph of sample ssa-05 showing increased severity of coating spalling following VUV exposure as evidenced by coating flaking off of entire sample.

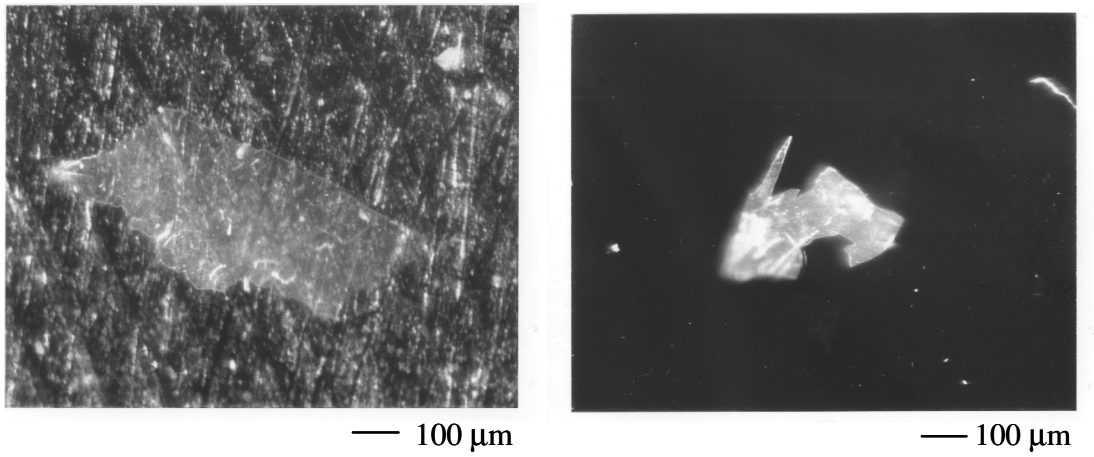
Figure 12: Evidence of loose flakes of OCLI coating (a) on sample fixture, and (b) on microscope slide used during sample examinations.

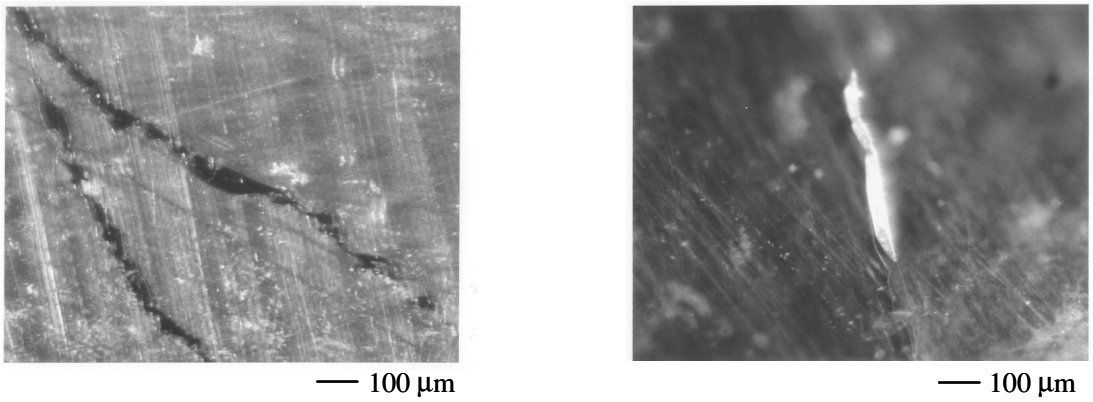
Prior to VUV and AO exposure, the second set or "new" OCLI-coated samples, which were not electron irradiated or rapid temperature cycled, were observed to contain occasional coating cracks, particularly in bent areas. Inside the cracks, small coating particles were observed, and there were some areas were the coating appeared to be missing (see Figure 13(a)). Occasionally coating particles from "crack" areas appeared to be loosely attached, and likely to dislodge (see Figure 13(b)). Besides these occasional areas with coating cracks and associated coating debris, there were no observed areas on any of the new OCLI-coated samples with delaminated or spalled coatings.

Figure 13: New OCLI coated samples prior to VUV exposure showing coating cracks evidenced by (a) dark areas in micrograph of sample rra-101 where coating is missing, and (b) bright area in micrograph of sample rrb-101 where coating from crack site is lifted away from the surface.

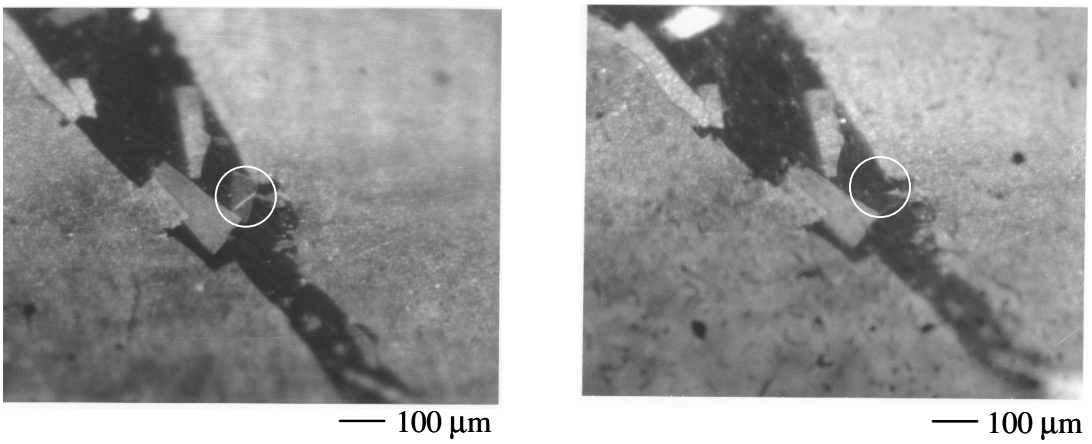
Figure 14: Crack area in sample rrb-102 (a) prior to and (b) after VUV and AO exposure. Note the small particle in the crack area near the center of micrograph (a) is missing from micrograph (b).

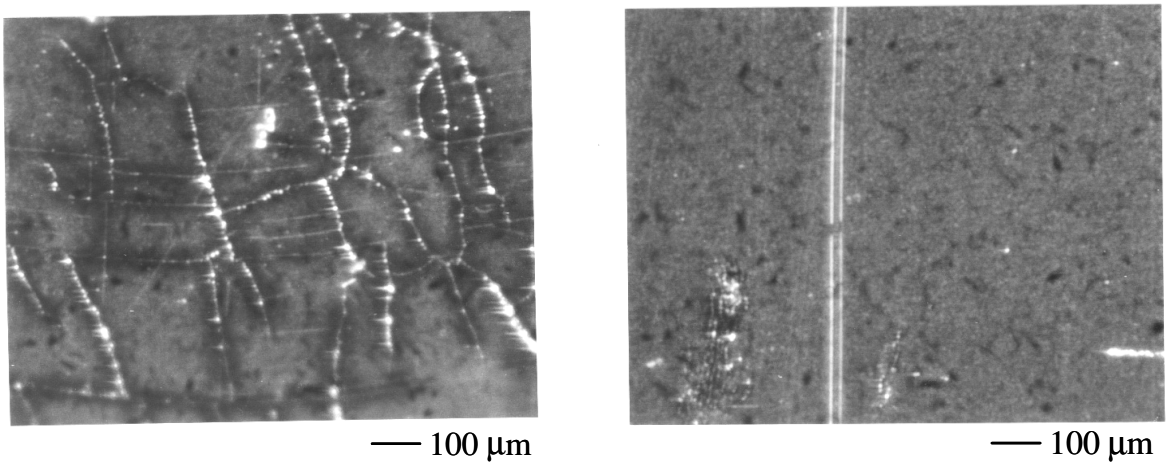
The uncoated samples had a variety of features prior to VUV exposure including cracks in the aluminum layer, scratches in the Teflon®, and diffuse or hazy appearances. Cracks in the aluminum layer are shown in Figure 15(a) for sample ua-02, and scratches on the Teflon® surface are shown in Figure 15(b) for sample ua-08. The development of hazy patches appeared to increase with increasing VUV and AO exposure. High magnification of these areas shows the haziness to be very fine diffuse spots on the surface of the Teflon®, indicating either surface texturing or contamination. Sample ub-204 had a large hazy patch with a streak through it as seen in Figure 16(a). It is not clear if this hazy patch was present prior to VUV exposure. The hazy patch in the middle upper portion of Figure 16(b) did develop on this sample during environmental exposure. After final VUV and AO exposure, one of the welded samples (ub-03), near an outer weld, had a section that appeared to have been atomic oxygen eroded (see Figure 17). The uneven erosion at the very edge of the weld (likely due to uneven thickness at the edge) resulted in very small sections of Teflon® left almost freestanding, and could result in the production of small Teflon® particles. If produced in space, these fine Teflon® particles would eventually erode away due to atomic oxygen erosion. This particular outer weld was bent over and appears to have received a higher VUV and AO flux than the other welds. Although this was a localized region, a few other welded samples showed evidence of microscopic erosion at the very edge of the outer welds after final VUV and AO exposure.

Figure 15: Examples of surface features observed for uncoated samples: (a) cracks in the aluminum layer of sample ua-02, and (b) scratches in the Teflon® layer of sample ua-08.

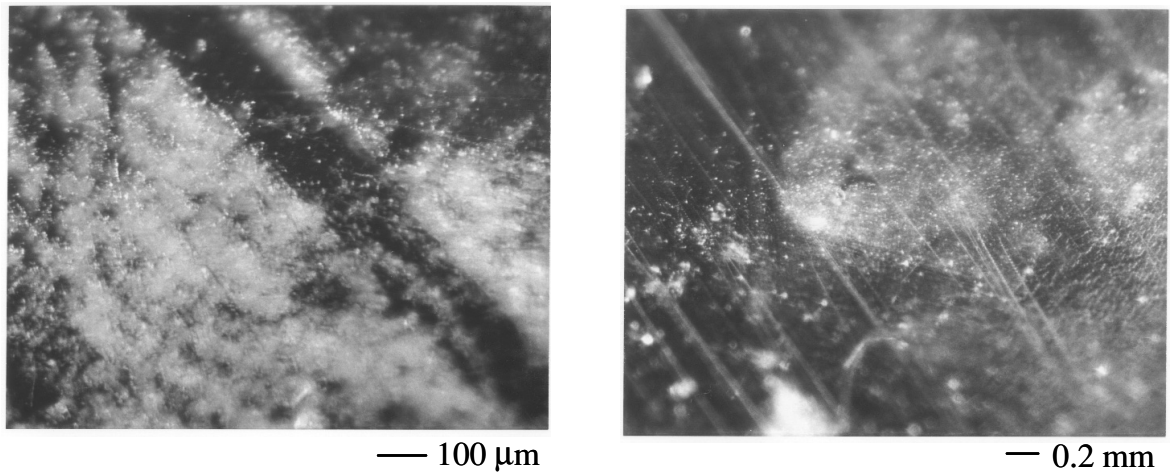
Figure 16: Examples of hazy area on sample ub-204: (a) hazy patch with a streak through it, may have been present prior to VUV exposure, and (b) hazy patch developed during VUV/AO exposure.

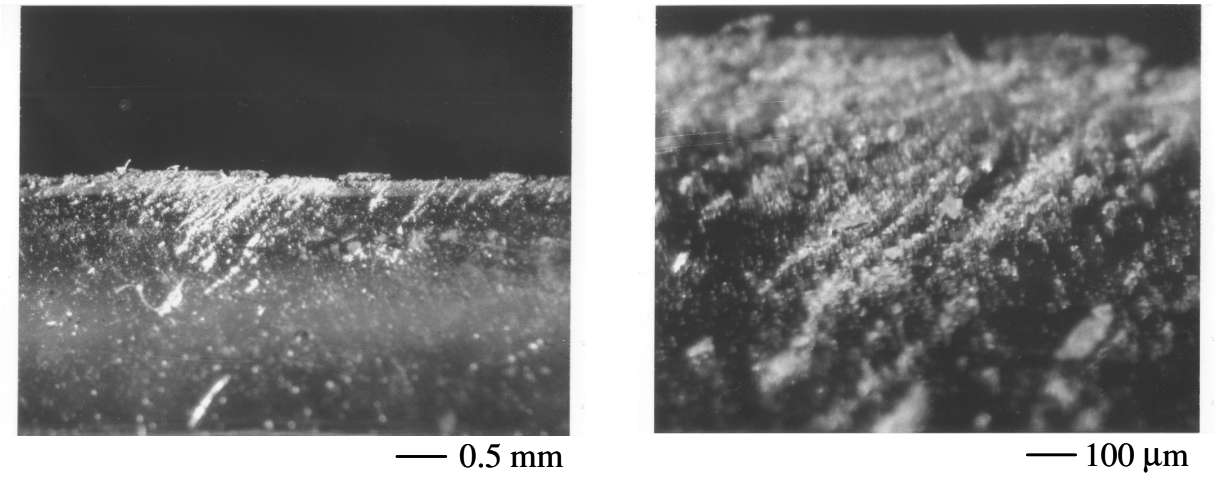
Figure 17: Atomic oxygen eroded area of an outer weld edge on sample ub-03: (a) small pieces of Teflon® at the top of the weld are left almost free-standing and (b) higher magnification of eroded area showing protective particles lined up in rows.

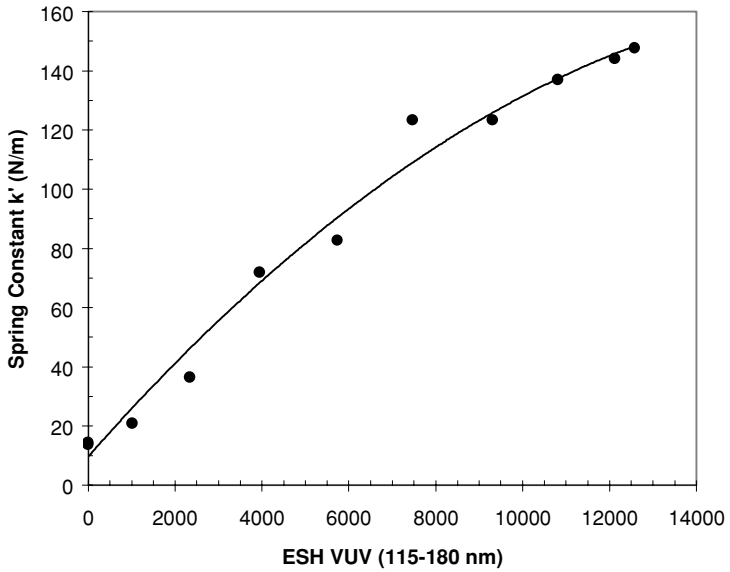
Surface hardness results for the seven AFM samples are given along with their exposure levels in Table 4. Samples 1 and 9 were exposed to increasing levels of VUV, from 0 to 12,573 ESH. These samples were expected to show increasing amounts of hardness due to the VUV-induced cross-linking of FEP Teflon® and resulting embrittlement. As can be seen in Table 4, the hardness for these two samples, as indicated by the spring constant (k') of the surface, did increase from ≈14 N/m for the pristine area to ≈148 N/m for the area exposed to 12,573 ESH of VUV. Plotting spring constant versus weeks of VUV exposure gives a second-order polynomial fit for increase in hardness as a function of VUV exposure resulting in embrittlement (see Figure 18).

Figure 18: Increase in surface hardness of Teflon® FEP is indicated by an increase in the spring constant with VUV exposure. Second order polynomial curve fit is shown.

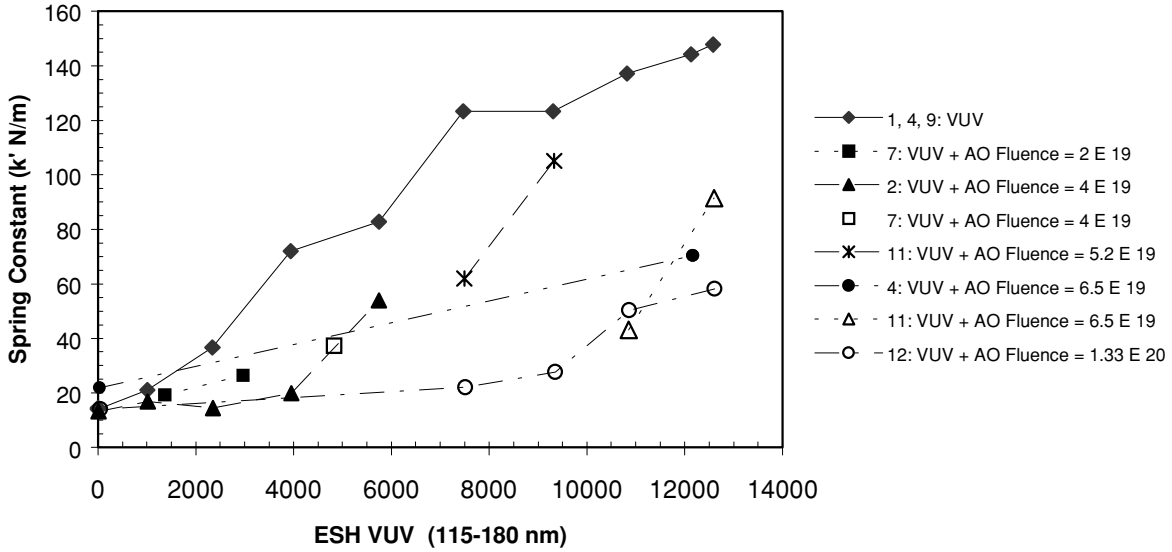
Results for all of the 7 AFM samples are plotted in Figure 19. Sample 7E was not plotted because there may have been an error in obtaining the data as reported by Digital Instruments. In the legend, AO fluence is in units of atoms/cm^2. As can be seen in the graph, all sample areas which received AO exposure in addition to VUV radiation exposure have lower spring constants and therefore have softer surfaces than the samples which received equivalent VUV exposure with no AO, indicating that the AO is removing some of the surface embrittled layer, as expected. If we examine the results for samples 2 and 7 (with AO fluence of 2-4 x 10^{19} atoms/cm^2) as compared to sample 1 which had approximately equivalent exposure to VUV but was not exposed to AO, it can be seen that an AO exposure of 2 x 10^{19} atoms/cm^2 (sample 7) only partially removes the embrittled layer formed by cross-linking upon exposure to 1369 and 2966 ESH VUV. Whereas, results from sample 2 indicate that an AO fluence of 4 x 10^{19} atoms/cm^2 did remove the embrittled layer for up to 2348 ESH of VUV exposure.

Figure 19: Spring constant versus VUV exposure for AFM samples. Based on higher values of spring constant for samples exposed only to VUV and lower values for samples exposed to both VUV and AO, it is evident that AO exposure removes some of the surface embrittled layer caused by VUV exposure.

As described earlier, the anticipated ratio of AO fluence to VUV equivalent sun hours in the HST environment is ≈$4x10^{15}$ atoms/(cm^2·ESH). It was desired to expose certain samples to this ratio in order to determine the degree to which AO would remove the VUV-embrittled layer on the HST thermal shields. Several sample areas were meant to receive this AO/VUV ratio; however, the samples that received the closest to this ratio were sample areas 11E, (AO/VUV ratio of $5.16x10^{15}$ atoms/(cm^2·ESH)) and sample areas 4C and 4E (AO/VUV ratio of $5.34x10^{15}$ atoms/(cm^2·ESH)). All other sample areas received even higher AO/VUV ratios. The significance of the AO-VUV ratio is that any value greater than $4x10^{15}$ atoms/(cm^2·ESH) indicates that the sample received a greater amount of AO erosion relative to the depth of VUV embrittlement than the anticipated HST equivalent space exposure increments. Despite the excess AO exposure, the VUV-hardened surface layer of Teflon® on samples 11E, 4C and 4E (with the AO/VUV ratio closest to that expected in the HST environment) was not removed. Therefore, it is concluded based on the results from the AFM samples, that for anticipated HST thermal shield AO/VUV exposure levels, AO will remove some of the VUV-embrittled surface layer, but will not completely remove it, and a surface embrittled layer will build up on the Teflon® HST solar array thermal shields that could form cracks.

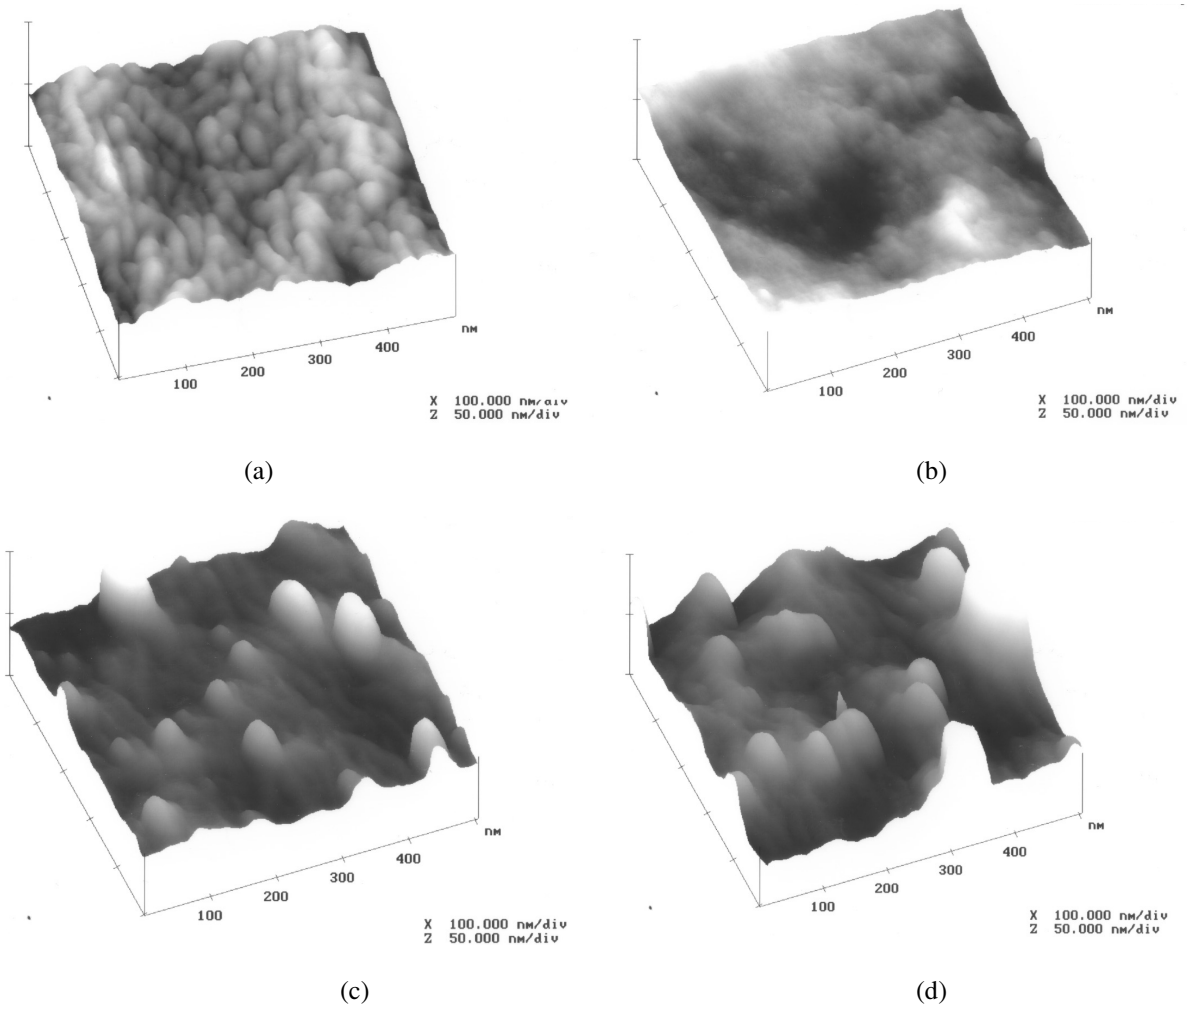
Figure 20: AFM surface topography images: (a) sample 7A (pristine), (b) sample 4D (12,131 ESH VUV), (c) sample 12E (43 ESH VUV and AO fluence of 1.33 x 10^{20} atoms/cm^2), and (d) sample 12A (12,616 ESH VUV and AO fluence of 1.33 x 10^{20} atoms/cm^2).

The pristine surface image for sample 7A (Figure 20(a)) shows a series of small linear mounds. Sample 4D (Figure 20(b)), exposed to 12,131 ESH of VUV exposure, shows a definite difference in the surface morphology. The VUV-exposed surface appears to be microscopically smoother, and the linear mounds are no longer present. Sample 12E (Figure 20(c)) which was exposed to a minimal amount of VUV (43 ESH) and an AO fluence in excess of that expected for 5 years in the HST environment (1.33×10^{20} atoms/cm^2), has the appearance of small rounded cone structures typical of atomic oxygen exposure. In between the cones, the surface is smooth with only a hint of the linear mounds. Sample 12A (Figure 20(d)) which was exposed to 12,616 ESH VUV and an AO fluence of 1.33×10^{20} atoms/cm^2, appears similar to sample 12E, with slightly larger cone structures.

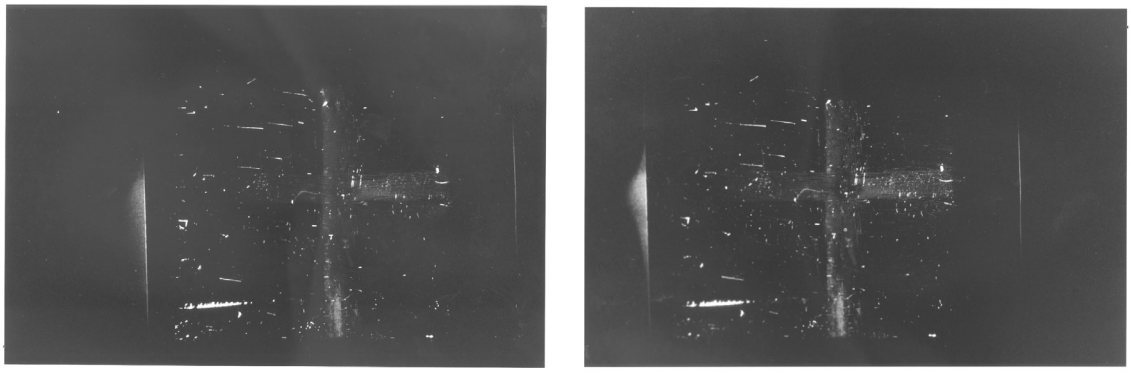
Evaluation of the light penetration photographs indicated no significant changes in the number or appearance of pinholes, scratches and cracks in the aluminum layer of the samples. A few samples showed a slight increase in the number of pinholes and scratches probably attributed to handling rather than to environmental exposure. Comparison of photographs taken before and after VUV and AO-VUV exposure did not show delamination of the aluminum for any of the samples. Figure 21(a) and (b) shows light penetration photographs for sample ua-02 prior to and after VUV and AO-VUV exposure. The fact that this sample had previously been exposed to RTC and was bend-tested, one would expect that it would be most susceptible to aluminum delamination. However, no increase in the number of pinholes, scratches or cracks was observed as can be seen in Figure 21.

Figure 21: Light penetration photograph of sample ua-02 (a) before and (b) after VUV and AO-VUV exposure.
