Mechanical Properties Degradation of Teflon[®] FEP Returned From the Hubble Space Telescope

Prepared for the
36th Aerospace Sciences Meeting & Exhibit
sponsored by the American Institute of Aeronautics and Astronautics
Reno, Nevada, January 12-15, 1998

After 6.8 years on orbit, degradation has been observed in the mechanical properties of second-surface metalized Teflon[®] FEP (fluorinated ethylene propylene) used on the Hubble Space Telescope (HST) on the outer surface of the multi-layer insulation (MLI) blankets and on radiator surfaces. Cracking of FEP surfaces on HST was first observed upon close examination of samples with high solar exposure retrieved during the first servicing mission (SM1) conducted 3.6 years after HST was put into orbit.¹ Astronaut observations and photographs from the second servicing mission (SM2), conducted after 6.8 years on orbit, revealed severe cracks in the FEP surfaces of the MLI on many locations around the telescope. This paper describes results of mechanical properties testing of FEP surfaces exposed for 3.6 years and 6.8 years to the space environment on HST. These tests include bend testing, tensile testing, and surface micro-hardness testi

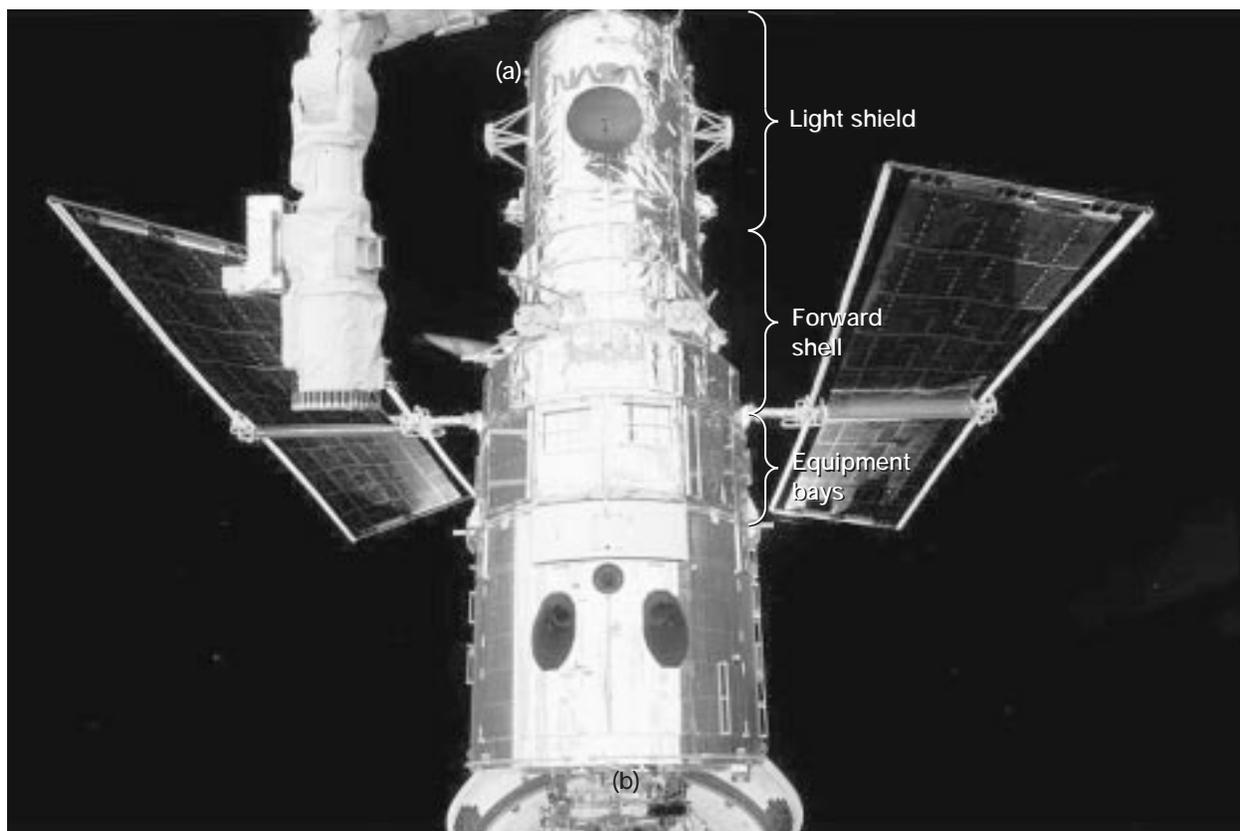
MLI blankets are used on HST to control the temperatures on the HST Light Shield (LS), Forward Shell (FS), and Equipment Bays shown in Fig. 1. MLI blankets were also used as covers for the magnetic sensing systems (MSS) retrieved during SM1. The approximate location of the MSS covers is also indicated in Fig. 1. The MLI blankets are comprised of the following layers: The

Also during SM2, the cryo-vent cover (CVC) on the aft shroud of HST (Fig. 1) was removed to allow installation of a new instrument on HST. This CVC contained a thermal control coating comprised of the following components: The top space-exposed surface was 127 μm (0.005 in.) FEP. The underside of the FEP was coated with silver followed by Inconel. The FEP/silver/Inconel assembly was bonded to the CVC with an acrylic adhesive. Small x-cuts were made throughout the surface of the silvered FEP assembly to allow venting from air bubbles that were produced during bonding to the CVC. Two separate pieces of CVC silvered Teflon were removed from the CVC piece. One was removed by mechanically pulling the coating off of the CVC surface and was used for chemical analysis. The other piece was removed using acetone to dissolve the adhesive to facilitate easy removal of the silvered Teflon from the CVC. The piece that was chemically debonded was used for mechanical properties

Figure 1.—Photograph of Hubble Space Telescope showing the Light Shield, Forward Shell, Equipment Bays and locations from which samples were retrieved. (a) Approximate location from which Magnetic Sensing System covers and Light Shield sample were retrieved from the opposite side of telescope. (b) Approximate location from which cryo-vent cover was retrieved.

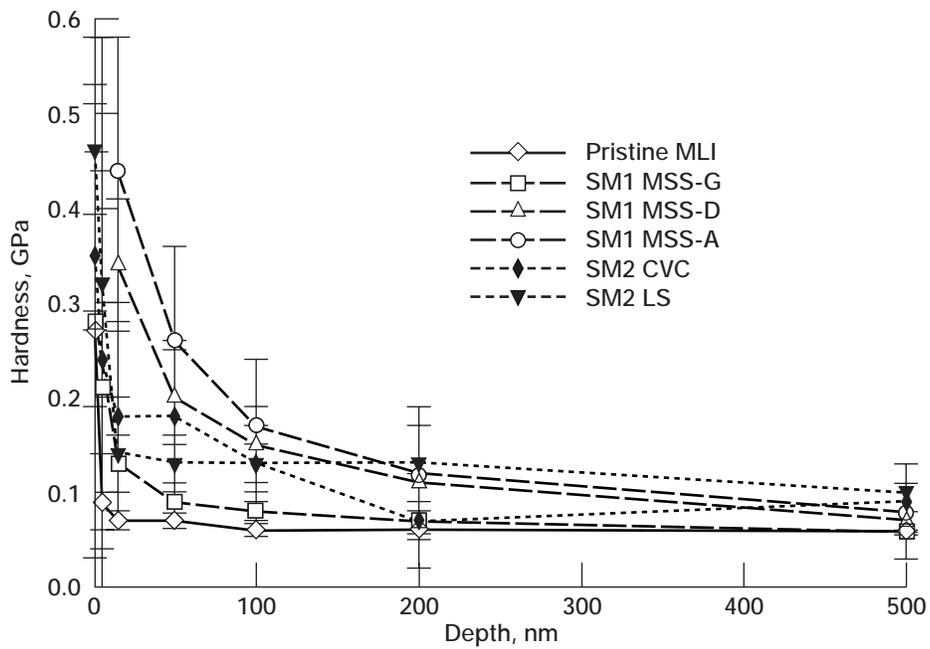
Table 4 and Fig. 5 show the results of the surface micro-hardness measurements. The legend of Fig. 5 shows sample labels in increasing order of solar exposure. The estimated exposure environment for each sample is described in Table 1. Evaluation and comparison of hardness among SM1 samples has been previously reported by de Groh et al.³ In general, the HST-exposed materials are harder at the surface, and hardness decreases with increasing depth into the material. According to the data in Table 4 and Fig. 5, at 500 nm depth all samples have similar hardness.

Figure 5.—Hardness of retrieved HST materials as a function of depth into the surface.
