Effects of Heating on Teflon[®] FEP Thermal Control Material From the Hubble Space Telescope

Prepared for the
44th International Symposium and Exhibition
sponsored by the Society for the Advancement of Materials and Process Engineering
Long Beach, California, May 23–27, 1999

Metallized Teflon[®] FEP (fluorinated ethylene propylene) thermal control material on the Hubble Space Telescope (HST) is degrading in the space environment. Teflon[®] FEP thermal control blankets (space-facing FEP) retrieved during the first servicing mission (SM1) were found to be embrittled on solar facing surfaces and contained microscopic cracks. During the second servicing mission (SM2) astronauts noticed that the FEP outer layer of the multi-layer insulation (MLI) covering the telescope was cracked in many locations around the telescope. Large cracks were observed on the light shield, forward shell and equipment bays. A tightly curled piece of cracked FEP from the light shield was retrieved during SM2 and was severely embrittled, as witnessed by ground testing. A Failure Review Board (FRB) was organized to determine the mechanism causing the MLI degradation. Density, x-ray crystallinity and solid state

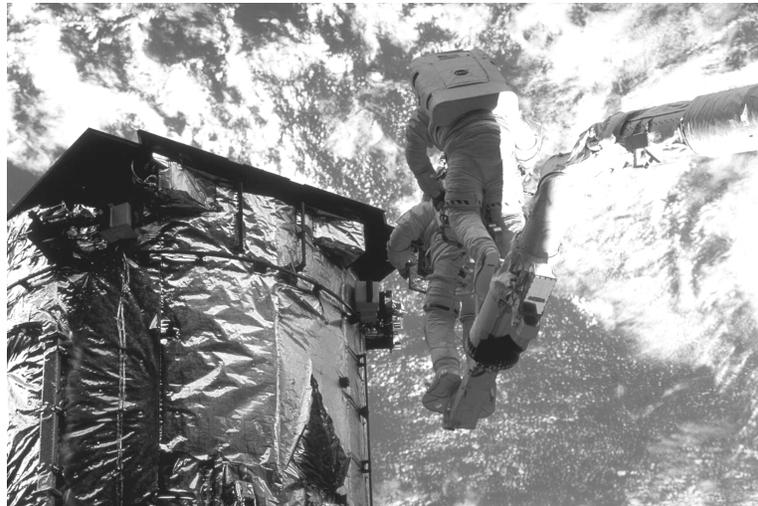
Figure 1. Two cracks in the MLI outer layer on the HST Light Shield photographed during a SM2 EVA. A large vertical crack is seen in the bottom of image, and a smaller cracked and tightly curled area is seen above the vertical crack.

During SM2, severe cracking of the MLI outer layer material (Al-FEP, 5 mil thick) was observed on the light shield, forward shell and equipment bays of the telescope. Astronaut observations combined with photographic documentation of HST taken during SM2, revealed extensive cracking of the MLI in many locations around the telescope (solar and anti-solar facing surfaces), with solar facing surfaces being particularly heavily damaged.¹ The FEP outer layer at several of the longest cracks was observed to be curled up and lifted away from the next MLI layer. The worst of the MLI outer layer cracks were patched during the last extravehicular activity (EVA) day. Figure 1, taken during an EVA, shows two cracked areas on the light shield. A very large vertical crack can be seen near the bottom of the photograph facing the astronauts, and a smaller cracked area which has curled-up tightly (with the FEP surface in compression) can be seen above the vertical crack. Prior to patching the upper light shield crack, the tightly curled Al-FEP outer layer was removed (cut off with scissors) and retrieved for post-mission analysis. A close-up of the tightly curled MLI section is shown just after being removed in Figure 2. After SM2, Goddard Space Flight Center (GSFC) established a HST MLI Failure Review Board (FRB). The objectives of the FRB were to determine the mechanism causing the MLI degradation, to predict the condition of MLI surfaces at the time of the third servicing

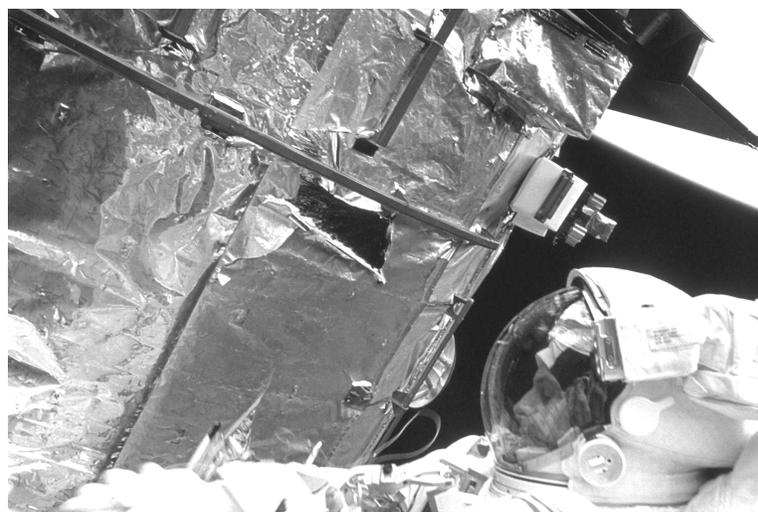
Figure 2. Close-up of the location of the tightly curled Al-FEP MLI section that was cut off and retrieved during SM2 for post-flight analyses.

2.1.3 HST SM2 FEP The SM2 FEP material was from the cracked and tightly curled outer layer of the MLI blanket covering the upper light shield (see Figure 2). The outer layer was composed of 127 μm FEP coated on the backside with 1000 \AA of VDA, and this sample had curled with the FEP surface in compression to a diameter of 1.5 cm.⁵ Two areas of the retrieved SM2 FEP sample were analyzed. One piece was from inside the tightly curled area, which experienced the +200°C temperature extreme when curled. The second piece was from the “flat” section of the retrieved sample, next to the astronaut cut area where the FEP had started to curl. This flat area most likely did not get as hot as the tightly curled area.

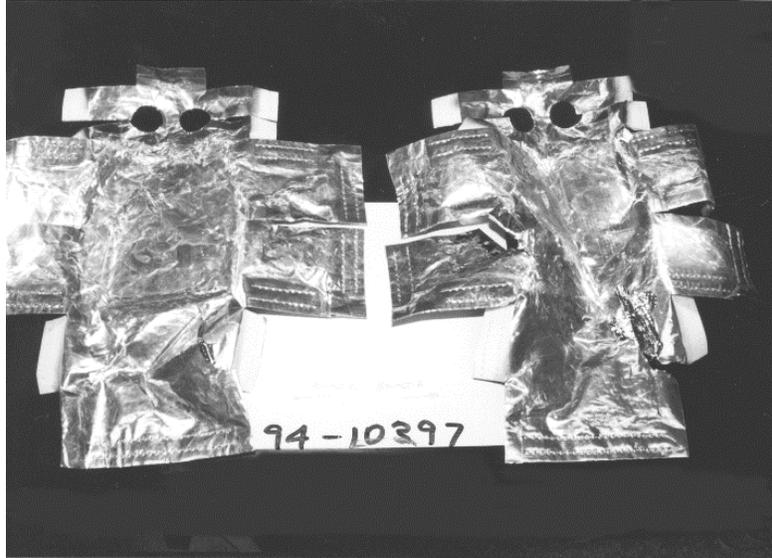
Figure 3. Photograph of the two MSS MLI blankets retrieved during SM1.

2.1.2 HST SM1 FEP The SM1 FEP material was from the outer layer of one of the two-retrieved magnetometer (or magnetic sensing system (MSS)) electronics box MLI blanket covers. The retrieved MSS MLI blankets are shown in Figure 3. These thermal blankets are roughly 35 cm x 38 cm in size. The outer layer was composed of 127 μm FEP coated on the backside with 1000 \AA of VDA. The MLI blankets were wrapped around the electronics boxes such that each blanket had 5 different areas that experienced difference solar exposures on-orbit.²

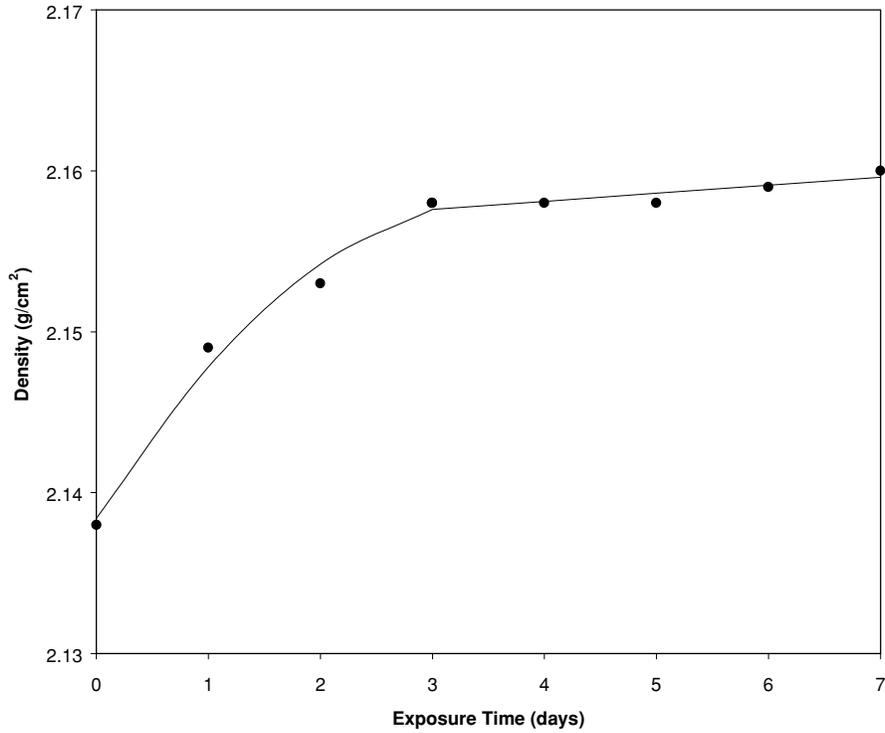
Figure 4. Effect of heating for 1 to 7 days at 200°C on the density of Al-FEP.

Pristine Al-FEP samples were heated to 200 °C and their densities were found to increase with heating. But, the increase in density of the pristine heated samples was less than for the space exposed samples. For example, pristine FEP increased in density by 0.020 g/cm² after 21 days (0.94%), while the 16,670 ESH SM1 sample increased in density by 0.030 g/cm² after 21 days (1.41%) (Table 4). Samples of pristine FEP were exposed to 200 °C for 1-7 days. These data, shown in Figure 4, indicate that the majority of density increase occurred within 72 hours of heating. An additional sample heated for 21 days showed no additional density increase than experienced after 3 days of heating. Samples of pristine FEP and SM1 FEP (11,339 ESH) were also exposed to temperatures ranging from 50 °C to 200 °C for 21 days to see what temperature causes an increase in density. The results are plotted in Figure 5. There appears to be a very small increase in density with increasing temperature up to 125 °C, then at a temperature of 150 °C and above, the density increases significantly. This was true for both the pristine and the SM1 FEP. The rate at which the density increases was greater for the SM1 FEP than for the pristine FEP, in both regions of the graph. For example, the slope of the SM1 line from 125 °C to 200 °C is 3.34 x 10⁻⁴ g/cm² °C, while it is 2.22 x 10⁻⁴ g/cm² °C for pristine FEP. These results indicate that heating at temperatures of 150 °C and above, without prior radiation or space exposure, can result in an increased density of FEP. It has been reported that elevated temperature exposure can cause chain scission in polymers.¹³ These results also indicate that prior space exposure causes greater density increases with heating than for unexposed FEP. This supports the idea that space exposure (at nominal temperatures of 50 °C) causes chain scission in the polymer structure, and that with sufficient heating the shorter chains can move into more densely packed areas.

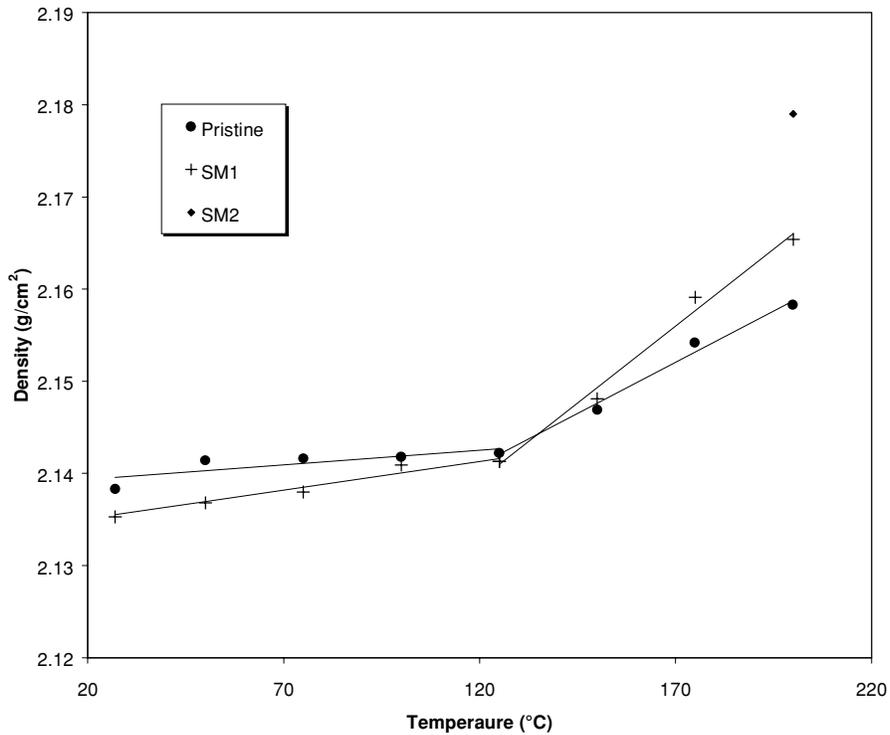
Figure 5. Effect of heating temperature (3 week exposure) on the density of pristine FEP and SM1 FEP.

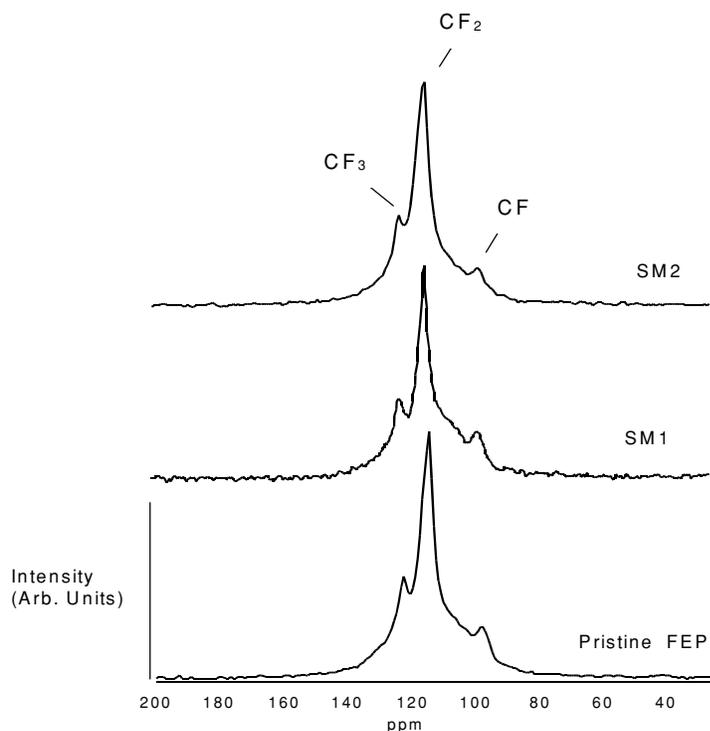
Figure 6. ^{13}C spectra of as-received pristine FEP, SM1 FEP and SM2 FEP.

The ^{13}C spectra for all three samples (Pristine FEP, SM1 FEP and SM2 FEP) consist of three peaks at 98, 115, and 122 ppm (frequency shift in ppm from a tetramethylsilane standard) arising from CF, CF_2 , and CF_3 groups, respectively, as shown in Figure 6. A comparison of the SM1 and SM2 FEP with the pristine material shows that there are no new peaks observable in the NMR spectrum after space exposure. These results show that if there is formation of new $-\text{CF}_x-$ species they are present at low levels ($<5\%$ of carbon sites). The three spectra also show little change in terms of the relative intensities of the three peaks. These results, in conjunction with the fact that there is little or no additional CFX species, indicate that there is no large-scale chemical modification of the material. The ^{13}C spectra for all three samples did not change after heating at 190°C (there were no indications of new peaks or changes in the relative intensities of the $-\text{CF}_x-$ peaks). Therefore, heating the samples at this temperature did not cause any significant chemical changes to the FEP films, consistent with the as-received SM2 results.

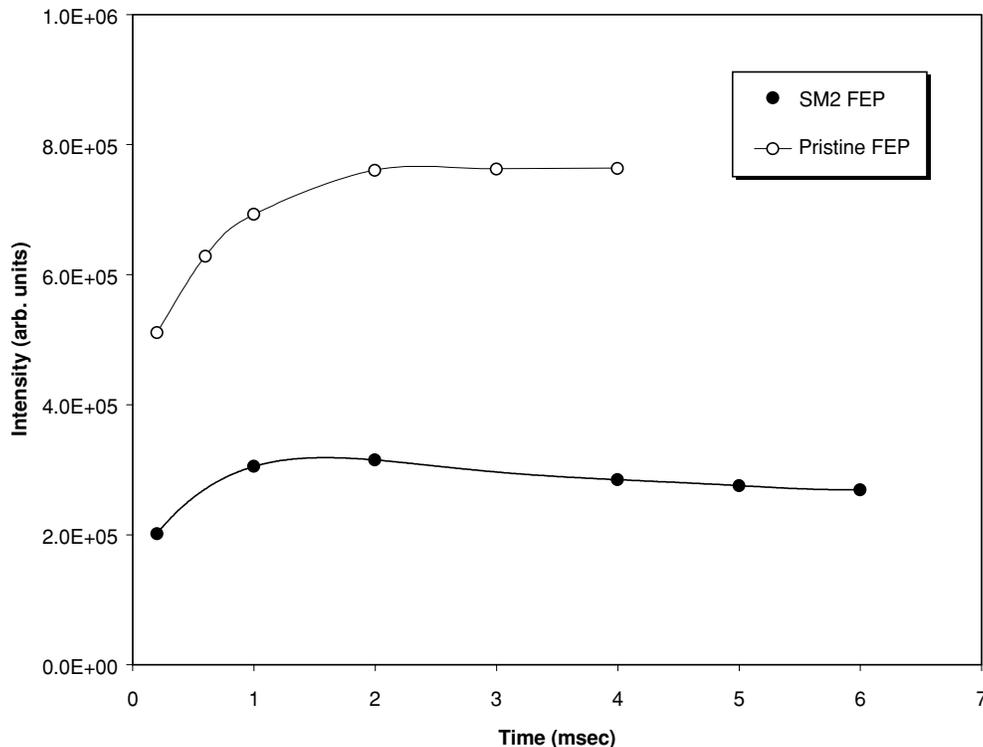
Figure 7. T_{CF} Curves for as-received pristine FEP and SM2 FEP.

The T_{CF} curve, shown in Figure 7, is a plot of the ^{13}C signal intensity versus the cross polarization time. The rate at which the intensity increases is dependent on the $^{13}\text{C} - ^{19}\text{F}$ dipolar coupling, which in turn is dependent on the molecular motion present. The tighter the chain packing and the less kHz regime motion that is present, the more rapid is the rise in intensity. The T_{CF} curves for the pristine and SM1 samples are nearly identical, indicating that the two samples have a similar structural morphology. However, the T_{CF} curve for the SM2 sample is different from the SM1 sample, the intensity reaches a peak at ≈ 1 ms versus 2 ms. These results indicate that there is less molecular motion and tighter chain packing in the SM2 sample. These changes in morphology may arise either from material changing from amorphous to crystalline or by the material becoming more ordered within the amorphous domains.
