NDE Methodologies for Composite Flywheels Certification

Prepared for the
2000 Power Systems Conference
sponsored by the Society of Automotive Engineers
San Diego, California, October 31–November 2, 2000

Manufacturing readiness of composite rotors and certification of flywheels depend in part on the maturity of nondestructive evaluation (NDE) technology for process optimization and quality assurance, respectively. Capabilities and limitations of x-ray-computed tomography and radiography, as well as advanced ultrasonics were established on NDE ring and rotor standards with EDM notches and drilled holes. Also, intentionally seeded delamination, tow break, and insert of bagging material were introduced in hydroburst-rings to study the NDE detection capabilities of such anomalies and their effect on the damage tolerance and safe life margins of subscale rings and rotors. Examples of possible occurring flaws or anomalies in composite rings as detected by NDE and validated by destructive metallography are shown. The general NDE approach to ensure quality of composite rotors and to help in the certification of flywheels is briefly outlined.

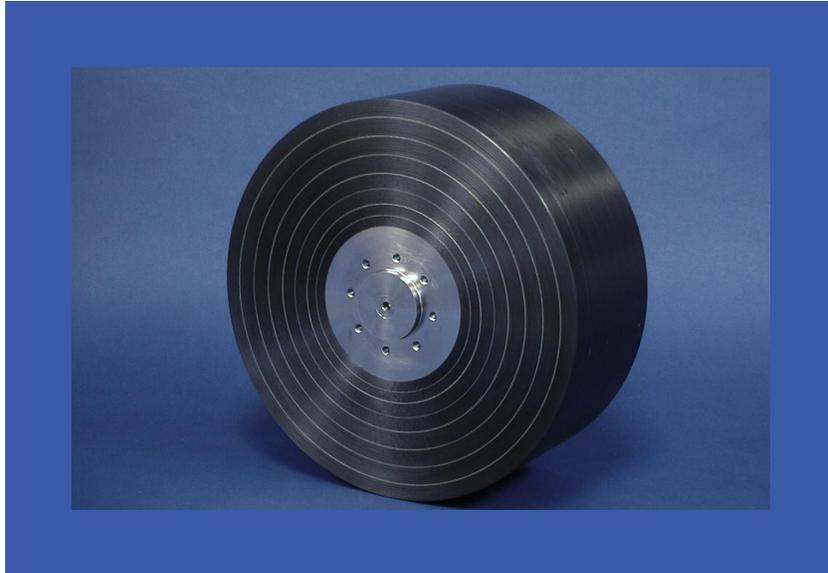
Fig. 1- Preloaded composite rotor for the flywheel energy storage system targeting the replacement of chemical batteries on the international space station

The flywheel, see Fig.1, consists of a solid cylindrical composite energy storage unit made of concentric rings press fit (preloaded) together, operating with a rotor tip speed approximately 835 m/s.

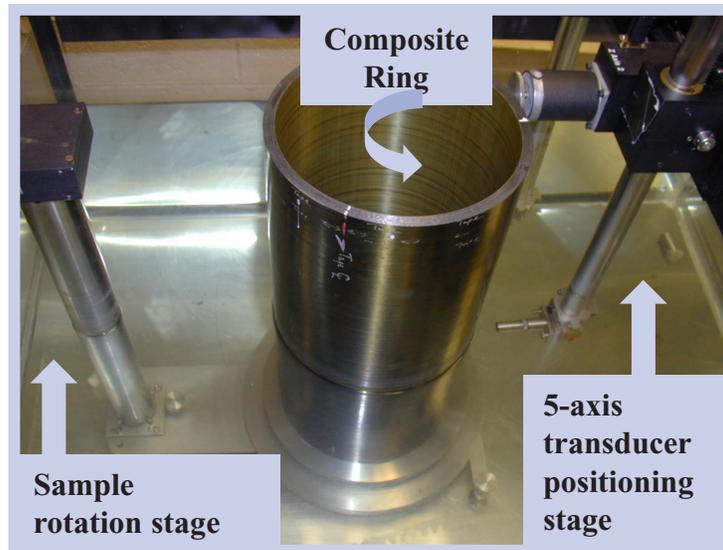
Fig. 2.- Immersion ultrasonic scanning system as applied to composite ring evaluation

Pulse Echo and Through Transmission Ultrasonics - Figure 2 shows the immersion ultrasonic scanning system during a PE inspection of one composite ring. PE is an ultrasonic method in which only one transducer is used to send the sound into the material and then to receive the sound after it bounces off the back surface of the object under inspection. TT is an ultrasonic method in which two transducers are used, one to send the sound from one side into the object under investigation, and a second transducer to receive the sound after it traversed the object. This method requires access to both front (OD) and back (ID) surfaces of objects like composite rings and rotors without a metallic hub. PE method is better suited for the evaluation of an object with one side access similar to the case of a composite rotor with a hub. Both TT and PE methods provide information on the internal state of the material by studying the attenuation mechanisms that take place during the traverse of sound through the material.

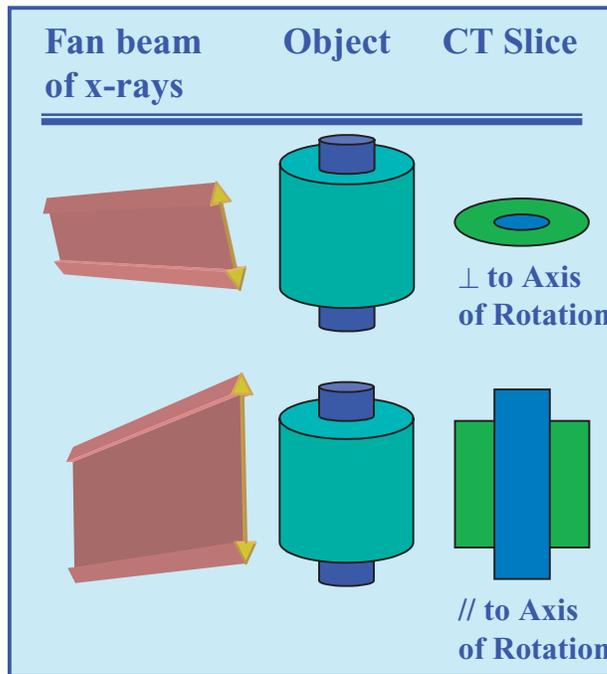
Fig. 3.- Schematic of x-ray computed tomography as applied to composite rotor evaluation

X-ray Computed Tomography and Radiography - Figure 3 shows a schematic of x-ray computed tomography setup where the object under inspection is rotated at small increment angles, 0.2 degree, collecting many projections from the x-ray fan beam after it attenuates through the object and is received at the detector. These projections are then built in the Fourier domain allowing fast inverse Fourier algorithms to be utilized for reconstructing the CT cross-section, called the CT slice, information at a specific location or height. The CT slice reveals internal mass attenuation coefficient differences due to the presence of different material compositions or features. These differences can be attributed to and correlated with density differences between material constituents. X-ray radiography on the other hand, a simpler imaging method than CT, uses the same principle of x-ray attenuation. In conventional and microfocus radiography the x-ray beam is in general conical in shape as opposed to the fan shape in CT, and the resulting image/radiograph is a 2D shadowgram that superimpose all information in the x-ray path. In microfocus radiography, the spatial resolution and contrast sensitivity are improved by comparison to conventional radiography because the focal spot size of the microfocus x-ray tube is on the order of 5-50 μm whereas that of a conventional tube is 400 μm and above. Also, the projection mode in microfocus radiography reduces the scattered radiation which

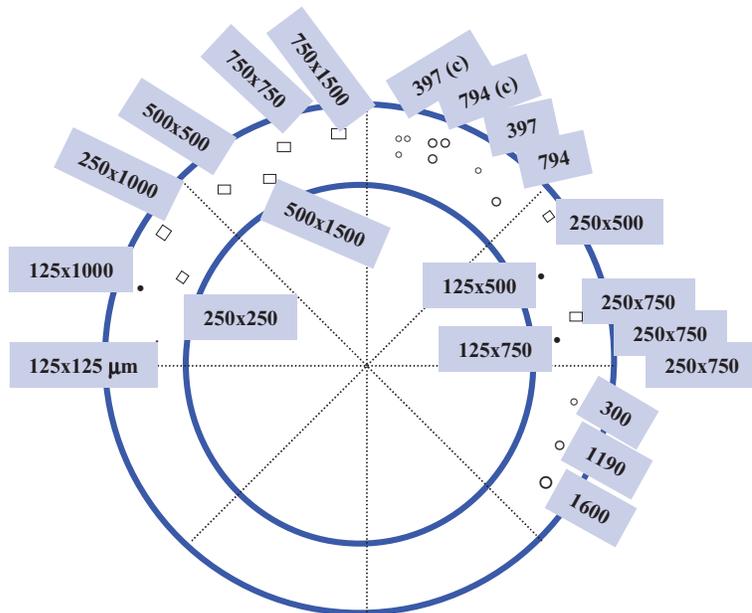
Fig. 4- Schematic of a nondestructive evaluation ring standard with EDM notches and drilled holes. Ring is 12.5 mm high and 12.5 mm thick, and notches and holes are 6.25 mm deep. Measurements shown on figure are in micrometers and the schematic is not to scale. C in 397 (c) stands for cluster of 397 μm drilled holes.

Composite Ring Standard - Figure 4 is a schematic of a typical ring standard with EDM notches ranging from 125x125 μm to 750x1500 μm (5x5 mils to 30x60 mils) and drilled holes ranging from 300 μm to 1600 μm (12 mil to 1/16") in diameter. These notches and drilled holes were 12.5 mm (1/2") deep in a 12.5 mm (1/2") wide by 12.5 mm (1/2") high composite ring.

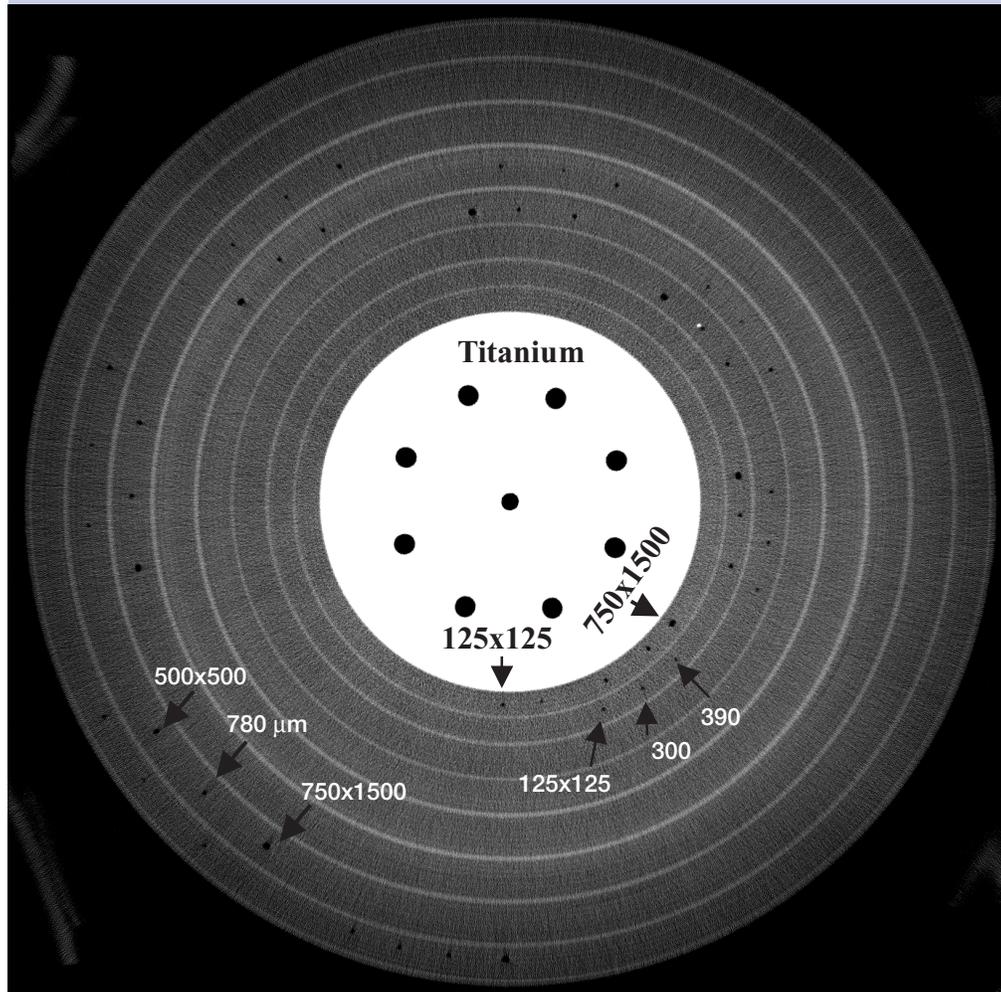
A rotor with composite rim and a titanium hub

Fig. 5 - Computed tomography slice of a multi-layered rotor standard with EDM notches and drilled holes set (125x125, 300, 390, 500x500, 780, and 750x1500 μm) in each layer. This set was duplicated in a spiral fashion starting at the innermost ring near the ID and finishing at the outermost ring near the OD.

Composite Rotor Standard - Figure 5 is a CT slice of a multi-layered rotor standard. The hub is made of Ti-6Al-4V and the rim is a multi-layered PMC. The same set of EDM notches and drilled holes (125x125 μm , 300 μm , 390 μm , 500x500 μm , 780 μm , and 750x1500 μm) was machined into each of the eight composite layers. The set was duplicated in a spiral fashion starting at the innermost ring at the ID to the outermost one at the OD.

selected CT slice shown in figure 5 substantiates the finding. This is a major result for high energy CT to detect low-density flaw down to 125x125 μm in a thick-rim rotor. This further demonstrates that x-ray CT can play a major role in rotor flight certification. Ultrasonic scanning results, not shown herein because of space limitation, demonstrated 1) penetration capabilities of 4.5 cm and detection capabilities down to 750x1500 μm (30x60 mils) in the outermost ring only for the case of 1 MHz, 2) penetration capabilities of 2 cm and detection capabilities of the whole set in the outermost ring and down to 500x500 μm (20x20 mils) in the second ring from the OD at 2.25 MHz, and 3) penetration capabilities of 2 cm and detection capabilities of the whole set in the first two ring from the OD.

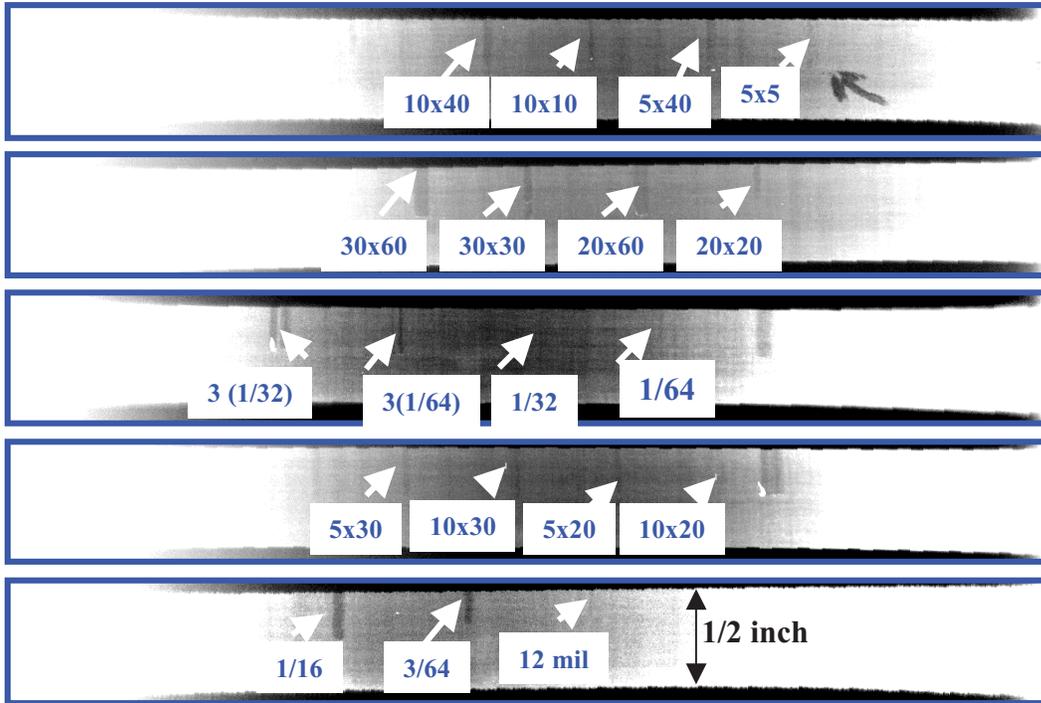
Fig. 6 - Microfocus radiography of one NDE ring standard showing the capabilities of detection down to 125x125 μm (5x5 mils) notch. Measurements shown are in mils and images shown are prints of 5 radiographs taken in direct contact with the ID of the ring.

Ring Standard - Table I shows all the NDE findings taken on two standard rings by using ultrasonic TT and PE methods, conventional as well as microfocus radiography and 420KeV and 3 MeV x-ray CT methods. The microfocus radiography images of one of the standard ring are shown in figure 6. The ultrasonic images are shown in figures 7 and 8. From table I findings and figure 6 images microfocus radiography was demonstrated to be a viable NDE technique to detect EDM notches and drilled holes down to a 125x125 μm notch and 300 μm drilled hole. Conventional radiography was capable of detecting EDM notches down to 250x750 μm and drilled holes down to 780 μm in diameter. However, conventional radiography is capable of detecting metallic inclusion down to 125x125 μm . Computed tomography findings demonstrate that EDM notches down to 125x125 μm and drilled holes down to 300 μm in diameter can be easily detected by 420KeV as well as by a 3 MeV systems. The PE ultrasonic method was found to be capable of detecting EDM notches down to 125x125 μm and drilled holes down to 300 μm in diameter. TT method was capable of detecting EDM notches down to 125x1000 μm and drilled holes down to 780 μm in diameter.

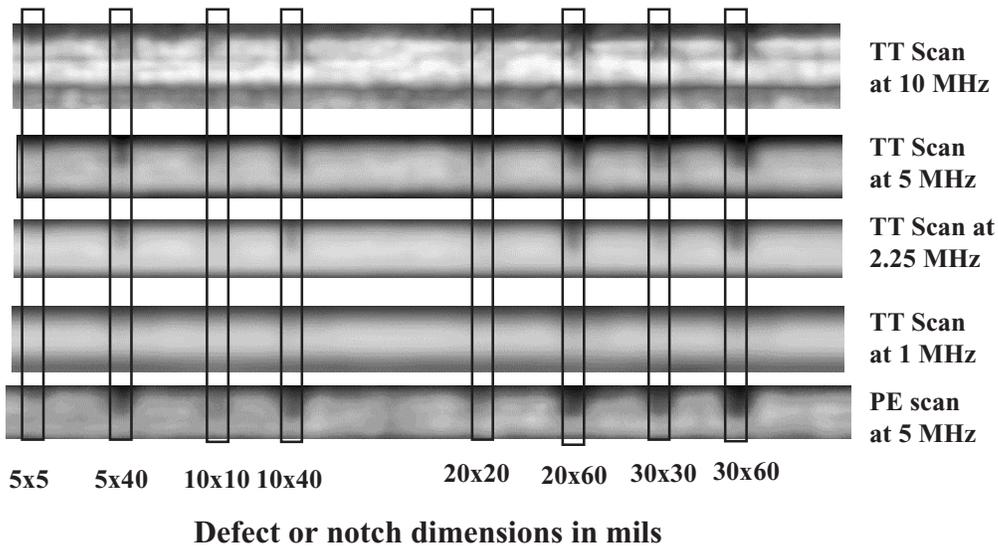
Fig. 7 - Ultrasonic scanning of one NDE ring standard showing the capabilities of detection with through transmission (TT) and pulse echo (PE) methods. The scans of the ring as displayed are open cylinders (rectangles) where the vertical direction represents the height of the ring and the horizontal direction represents the circumference from 0-359 degrees.

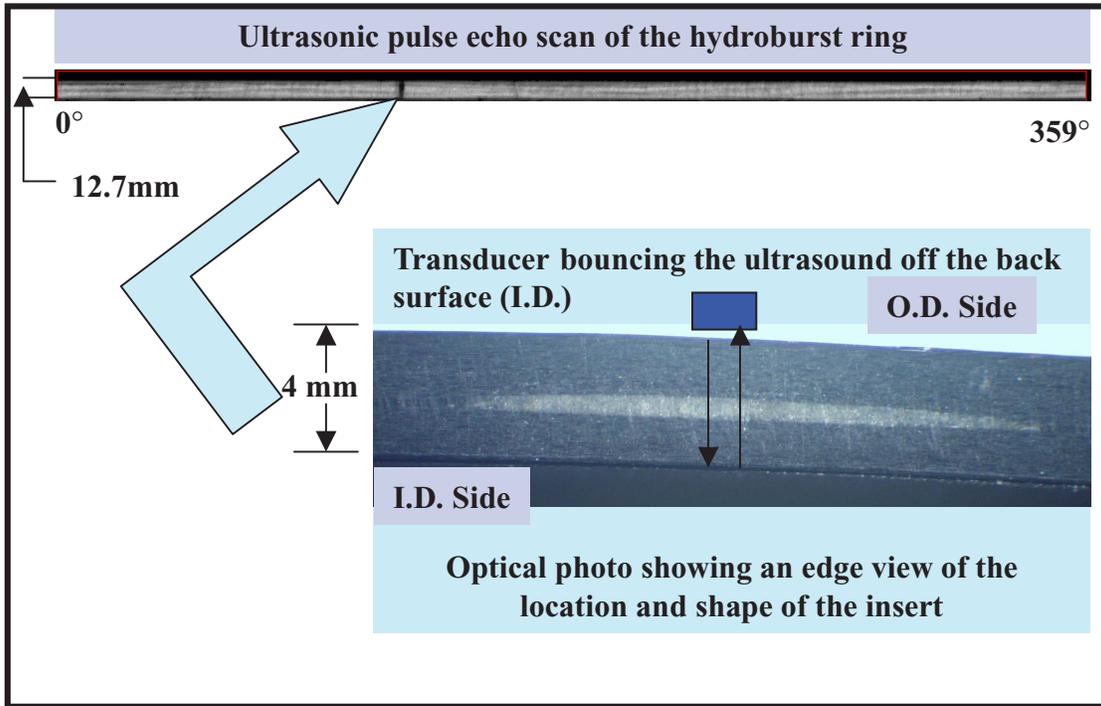
Fig. 10- Immersion ultrasonic pulse echo scan detects the insert of bagging material in a hydroburst ring

Figure 10 shows the ultrasonic PE scan of the hydroburst ring with seeded insert of bagging material located at 120 degree in the middle of the 4 mm thick by 12.7 mm wide ring. The insert was easily detected by PE ultrasonics and is depicted as a black line at the 120 °-angle location at the top of figure 10. The tow-break was simulated by an EDM notch on the ID surface of a hydroburst ring. The notches were easily detected because they were comparable to the larger EDM notches imaged in the ring standard as shown previously in figures 6-8 and Table I.

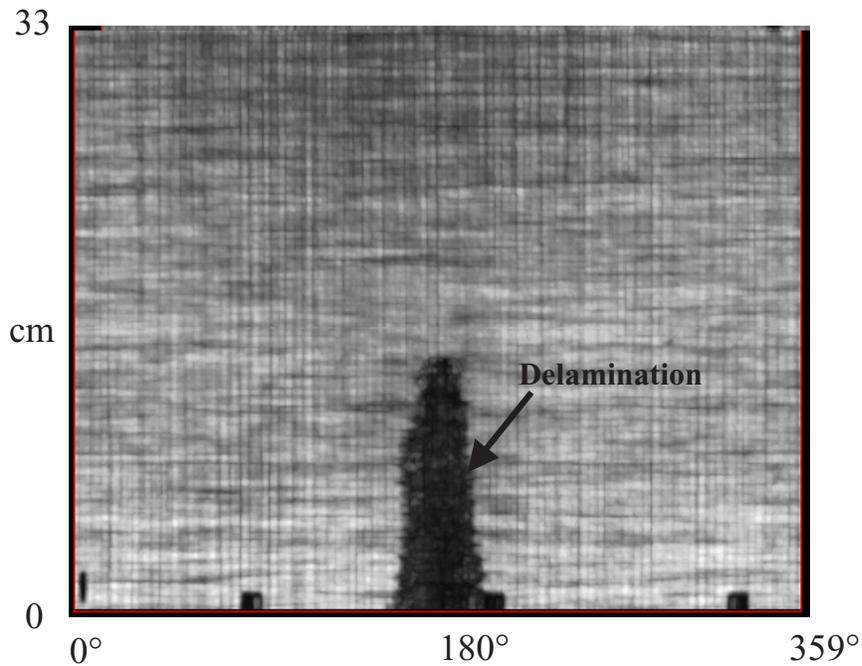
Fig. 11 - Ultrasonic scan showing a large delamination in one of the rings

Examples of Possible Occurring Flaws - Figure 11 shows a large delamination in one of the rings as detected by PE ultrasonic method. This delamination spans a 54-degree angle near the bottom edge, and is 15 cm in height. The optical photograph of a section of the ring as exposed to the surface shows clear evidence of that delamination in figure 12. Figure 13 shows a sizeable void, about 1x2 mm (40x80 mils), at the glass-composite interface as detected by x-ray CT. The glass layer was machined off and the low-density feature as detected by CT was demonstrated to be a void. A selected area from a CT slice of a composite ring is shown in figure 14(a). The dark region, lower-density feature near the I.D., depicts the presence of a resin rich area. After the ring

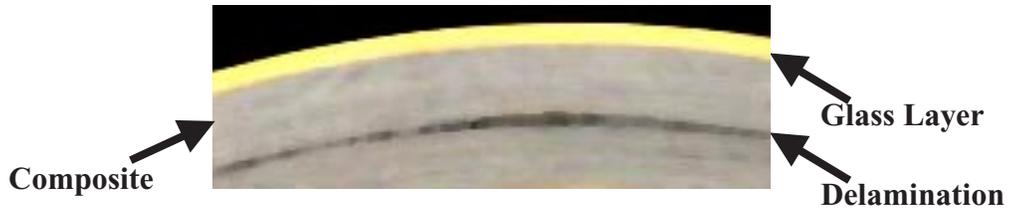
Fig. 12 - Optical photograph of a section of the ring showing the delamination (Fig. 11) as exposed to the surface

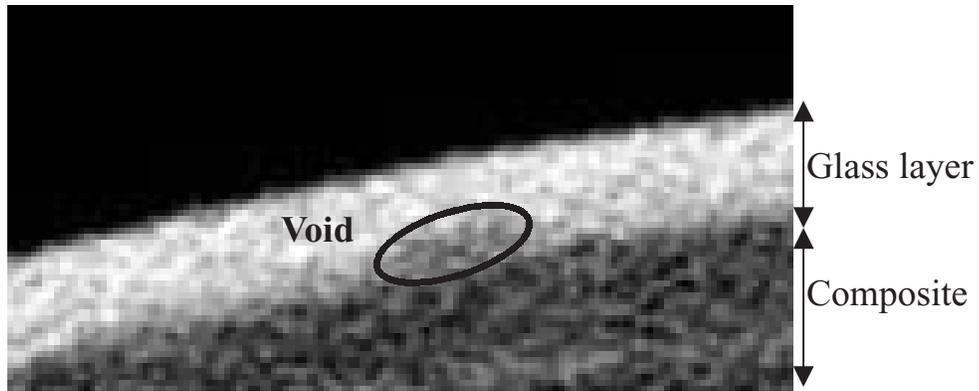
Fig. 13 - Selected section from the CT scan showing a 40x80 mils void in the glass layer

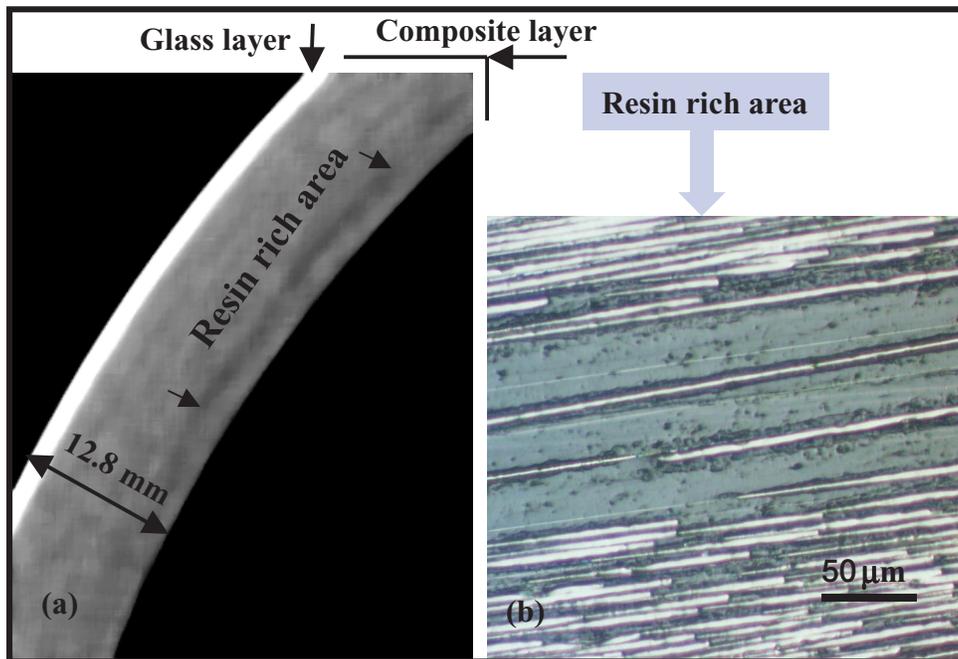
Fig. 14- Selected area from a computed tomography cross section showing a resin rich region within the composite layer (a), and an optical photograph of the resin rich region after destructive sectioning and polishing for validation (b)

was sectioned destructively and the specific location was exposed to the surface and polished, the optical photograph (Fig. 14b) confirms the CT findings of the resin rich area.
