NASA/TM—2001-210960

Ultrasonic Resonance Spectroscopy of Composite Rings for Flywheel Rotors

Laura M. Harmon
Cleveland State University, Cleveland, Ohio

George Y. Baaklini
Glenn Research Center, Cleveland, Ohio

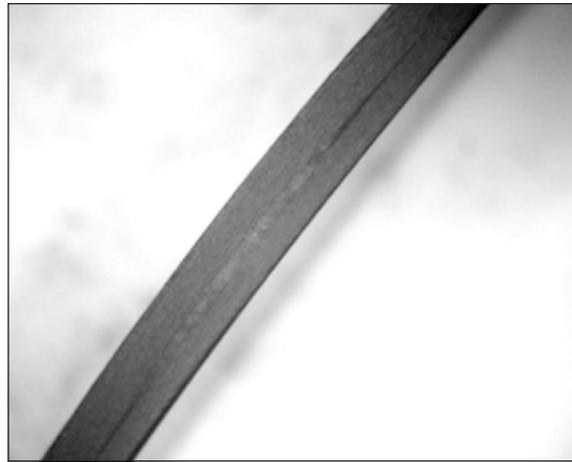
Figure 7.—Optical photograph of HB1.3.1 at the insert.

Figure 7 shows the region of ring HB1.3.1 with the foreign material insert. Figure 8 presents plots of the spectrum and spectrum resonance spacing domains for locations with and without the foreign material insert. In a portion of the ring without the insert, the fundamental resonant frequency for the full thickness of 2.527 mm (0.0995 in.)
