IAC-02-1.5.02

**Durability Issues for the Protection of
Materials From Atomic Oxygen Attack
in Low Earth Orbit**

NASA Glenn Research Center

53rd International Astronautical Congress

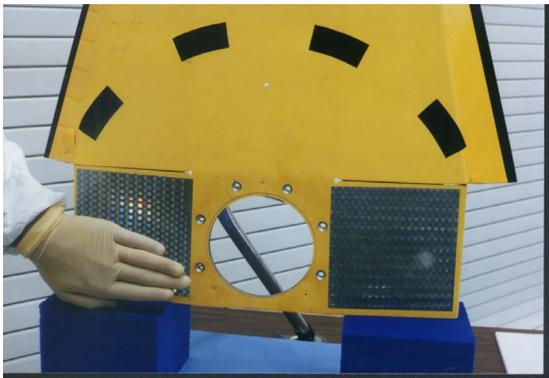
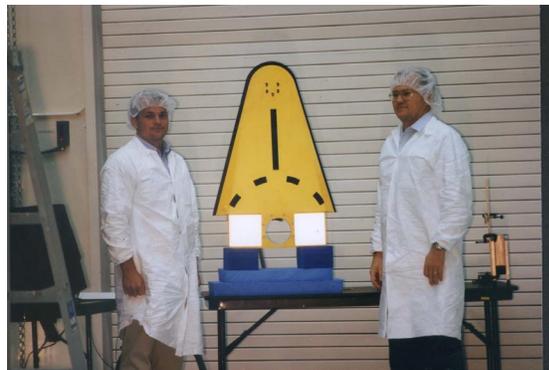
Figure 1. – EURECA retroreflectors after retrieval close up and during illumination.

The results indicated that the protective coating provided excellent protection and the retroreflector performed as planned except in a small 3 cm patch where the protective coating was accidentally abraded prior to flight as a result of handling during preflight ground integration.³ Figure 1 shows a close up picture of the retroreflectors as well as their appearance during illumination after retrieval.

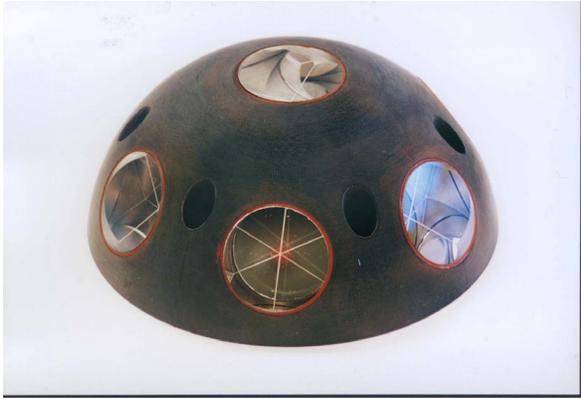
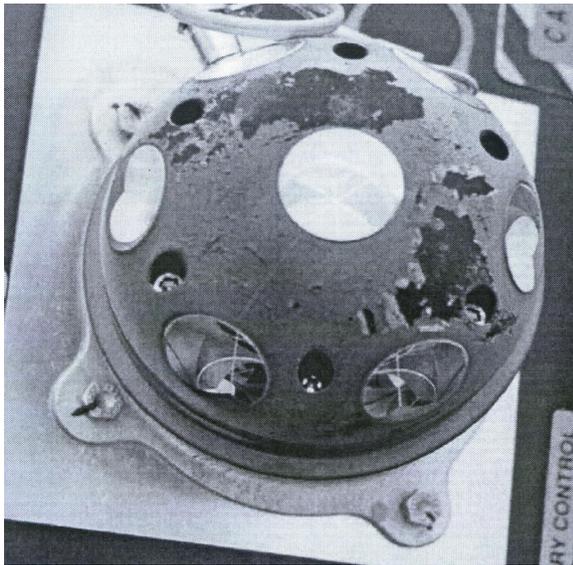
ISS retroreflectors, which serve in a similar role as the EURECA retroreflectors, employ a glass corner cube retroreflector that is housed in a 10 cm diameter Delrin[®] 100 polyoxymethylene mount. To prevent atomic oxygen attack of the Delrin[®], the machined polymer surfaces were coated by the same processes, in the same facility and with the same ~ 1000 Å thin film of sputter deposited 8 percent fluoropolymer-filled SiO₂ that was used for the EURECA retroreflector. Several of these retroreflectors have been mounted on the external surfaces of the ISS structures at various locations that are exposed to LEO atomic oxygen. Figure 2 shows a close up of one of the coated retroreflectors prior to use on ISS in space as well as a photograph from space of a retroreflector after attack by atomic oxygen.

It is clear from the in-space photograph that the coating was only partially attached allowing direct atomic oxygen attack of the unprotected areas.

Figure 2. – ISS retroreflectors prior to launch and after atomic oxygen attack during use in space on ISS.

The machining of the Delrin[®] 100 retroreflector mount surfaces produces machine marks or rills in the surface resulting in a highly defected atomic oxygen protective coating. Such rills allow atomic oxygen to oxidize and undercut the high erosion yield Delrin[®] causing the coating to gradually be left as an unattached gossamer film over the retroreflector mount which could be easily torn and removed by intrinsic stresses and thruster plume loads. The use of smoother surfaces, surface-leveling coatings over the machined Delrin[®] or use of alternative atomic oxygen durable materials could potentially eliminate the observed problem.

Atomic oxygen protective coatings have been developed and used in space that performs acceptably. However, rough surface substrates cause defects in the protective coatings that allow atomic oxygen to react and gradually undercut the protective coating. In the case of machined Delrin[®] ISS retroreflector mounts, such roughness has lead to detachment of portions of the protective film covering the retroreflector mount.

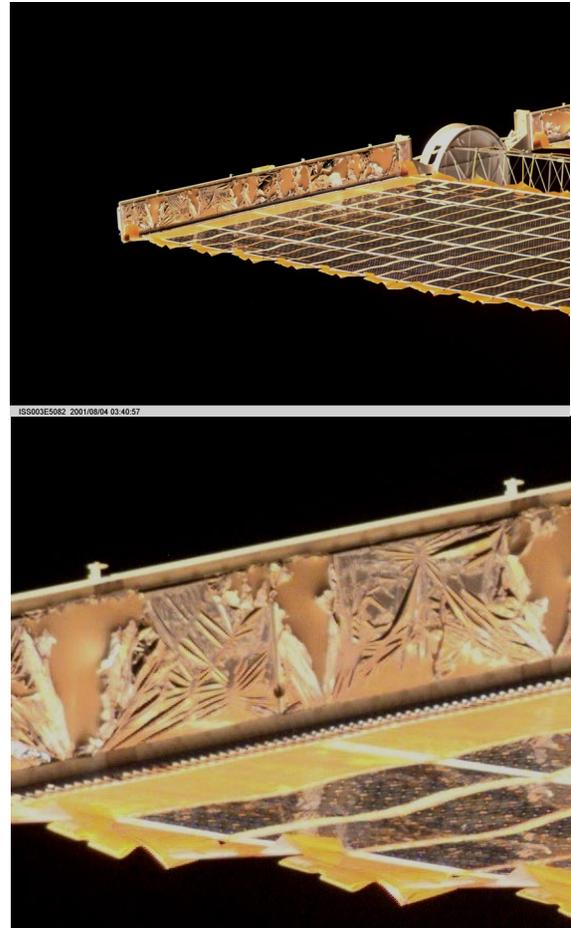
blanket. The Kapton[®] was coated on both surfaces with 1000 Å of vacuum deposited aluminum. Photographs of the array were taken in orbit, after exposure to atomic oxygen from December 2000 through December 2001, which indicated that the Kapton[®] blanket had been almost completely oxidized, leaving only the thin largely torn aluminization in place as shown in Figure 3.

Figure 3. – ISS photovoltaic array blanket box cover after one year in LEO.

The lack of atomic oxygen protection provided by the aluminized Kapton[®] blanket cover for the ISS photovoltaic arrays box cushion is thought to be due to the trapping of atomic oxygen between the two aluminized surfaces on the 0.0254 mm thick Kapton[®] blanket. Defects in the space exposed aluminized surface allow atomic oxygen to erode undercut cavities. If the undercut cavity extends downward to the bottom aluminized surface, then the atomic oxygen becomes somewhat trapped and has multiple opportunities for reaction until it either recombines, reacts, or escapes out one of the defects in the aluminization. This eventually results in a complete loss of the Kapton[®] with only the aluminized thin film remaining. The vacuum deposited aluminum has a slight tensile stress that causes stress wrinkling of the unsupported aluminum films. Figure 7 is a photograph of a vacuum deposited aluminized Kapton[®] sample that was placed in a radio frequency plasma environment to completely oxidize the Kapton[®] over a portion of the sample.

As can be seen in Figure 7, where the ~1000 Angstrom aluminum film in the lower portion of the sample is free standing, stress wrinkles and tears develop similar to those seen in the ISS photograph of Figure 3.

Atomic oxygen undercutting of the double aluminized Kapton[®] blanket covers for the ISS photovoltaic array box cushions has occurred resulting in a torn and partially detached aluminum film. Based on computational modeling, and ground laboratory characterization testing, early failure of the aluminized Kapton[®] ISS PV blanket box covers can be caused by excessive atomic oxygen attack resulting

from the presence of many small defects in the aluminization in comparison to many fewer defects in the double SiO₂ coated Kapton[®]. High defect area, defect density and the application of the protective coating to both sides of the aluminized Kapton[®] ISS PV blanket box covers appear to have contributed to the early failure of the covers as indicated by ground laboratory atomic oxygen testing, SEM, moisture transmission and Monte Carlo computational modeling. The use of a protective coating on only the exposed side of the Kapton[®] blanket may increase the durability of the blanket.

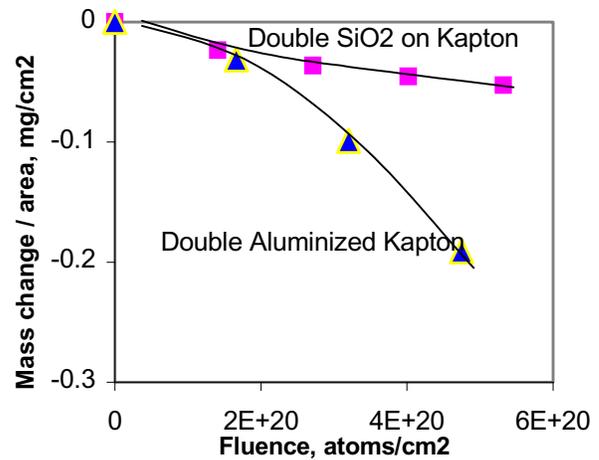
The double-SiO₂ coated ISS solar array blankets may show similar detachment of the outer surface SiO₂ layer with time. However, the defect density appears to be much lower for SiO₂ coated Kapton[®] than for vacuum deposited aluminum coatings as shown in Figure 4, which compares the experimental results of RF plasma oxidation

Figure 4. – Comparison of RF plasma oxidation of aluminized and SiO₂ coated Kapton[®].

of double-sided aluminized Kapton[®] with that of double-sided SiO₂ coated Kapton[®].

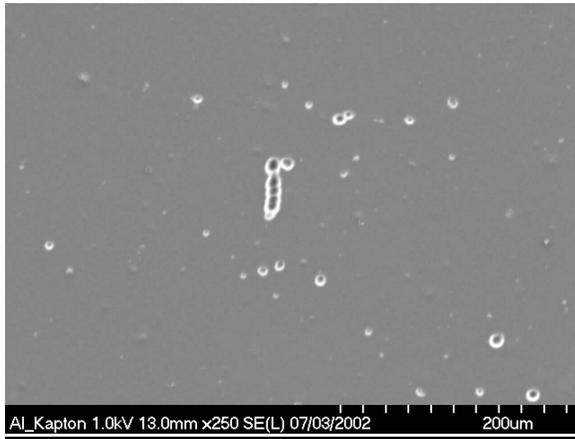
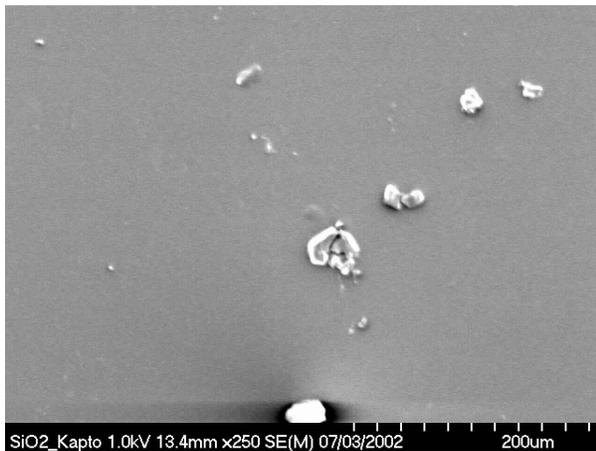
Figure 5 shows corroboration of the much greater defect density of double aluminized Kapton[®] than that of double SiO₂ coated Kapton[®]. Scanning electron microscopy (SEM) of the two surfaces after atomic oxygen exposure of the materials in ground laboratory RF atomic oxygen plasmas to an atomic oxygen effective fluence of 3.18×10^{20} atoms/cm² followed by tape peeling to remove any unsupported protective coating at defect sites.

As can be seen in Figure 5, the aluminized Kapton[®] shows evidence of far greater number of defect sites than for the SiO₂ protected Kapton[®], where only debris particles are evident on the surface.

a. Kapton[®] that had been aluminized

b. SiO₂ protected Kapton[®]

Figure 5. – SEM photos of atomic oxygen exposed ISS PV blanket box cover and ISS PV array coated Kapton[®].

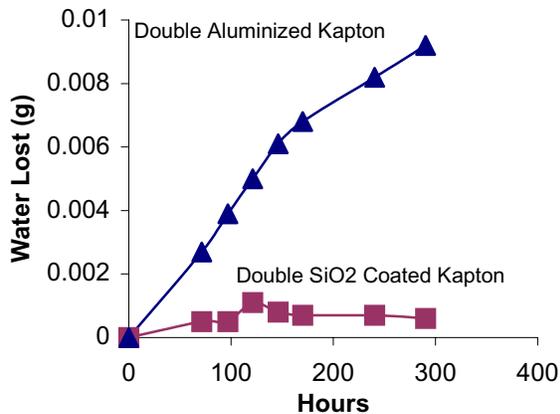
Further evidence of the greater number of pin windows in the aluminized coatings can be seen by comparing the water vapor transport through the two protected materials in their pristine condition, as shown in Figure 6.

Figure 6. – Water vapor transport rate through protected Kapton[®].

Data for Figure 6 was obtained by measuring the weight loss of water filled Petri dishes which had covers made of the pristine ISS PV blanket box cover and ISS PV array coated Kapton[®] materials. The samples were sealed to the Petri dishes by means of petroleum jelly to minimize moisture loss other than from through the protected polymers. As can be seen there is approximately a factor of 16 greater defect area in the double aluminized Kapton[®] compared to the double SiO₂ coated Kapton[®]. When one considers the greater apparent number of defects as well as the greater area of defects, one is lead to consider that the aluminized Kapton[®] has many more small defects than the SiO₂ coated Kapton[®].

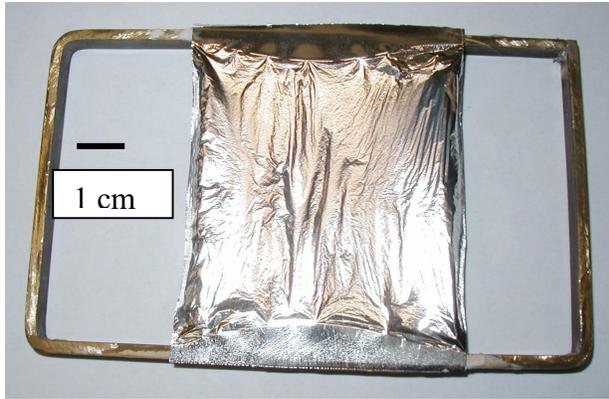
Figure 7. – Photograph of a vacuum deposited aluminized Kapton[®] sample bonded to a metal frame after ground laboratory oxidation of the Kapton[®].

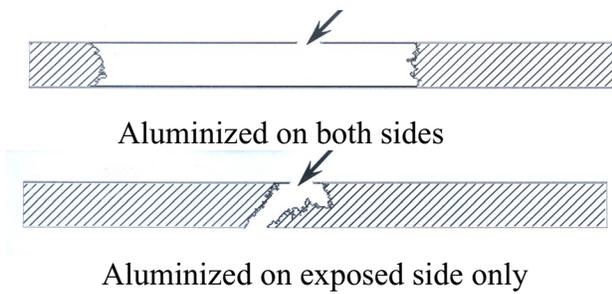
0.0254 mm thick) Kapton[®] blanket. Figure 8 compares the Monte Carlo model computational erosion results for a 45-degree angle of attack (relative to the surface normal) of the atomic oxygen for both double surface-coated Kapton[®] (which was the case for ISS) and single top surface-coated Kapton[®].

Figure 8. – Monte Carlo computational atomic oxygen erosion predictions for a 45 degree from perpendicular angle of attack of atomic oxygen at a crack or scratch defect in the aluminized Kapton[®] surface.

As can be seen from Figure 8, even though the atomic oxygen gradually becomes less energetic with the number of interactions and has approximately a 13% chance of recombination, the trapped atoms undercut far more in the actual ISS case of a double aluminization as would have occurred if the Kapton[®] was simply aluminized on one side. Thus, contrary to intuition, the use of two atomic oxygen protective coatings rather than a single coating appears to cause more rather than less undercutting attack. The extent of undercutting of trapped atomic oxygen is also dependent on the opportunity for the atoms to lose energy, recombine, or escape back out the defect opening. Figure 9 shows the results of 2-dimensional Monte Carlo computational modeling predictions for a 45-degree angle of attack atomic oxygen on a 13.4 micrometer wide crack or scratch in the protective coating for both single side and double side aluminized Kapton[®].

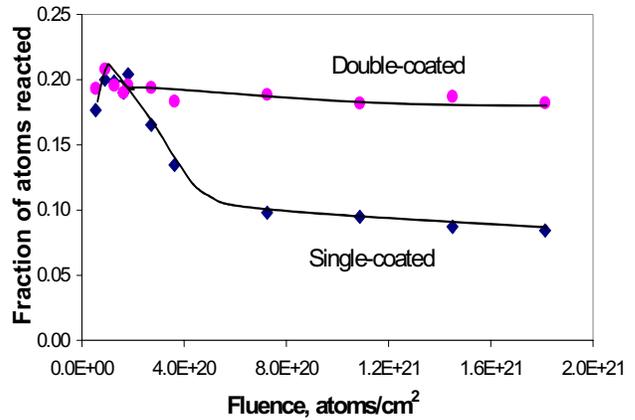
As can be seen in Figure 6, initially, as the undercutting starts the existence or absence of the back surface coating plays no role and as the cavity grows the probability of atoms reacting increases due to trapping of the incoming atom. However, when the undercutting reaches the bottom surface,

Figure 9. – Computational atomic oxygen erosion predictions for 45-degree incident atomic oxygen attack at crack or scratch defect sites on protected Kapton[®].

atoms arriving at the plane of the bottom can either escape (in the case of no bottom protective coating) or have a chance or scattering with reduction in energy through partial thermal accommodation or recombine (in the case of the a bottom surface protective coating). The modeling indicates that the double surface aluminized Kapton[®] consistently reacts about twice as many atomic oxygen atoms as the single surface aluminized Kapton[®] except at very low fluences where the erosion in either case does not reach the bottom of the polymer. Thus, it appears that a single surface aluminized Kapton[®] would have been much more durable because the unreacted atoms passing through the bottom of the polymer would simply enter into the open pore foam and gradually react with it, without causing much damage to the aluminized Kapton[®].

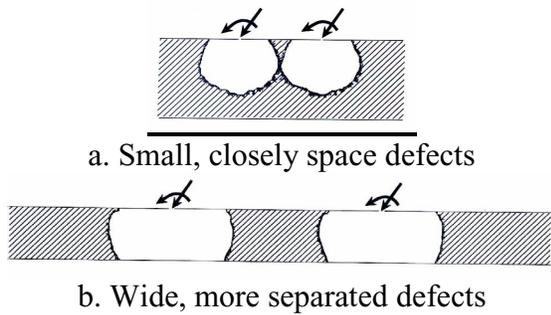
Figure 10. – Monte Carlo predictions comparing the same fractional crack defect areas but different defect sizes.

width of the crack defect in the protective coating. The comparison of resulting undercut cavities is shown in Figure 10 which compares the undercut cavities under LEO sweeping atomic attack conditions. Each configuration was run to the same fluence level.

As can be seen from Figure 10, the undercut cavity for the closely spaced small defects touch each other which would allow the upper portion of the blanket to become detached and even more vulnerable to atomic oxygen attack. However the wide but more separated defected configuration would only have occasional holes in it.

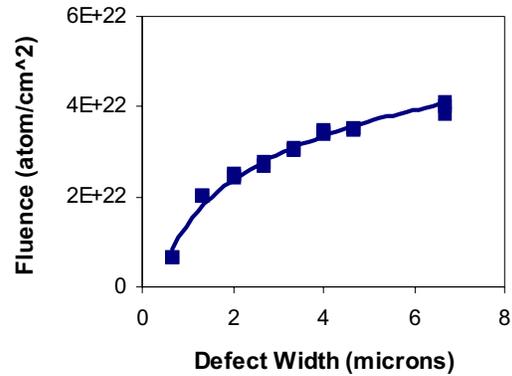
The Monte Carlo computational model can be used to compute the critical atomic oxygen fluence needed to create touching or connecting under cut cavities as a function of defect size for constant fractional defect areas (the ratio of defect area to total surface area). The resulting prediction for fractional defect areas of 0.0257 is shown in Figure 11.

As one can see, the critical fluence, which will allow the upper surface of the blanket to become detached, drops rapidly with defect width for small defects. Thus, if the aluminized surface contains many very small defects, the connection of under cut

Figure 11. – Computational atomic oxygen prediction of critical fluence for fractional defect areas of 0.0257.

cavities will begin to occur at much lower fluences that if the defects were larger and more separated.
